# **Streams and Structures Roadway Design and Bridge Conference**

# Overview of Fluvial Geomorphology and a Tale of Two Bridges

# FM 68 at North Sulphur River

# FM 787 at Trinity River

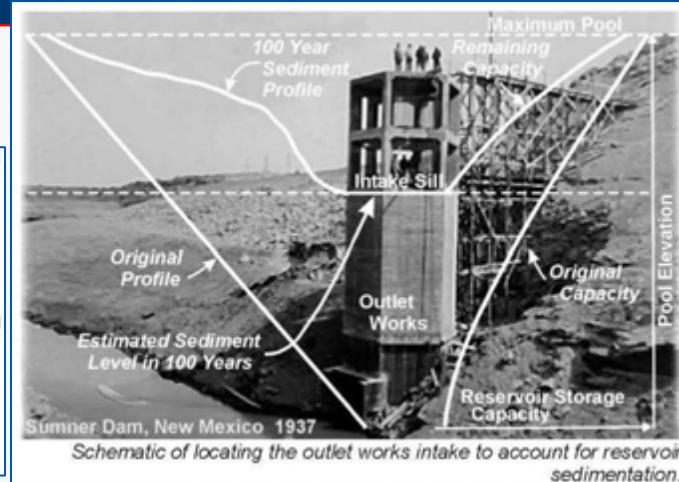
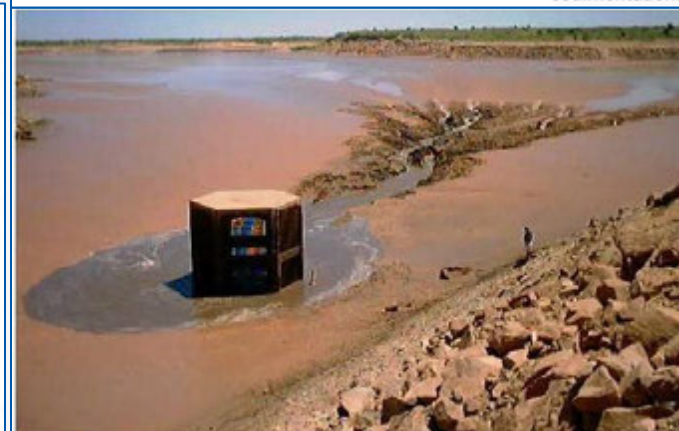
i. Channel degradation resulting from lack of upstream sediment source, downstream from Sumner Dam near Fort Sumner, NM.

f. Reservoir sedimentation has buried the outlet at Sumner Dam near Fort Sumner, NM.

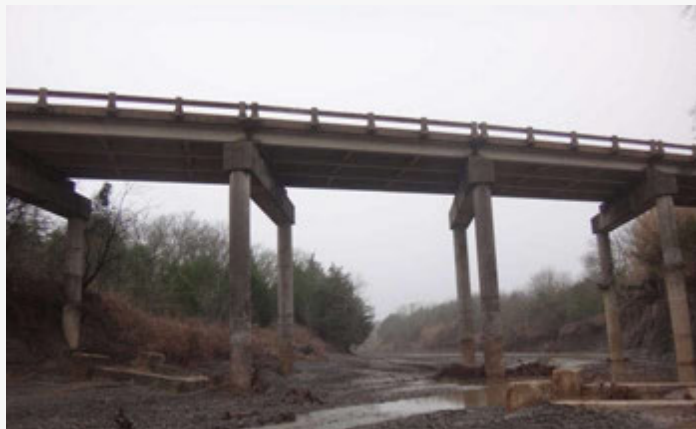
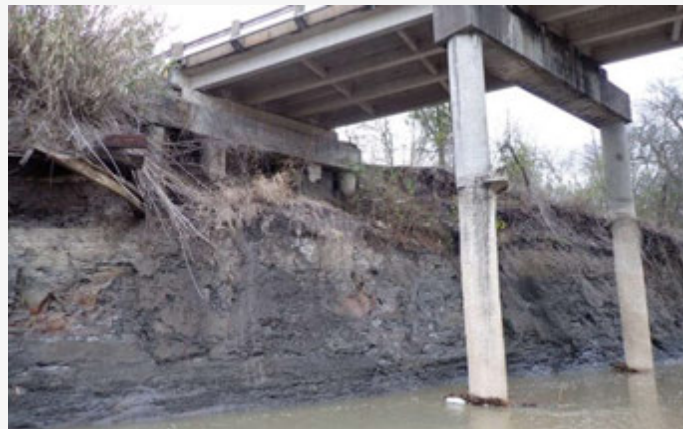
## Existing FM 68 Bridge

- Built in 1943 at 200' long with spread footing foundations
- Lengthened in 1979 to 280' and foundations replaced with drilled shafts
- As of 2022 inspection, there was up to 20' of drilled shaft exposure at interior bents and increasing encroachment of the north channel bank into the north abutment
  - 8'-10' of the channel degradation was through shale

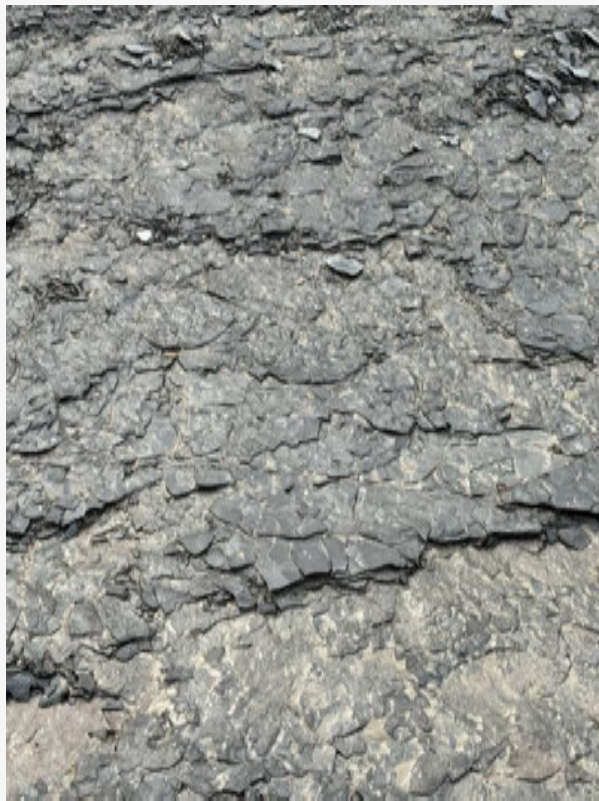
## Site Visit – 1/9/2024

- Participants - TxDOT Paris District, TxDOT DES H&H, Huitt-Zollars, Inc., WEST Consultants, Inc.
- Observations
  - Exposed bedrock (shale) in the riverbed showed active signs of weathering.
  - Bed material varies in thickness, 1' – 3', and is composed of predominantly well-sorted fine-grained silt and clay, likely from the slaking of the shale. Bars and the presence of a sinuous channel within the main channel are evident.
  - Over 8' of riverbed degradation observed since bridge was lengthened in 1976.
  - Channel is actively widening. Shale is exposed on channel banks. Soil on top of shale shows signs of slumping, typical of oversaturation and sudden drawdown (flash flooding).

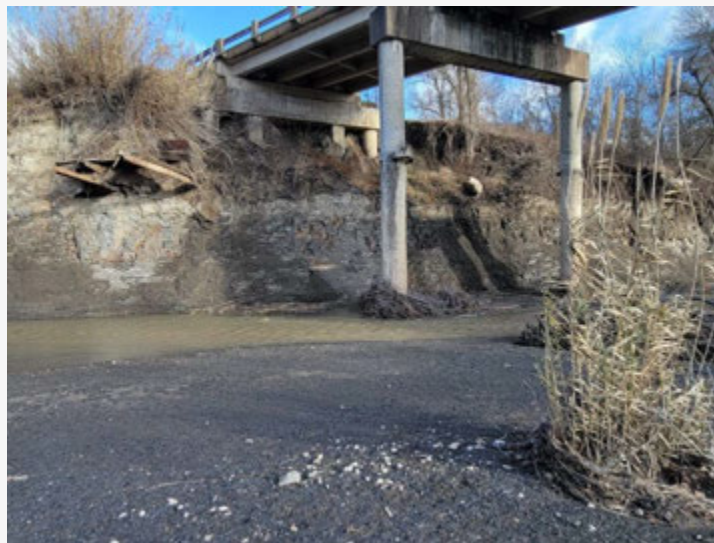
## Site Visit – 1/9/2024

- Observations, cont'd.
  - Trees located along bank edges are failing due to bank erosion in vicinity of bridge. Channel conditions farther upstream and downstream appear more stable with stable bank vegetation.

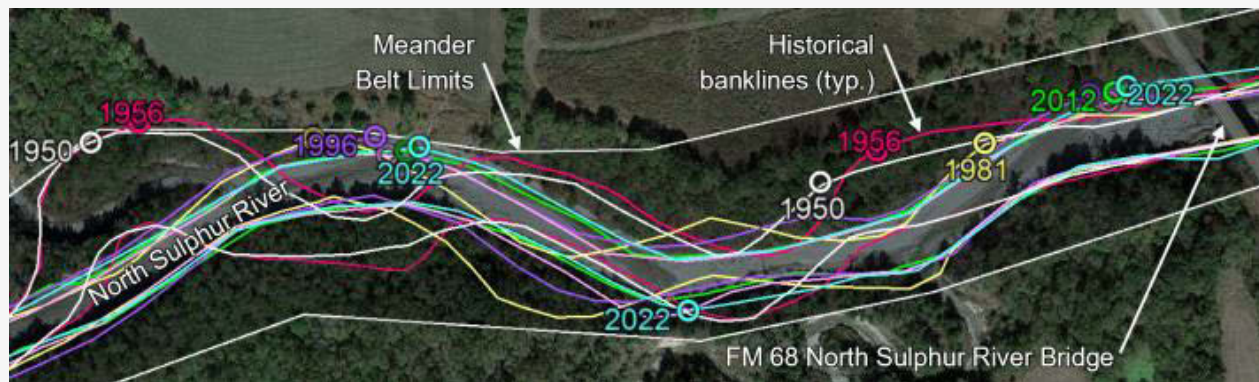
**Figure 5. Channel top width bank lines since 1950, just upstream of bridge site**

- Aerial photographs were collected from the past 74 years (since 1950), and the top edges of the channel bank visible on the photographs was digitized and georeferenced.
  - 1950, 1956, 1981, 1996, 2001, 2005, 2012, 2022
- The meander belt was delineated based on observance of peaks and troughs in historical imagery, which estimates the limits to which the river will migrate laterally.

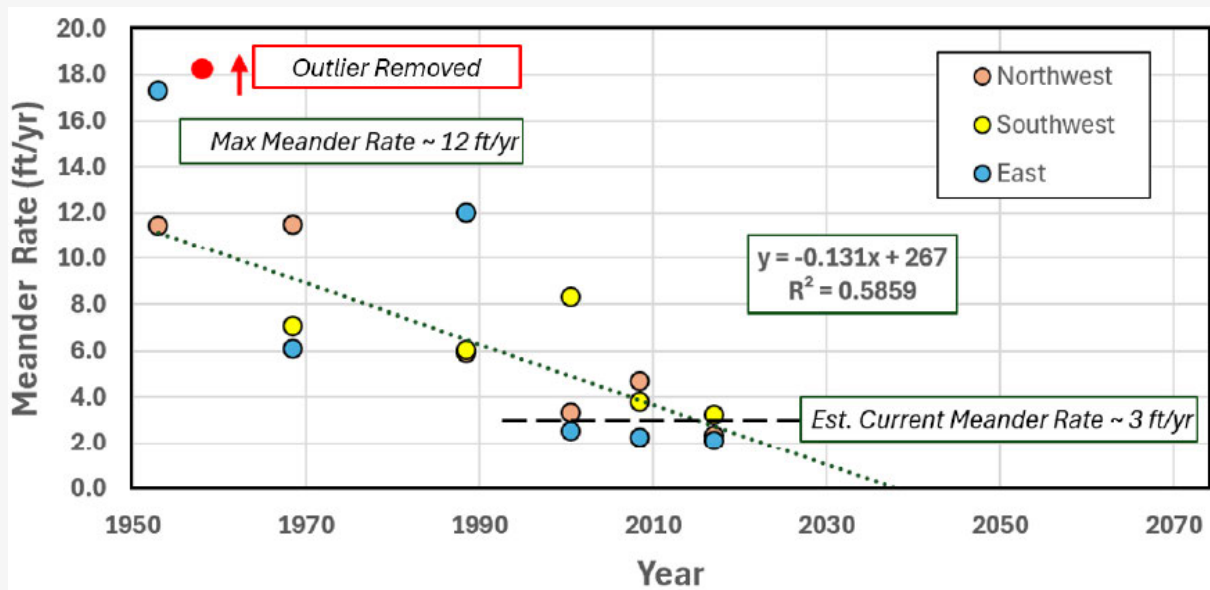
**Figure 6. Analyzed meander migration rate locations**

- The observed meander rates were at a maximum of 12 ft/yr observed between 1950 and 1990, with values of 3 ft/yr in recent years.

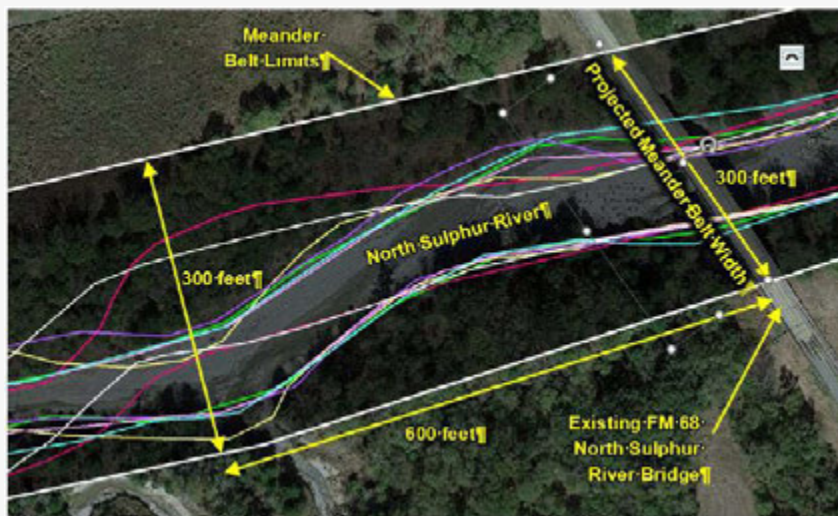
**Figure 9. Projected meander belt width**

- A 300' meander belt was estimated for purposes of determining the proposed bridge length. It was recommended for the bridge to span this belt by at least 50' on each end.

- The proposed bridge was designed at 410' span to sufficiently span the estimated meander belt.

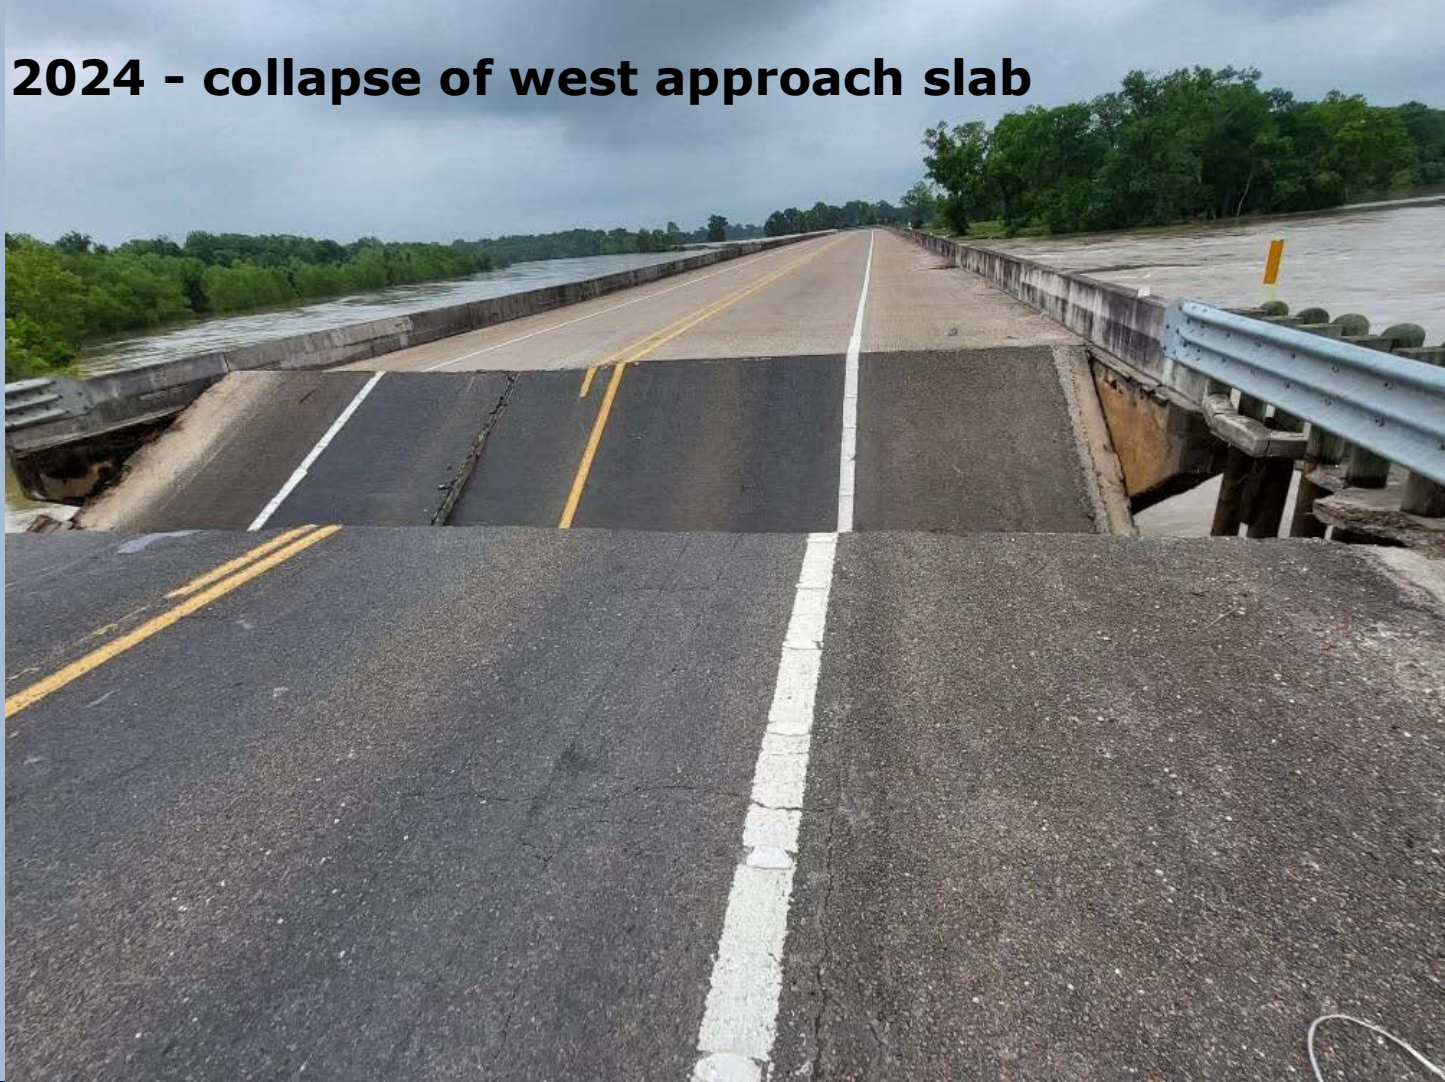
**May 7, 2024 - collapse of west approach slab**

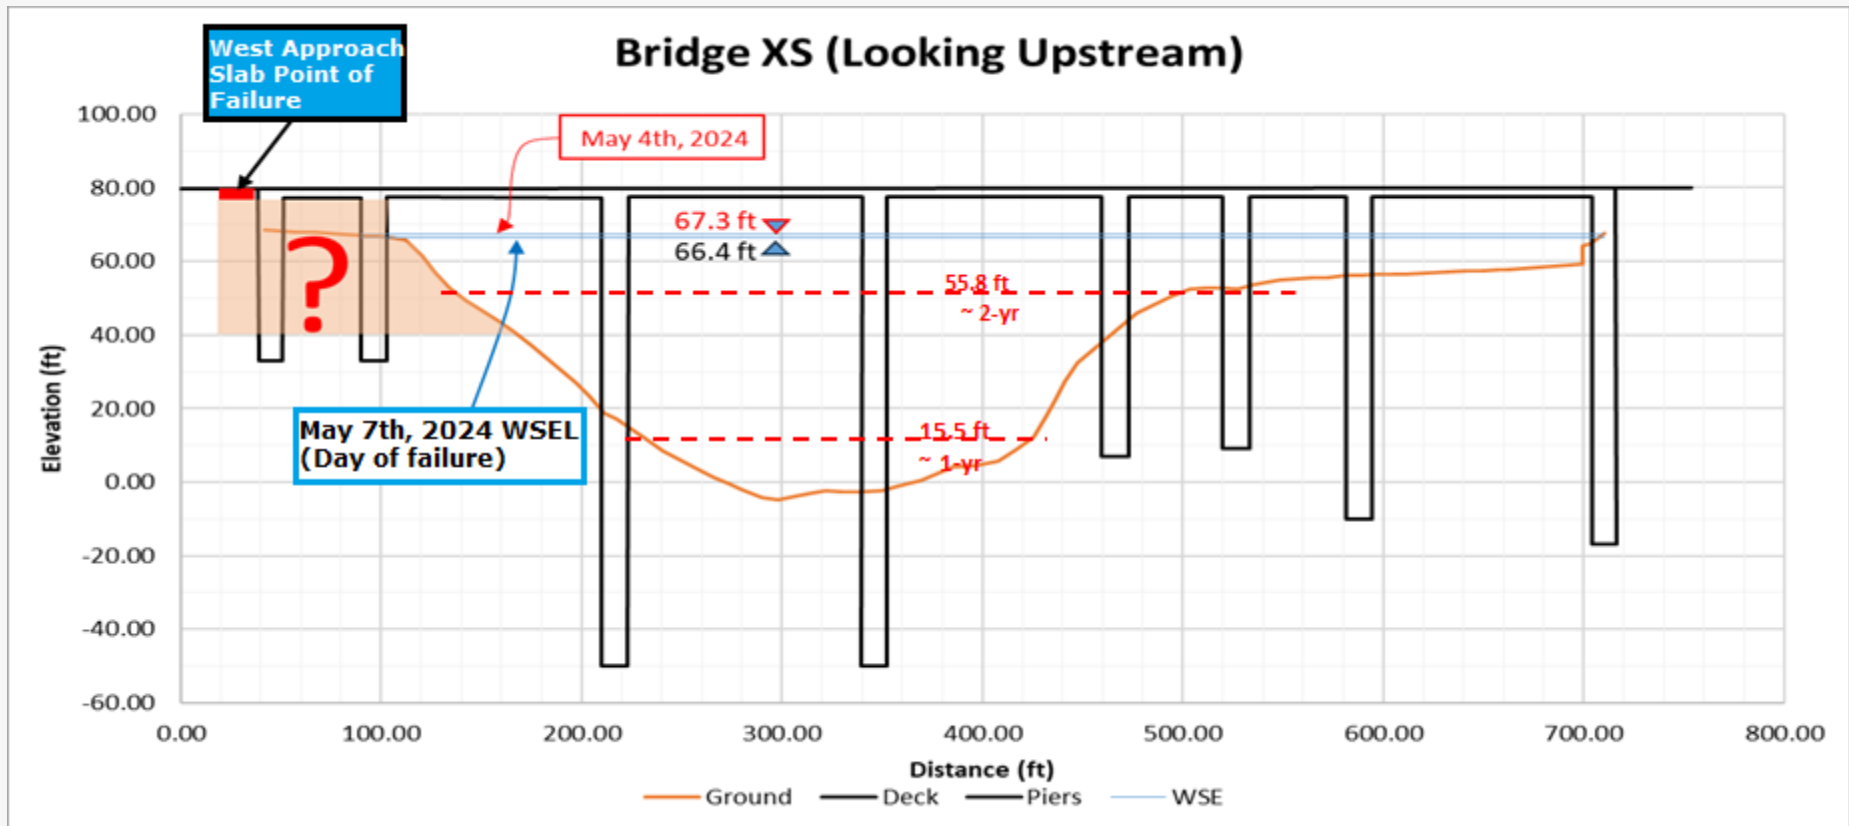
## May 7, 2024 – Trinity River Bridge experienced Partial Collapse

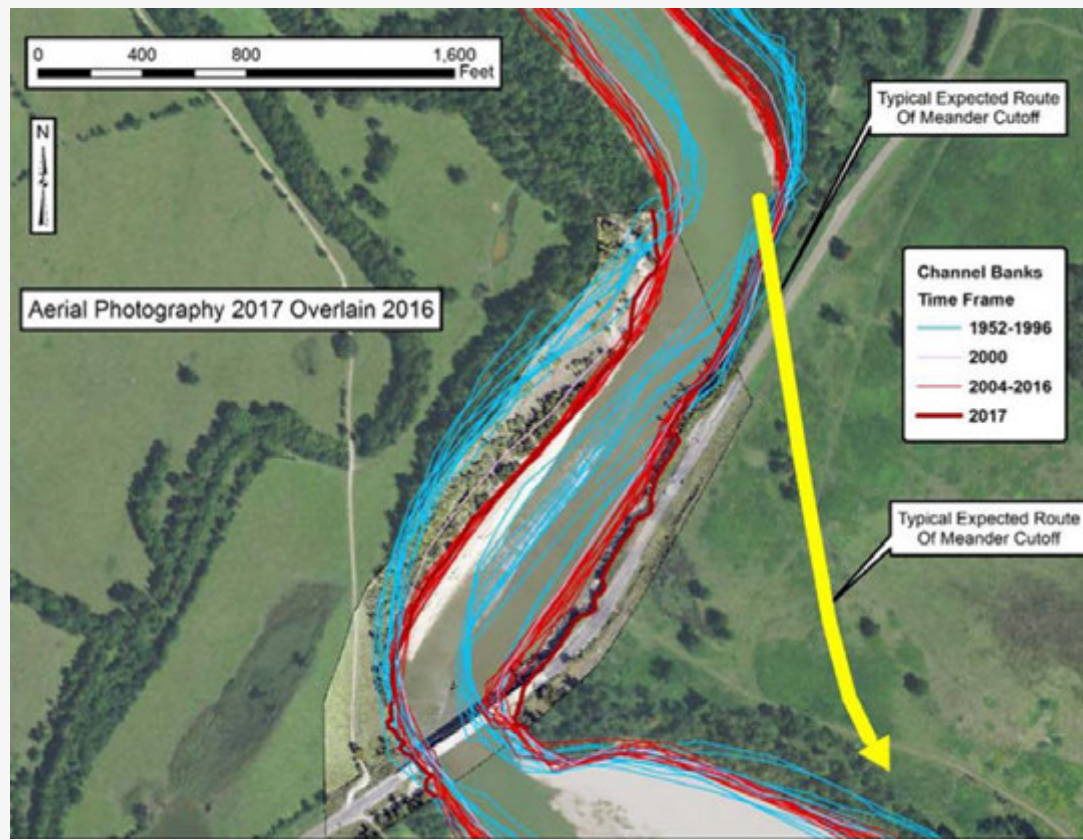
- Evaluated stability of channel based upon historical aerial imagery
- Determined that erosion pressure at abutments of the existing bridge will continue to increase over time
- Recommended relocating crossing

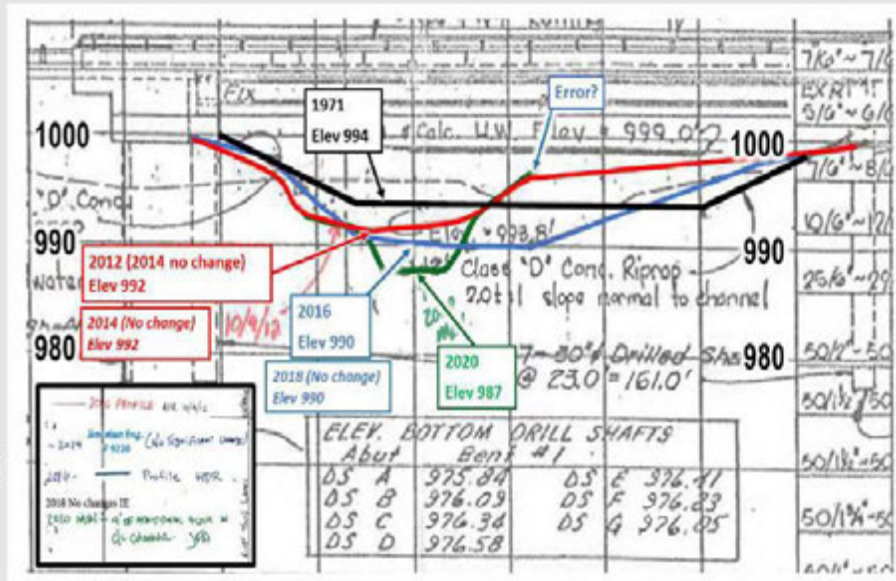
- Scour from as-built to 2012 = 2 ft.
- Scour from 2012 to 2014 = 0  
(no difference)
- Scour from 2014 to 2016 = 2 ft.
  - Channel appears to have scour on right bank and scour on channel bottom.
- Scour from 2016 to 2020 = 3 ft.
  - Channel shown 3 ft of degradation at the thalweg.
- Scour from 2020 to 2021 = 1 ft.  
(not shown on the sketch)
