RE: US 181 Harbor Bridge Replacement Project
CSJ# 0101-06-095
Notice of Nonconforming Work

TxDOT retained International Bridge Technologies (“IBT”) to provide an independent review of ARUP-CFC’s design of the New Harbor Bridge. Attached to this letter as Exhibit A is a report prepared by IBT dated April 23, 2022 (the “IBT Report”) detailing its findings regarding FDLLC’s design. The IBT Report identifies a number of instances of Nonconforming Work¹ that raise significant and alarming concerns with the design and construction of the New Harbor Bridge. The findings in the IBT Report establish that FDLLC has failed to provide a design for the New Harbor Bridge that ensures the safety and integrity of the New Harbor Bridge. In short, FDLLC has failed in many significant and material ways to perform the Work on the New Harbor Bridge in accordance with the Contract Documents. Attached to this letter as Exhibit B is a table summarizing certain findings by IBT and corresponding provisions of the Contract Documents that FDLLC has breached. The table is intended as a high-level summary and FDLLC should refer to the complete IBT Report for a full description of IBT’s findings and the numerou

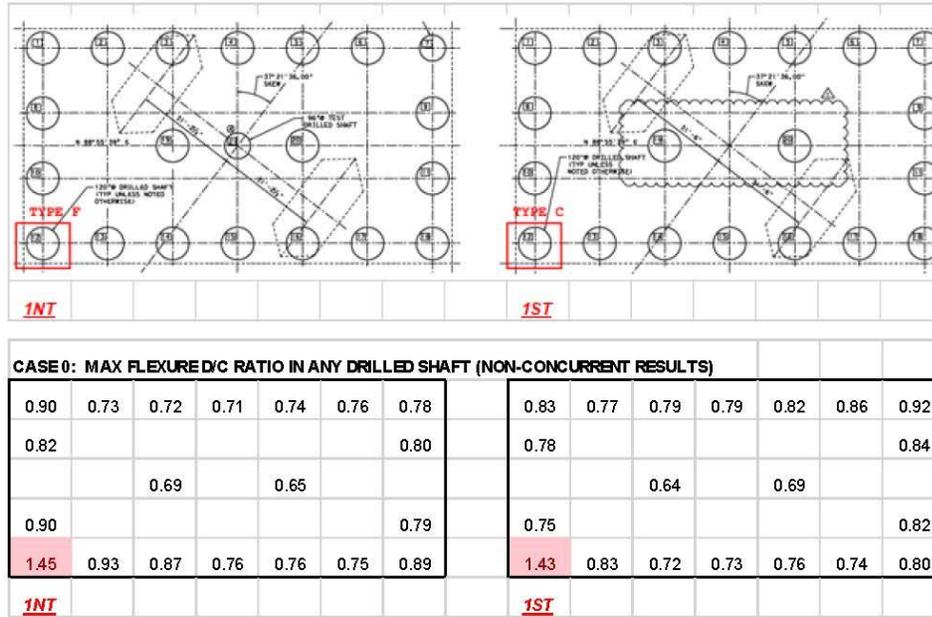
Figure 4: Summary of Maximum Axial Load - Flexural D/C Ratios for the 1NT and 1ST Drilled Shafts – Drilled Shaft Layout Schematic Provided by Others

The capacity at critical sections are reduced due to shallow termination of longitudinal reinforcement in the shaft. Noting that the deficient drilled shafts are at tension locations, Figure 5 below shows that the demand-to-capacity is critical at a lower position in the shaft (~64 ft) where the reinforcement is discontinued at a depth that is too shallow, given the demands in these two drilled shafts at those depths.

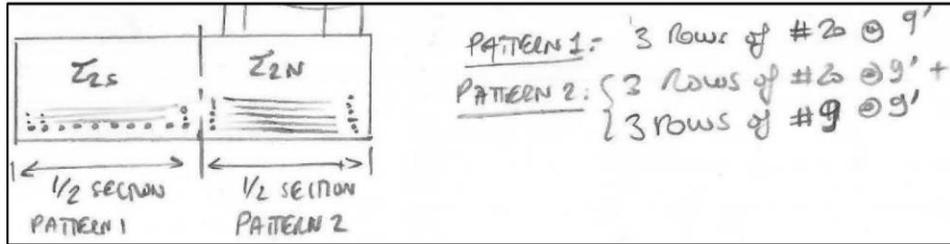
The Section 2 check is shown below, which is similar to Section 4 but with greater demand. Therefore, the check at Section 2 suffices as a check for both sections.

Σ2 Axial + Bending – Strength Limit state – Result Summary		
Section	Governing LC	Max D/C ratio
Σ2 North	2	1.05 → DEFICIENT
Σ2 South	10	0.33 → OK
Σ2 total	2	0.67 → OK

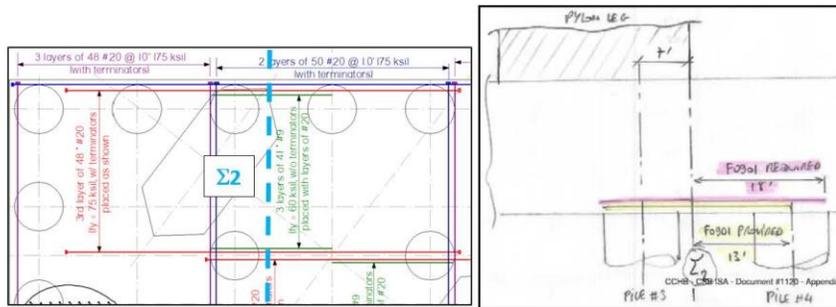
Figure 18: Foundation Cap 1NT and 1ST, Insufficient Reinforcement Development at Section 2

The reinforcement development length of the pile cap at Section 2 was calculated and found to be deficient per AASHTO LRFD §5.11.1.2.

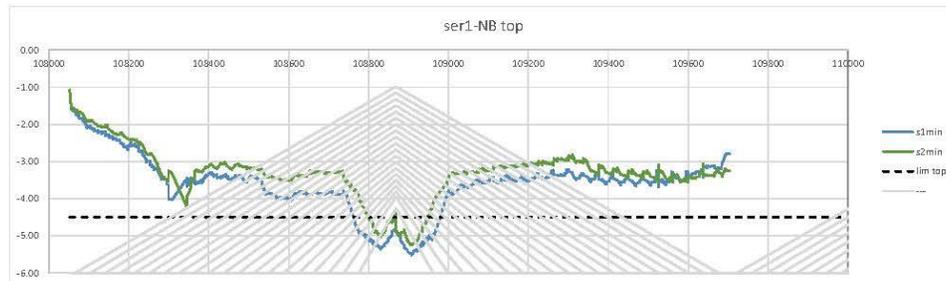
Figure 31: NB Service 1 top compressive stress

It is possible that the top slab compression and positive (sagging) moment could be reduced with a refined third-stage stressing. However, this is not provided in detail in the erection document 277609-NHB-MAN-MEM-01.

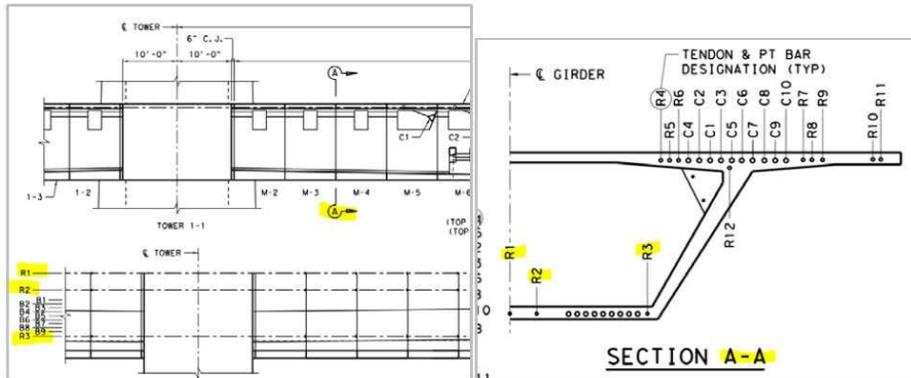
Figure 33: NB shown, 5 PT bars in bottom slab in the first 23 segments adjacent to the pylon – Schematic by Others

Another possibility is that the bottom post-tensioning could be increased in the segments adjacent to the pylon where the PT quantity seems inadequate. For example, there are only 5 - 1 ¼” PT bars in the bottom slab of the northbound box girder (similar for southbound).

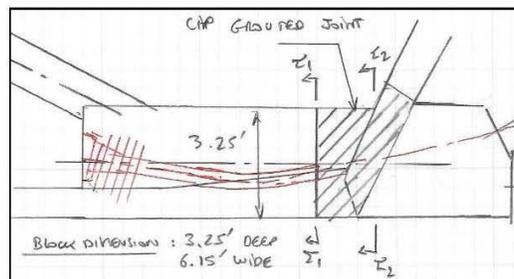
Figure 35: Sketch of bottom block connection between the delta frame and box girder

The ISA team evaluated the demand on the connection between the delta frame and the precast block located at the bottom inside corner of the box girder and the cast-in-place grouted pour, shown as Section $\Sigma 1$ in Figure 35 below. The shaded region, critical to the transfer of loading from the box girder to the delta frame and supporting stay cables, is unreinforced, with the exception of the two tendons located roughly at the center of its section. ISA model results indicate that this section is subjected to both axial and bending demand, leading to tension at the top fiber of the precast block and the unreinforced region of the connection. Moreover, this joint must transfer shear across the unreinforced joint.

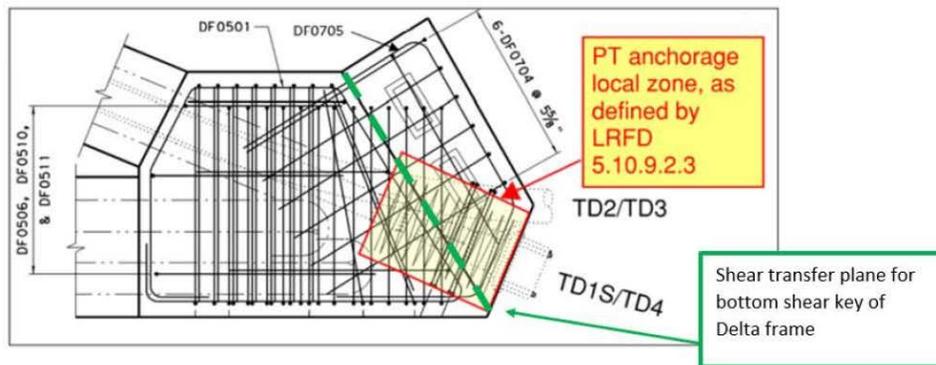
Figure 36: shear key reinforcement and location of tendon local anchorage zone

located within the local zone of the PT anchorage, as defined by AASHTO LRFD §5.10.9.2.3, where large localized tensile stresses are expected and where reinforcement congestion is considerable, as shown in Figure 36 below. The reduction in this shear plane's capacity due to the presence of these tendon anchorages is unknown, since no provision exists within AASHTO LRFD to account for this configuration. As such, the ISA team cannot validate that the shear key as designed meets the AASHTO LRFD specifications.

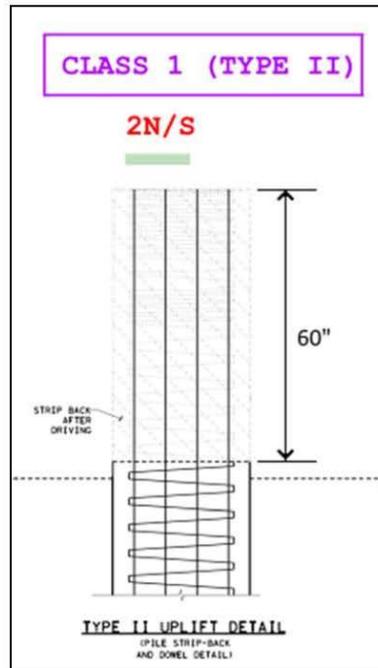
Figure 40: Passive Strand Development in Pier Foundation 1N, 1S, 2N, and 2S – Detail Provided by Others

For the “Class 1, Type II” and “Class 2 Type II” piles, the original design and the current drawings specify a passive strand development length of 60 inches, extending above the top of the stripped back pile. Calculations for passive strand development into the pile cap are not specified by AASHTO LRFD, and very little research on this topic exists. The design check of piles under tension (if tension is permitted, see related Finding #26) is dependent on the development of these passive strand, and therefore cannot be verified.

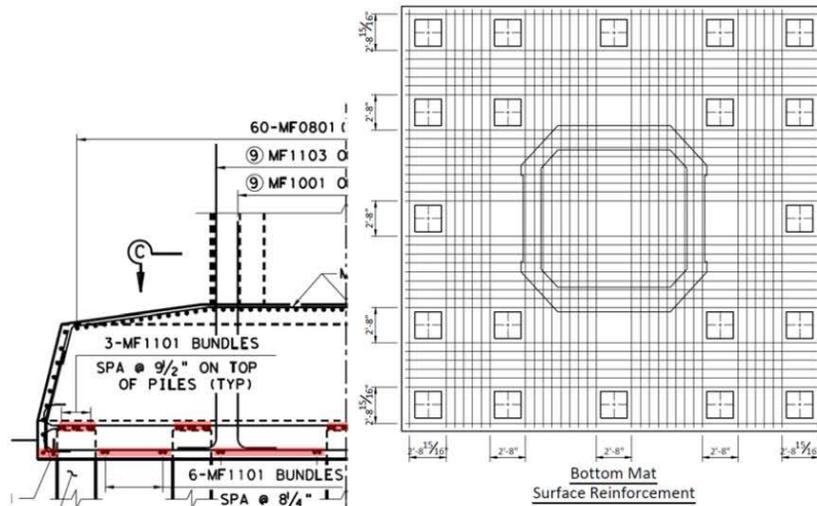
Figure 42: Gaps in Pile Cap Bottom Surface Reinforcement in Between Piles

- In Piers 1N, 1S, 2N, and 2S, the pile cap bottom mat reinforcement bars exceed the maximum spacing requirement of 18 inches in the zones between piles, per AASHTO LRFD §5.10.3.2; see Figure 42 below.

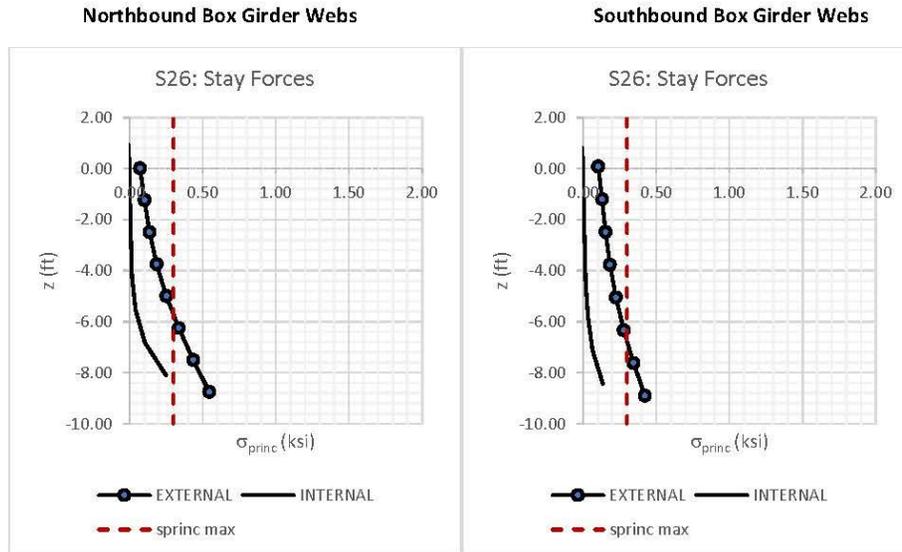
Figure 46: Web principal tensile stresses at Segment 7 when stressing the S26 stay cables

A beam element model tends to overlook certain effects, especially for a bridge of this width with stays anchored at the middle of the superstructure between the box girders. When considering the effects of shear lag of the horizontal components of the stay forces using a plate element model, the ISA team has found that principal tensile stresses in the webs exceed the allowable values specified by AASHTO LRFD §5.14.2.3.3. Figures 44 - 46 present an example of this problem at Segment 7 when stressing Stays 26, where principal tensile stresses in the webs exceed that allowed by AASHTO LRFD.
