# **TXDOT PROJECT NO. 0-7193**

## ***DEVELOP ASSESSMENT AND MITIGATION GUIDANCE FOR ANCILLARY HIGHWAY STRUCTURES WITH EXISTING CRACKS***

*TASIG Meeting*  
**RESEARCH TEAM**

**AUGUST 14, 2025**

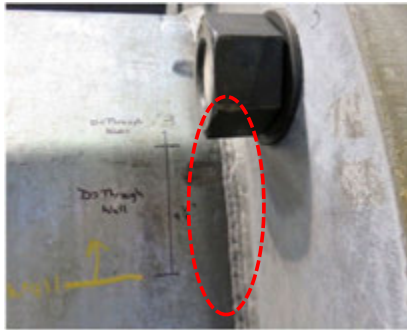
Cracks not visible to eye

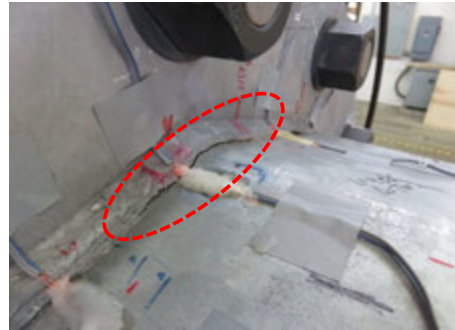
Visible significant crack

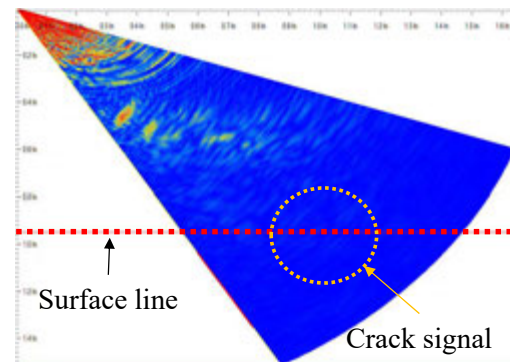
PAUT result

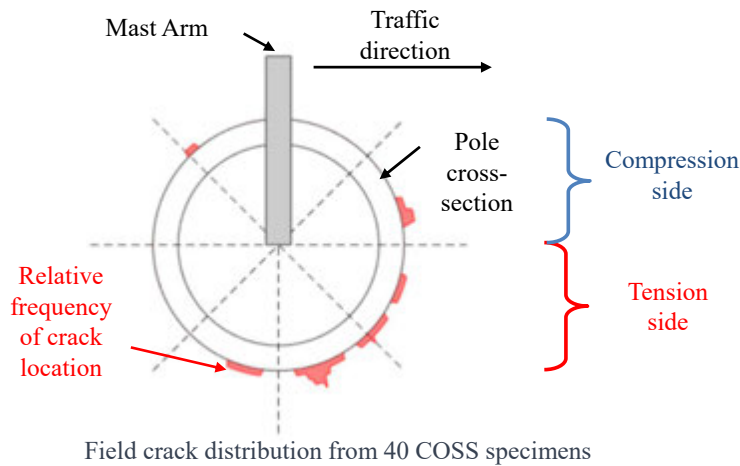
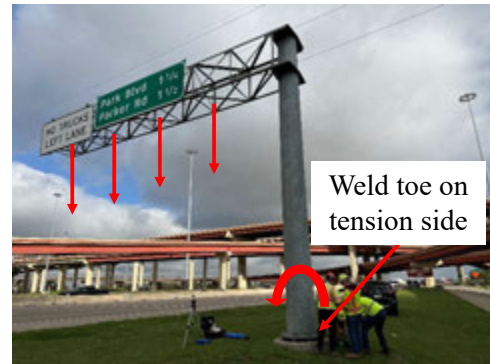
- Cracks primarily on tension side (opposite mast arm)

Common crack location of COSS

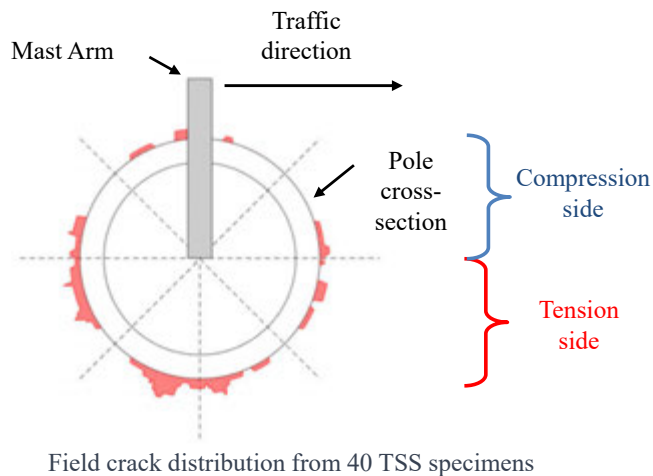
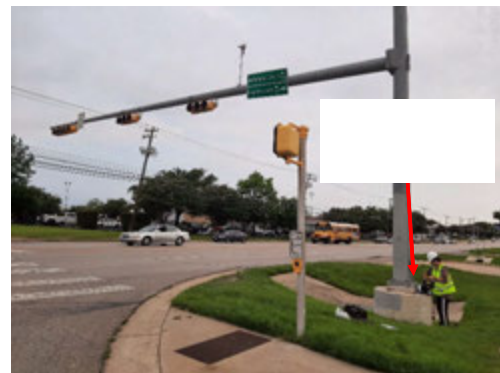
- Cracks more scattered, but concentrated on tension side

Common crack location of TSS

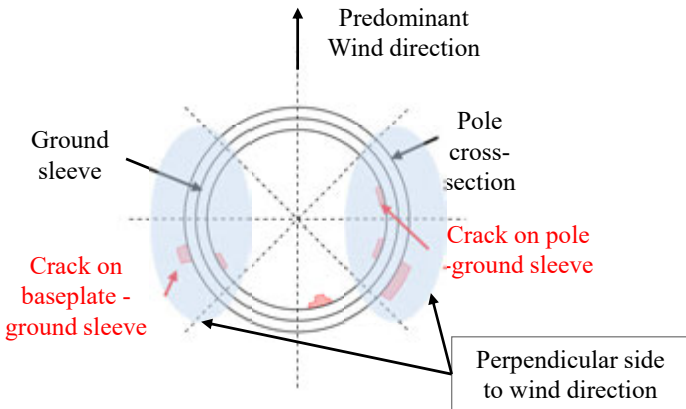
- Cracks primarily perpendicular to wind (vortex shedding)

The diagram shows a cross-section of a pole with a ground sleeve. A vertical arrow indicates the 'Predominant Wind direction'. Red arrows point to 'Crack on baseplate - ground sleeve' and 'Crack on pole - ground sleeve'. A box labeled 'Perpendicular side to wind direction' points to the crack locations. The text 'Field crack distribution from 40 HMIP specimens' is at the bottom.

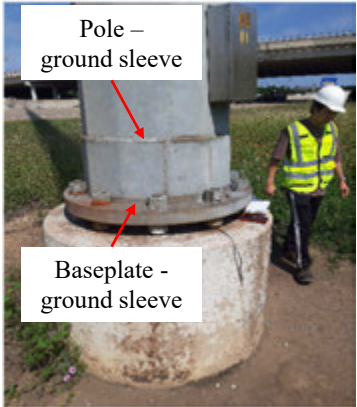
The photograph shows a worker in a yellow vest and hard hat standing next to a large concrete baseplate. Red arrows point to the 'Pole - ground sleeve' and 'Baseplate - ground sleeve' areas. The text 'Common crack location of HMIP' is at the bottom.

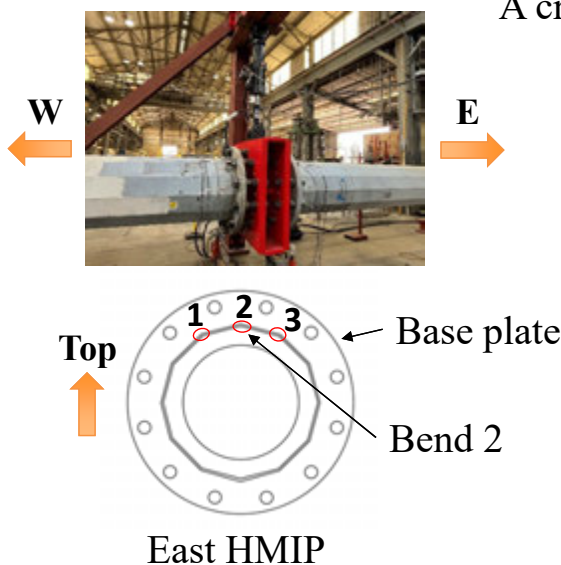
A crack first appeared → 210,000 cycles (approx. 34 yrs)

Welding repairs → 5 times

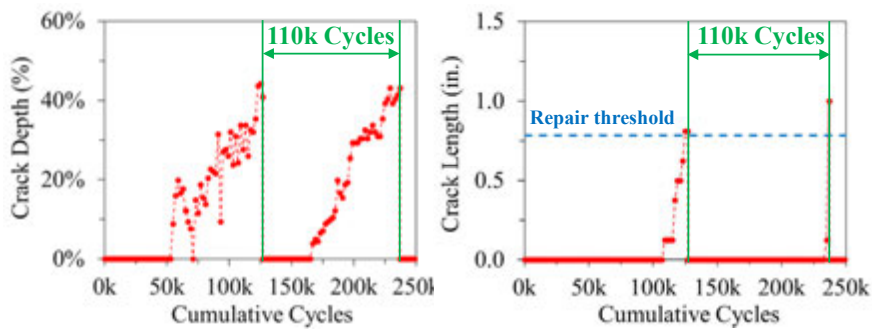
PAUT result (S-Scan)
