Historic Bridge Adoption Information Packet

Limestone County
County Road (CR) 723/Old Thornton
Big Creek
October 2024

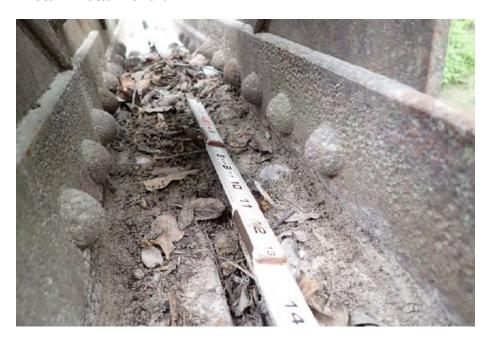
Photo 1: Bottom Chord

The bottom chord of the truss shows significant corrosion with section loss at connection plates at the bottom chord. The total number of connections is not determined. These repairs can be completed after moving the truss and can be deferred further if needed. However, corrosion will continue until addressed by cleaning, painting, and sealing areas of deformation where water will collect. TxDOT highly recommends cleaning and painting the entire structure. The bottom chord controls the load rating.

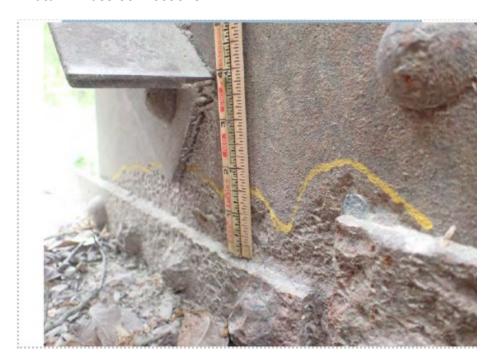
Photo 2: Truss Connections

All 14 connections at the bottom chord of the truss show significant pitting on gusset plates, connection angles, and rivet heads with section loss at the gusset plate and bottom chord. These repairs can be completed after moving the truss and can be deferred further if needed. However, corrosion will continue until addressed by cleaning, painting, and sealing areas of deformation where water will collect. TxDOT highly recommends cleaning and painting the entire structure.

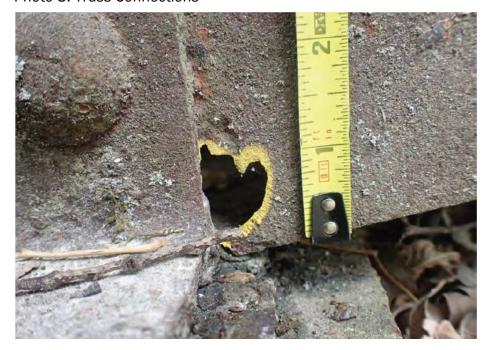
Photo 3: Truss Connections

Same recommendations as Photo 2.

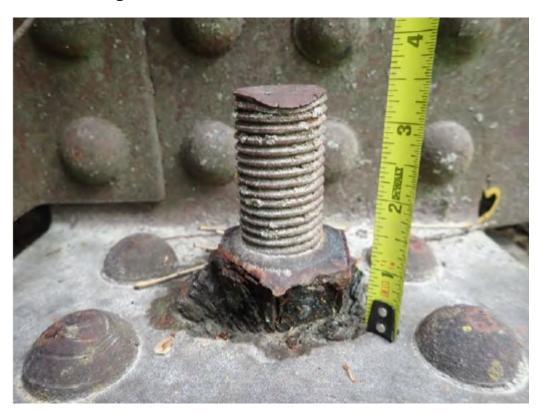
Photo 4: Bearings

The bolts on the bearings have severe corrosion resulting in approximately 50% of the section remaining. These repairs would need to be performed once the truss is moved, since they will likely be torched off to enable the move.

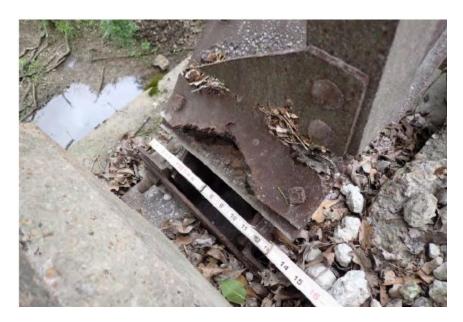
Photo 5: Truss End Cover Plate

The end cover plate at one location has severe corrosion resulting in a hole greater than two inches in length. These repairs can be completed after moving the truss and can be deferred

further if needed. However, corrosion will continue until addressed by cleaning, painting, and sealing areas of deformation where water will collect. TxDOT highly recommends cleaning and painting the entire structure.

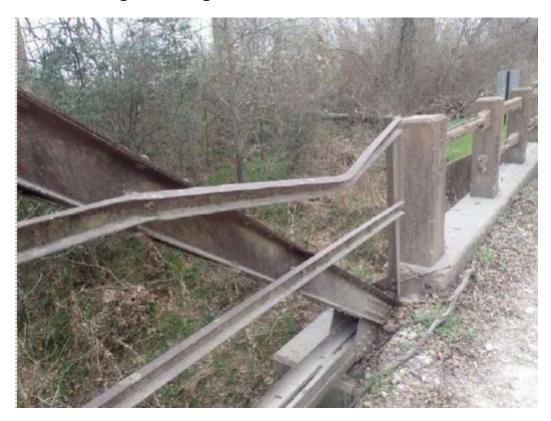
Photo 6: Existing truss railing

The steel rails in truss span have minor surface corrosion and minor deflections. These repairs can be completed after moving the truss but should be completed prior to converting the truss to pedestrian use. This railing is not considered acceptable for pedestrians.

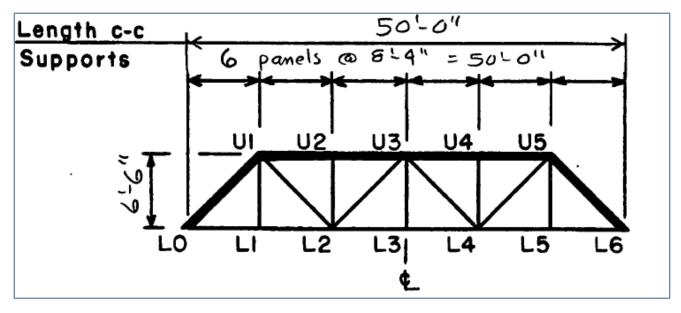
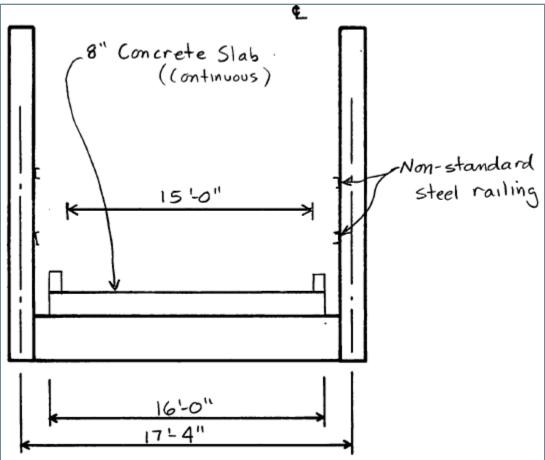
Photo 7 and 8: Truss Dimensions in Elevation and Cross Section

The configuration and dimensions of the structure are shown to assist in estimating costs associated with moving the truss, and for purchasing and installing the pedestrian walkway and railing. The 8-inch concrete deck will need to be removed prior to moving the truss. The width of

the walkway will need to be determined from pedestrian load rating calculations provided by a

professional engineer.
