# **TXDOT PROJECT NO. 0-7193**

***DEVELOP ASSESSMENT AND MITIGATION GUIDANCE***

***FOR ANCILLARY HIGHWAY STRUCTURES WITH EXISTING***

*TASIG Annual Meeting*

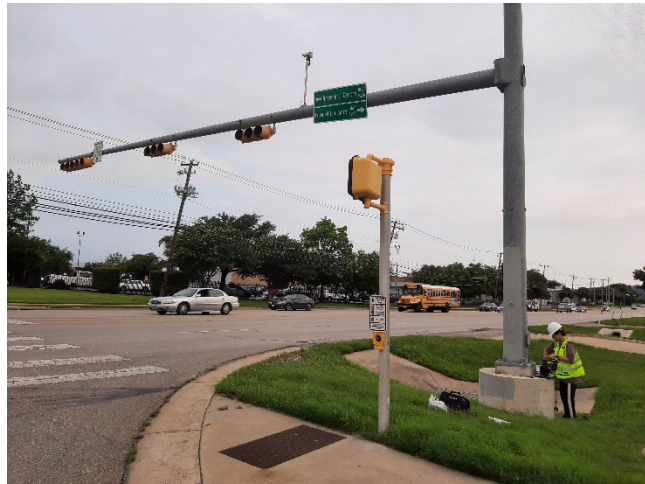
Traffic Signal Structure  
(TSS)

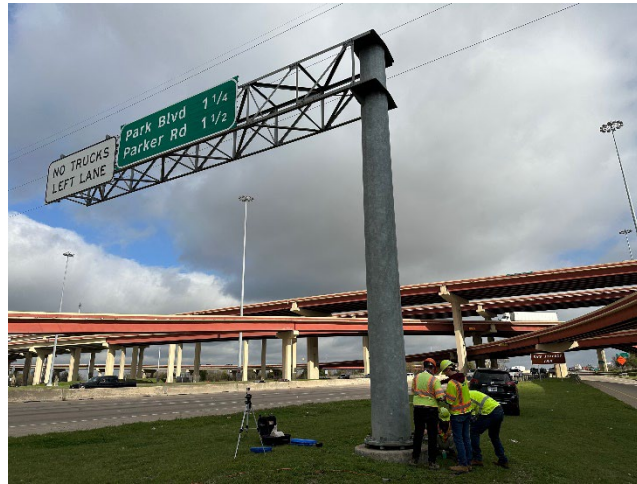
Cantilever Overhead Sign Structures  
(COSS)

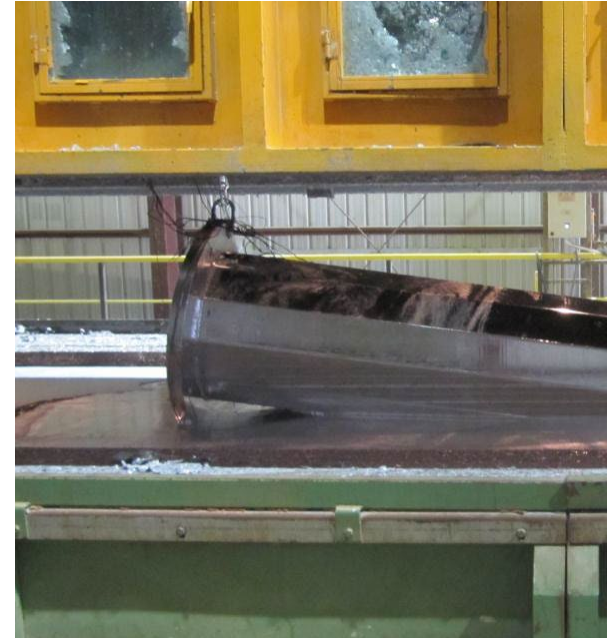
- There have been a number of previous studies related to damage and fatigue performance of HMIP/COSS/TSS poles.
- The poles are all galvanized to improve the long-term corrosion performance.
- Galvanizing has been found to often initiate cracks in welds of components prior to the structural elements installation into the field. The likelihood of cracking is related to the geometry of the pole shaft and base plate.

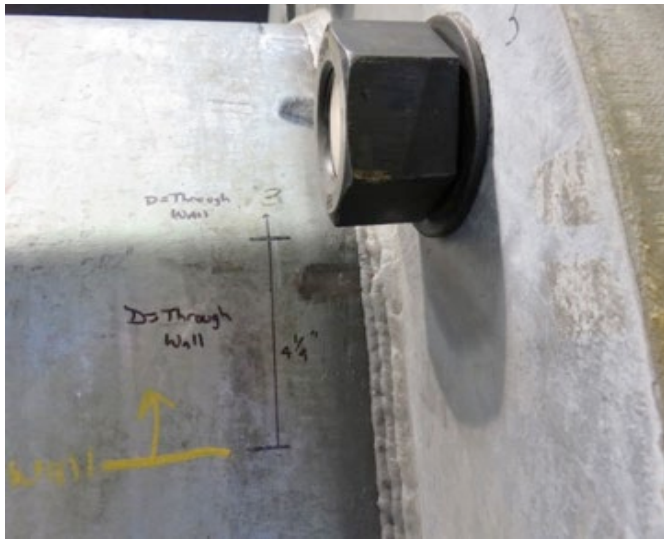
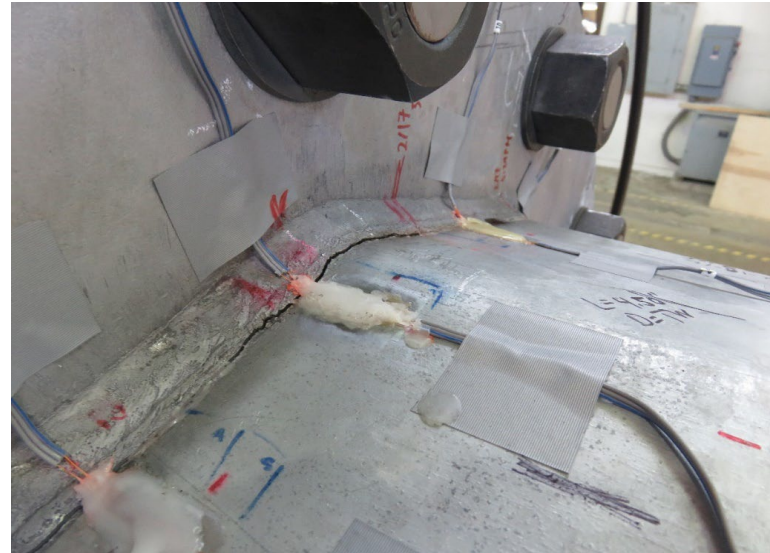
Cracks are not generally visible by eye in the field, until very significant damage

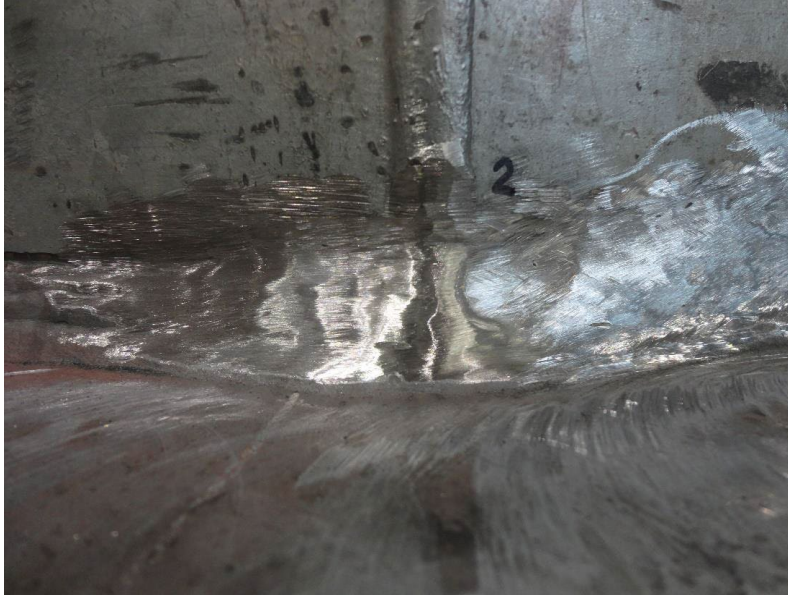
Weld Repair

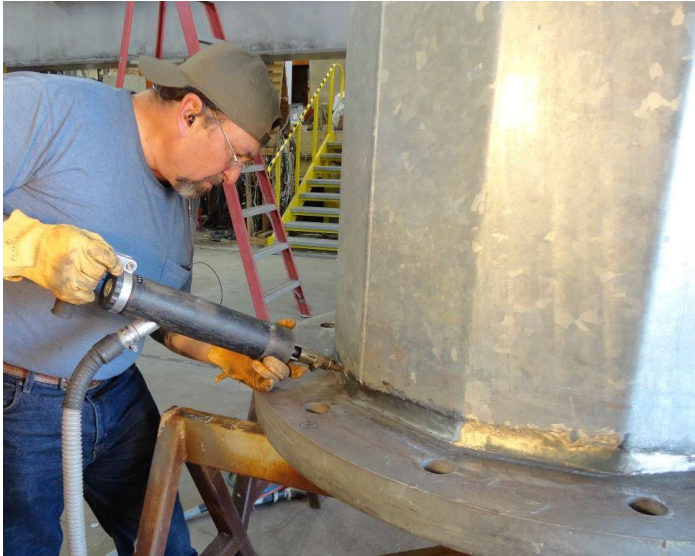
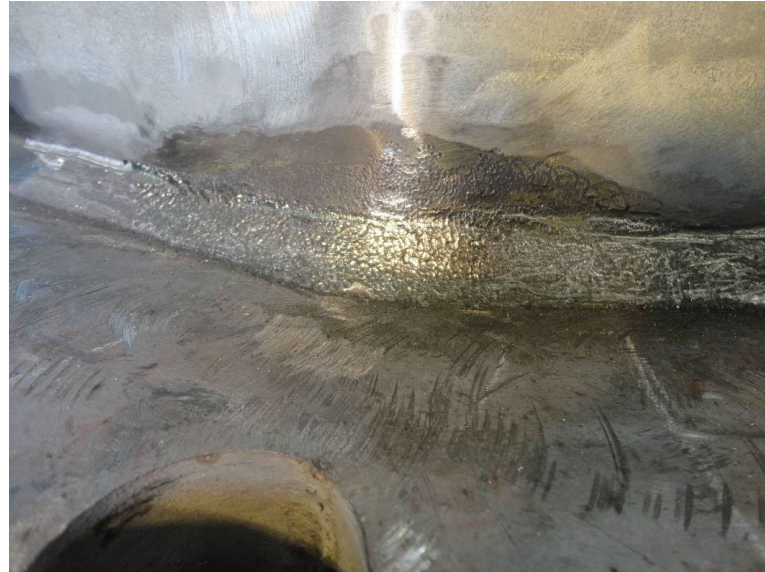
Ultrasonic Impact Treatment (UIT)  
Is this needed?

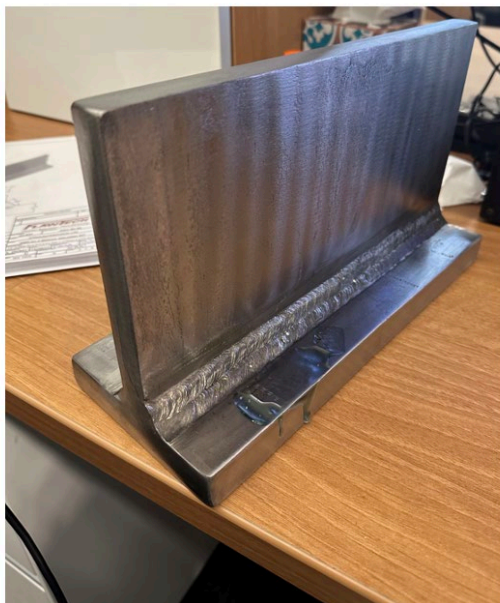
FlawTech Specimen

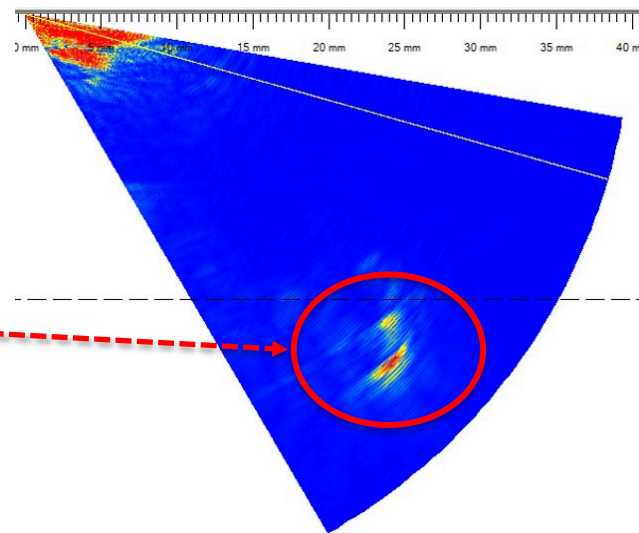
PAUT Results

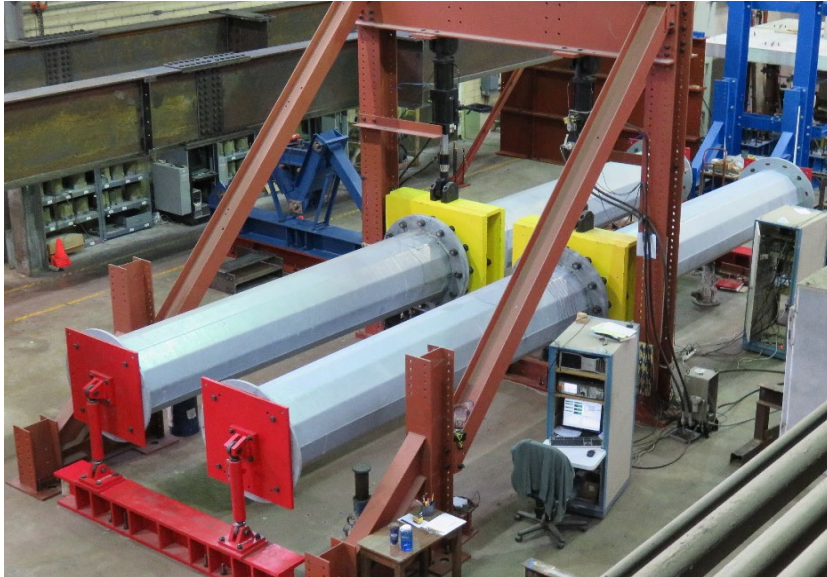
- Induce and/or extend fatigue cracks by applying cyclic loading to the specimens

Tests at both UT and A&M on HMIP, COSS, and TSS Specimens. Cyclic loading to obtain cracks, study weld repair techniques and performance.

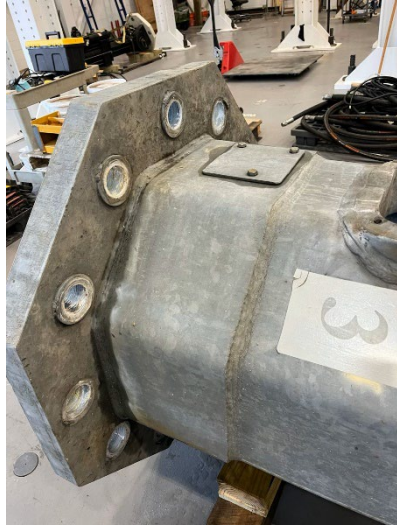
With Ground Sleeve

- Previous research showed that cracking during galvanizing could be greatly reduced or even eliminated by using a thicker shaft thickness.
- Should the practice of using a ground sleeve continue as the “preferred detail” for HMIPs
- Speaking with Carl Macheitto from Valmont at AASHTO, he commented on the significant expense of the ground sleeve during fabrication.
- Thoughts?

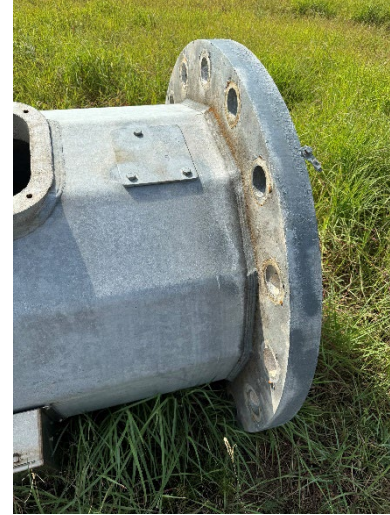
Without Ground Sleeve
