TxDOT ROW

Pipeline Safety & Damage Prevention

Atmos Energy

12/14/2023

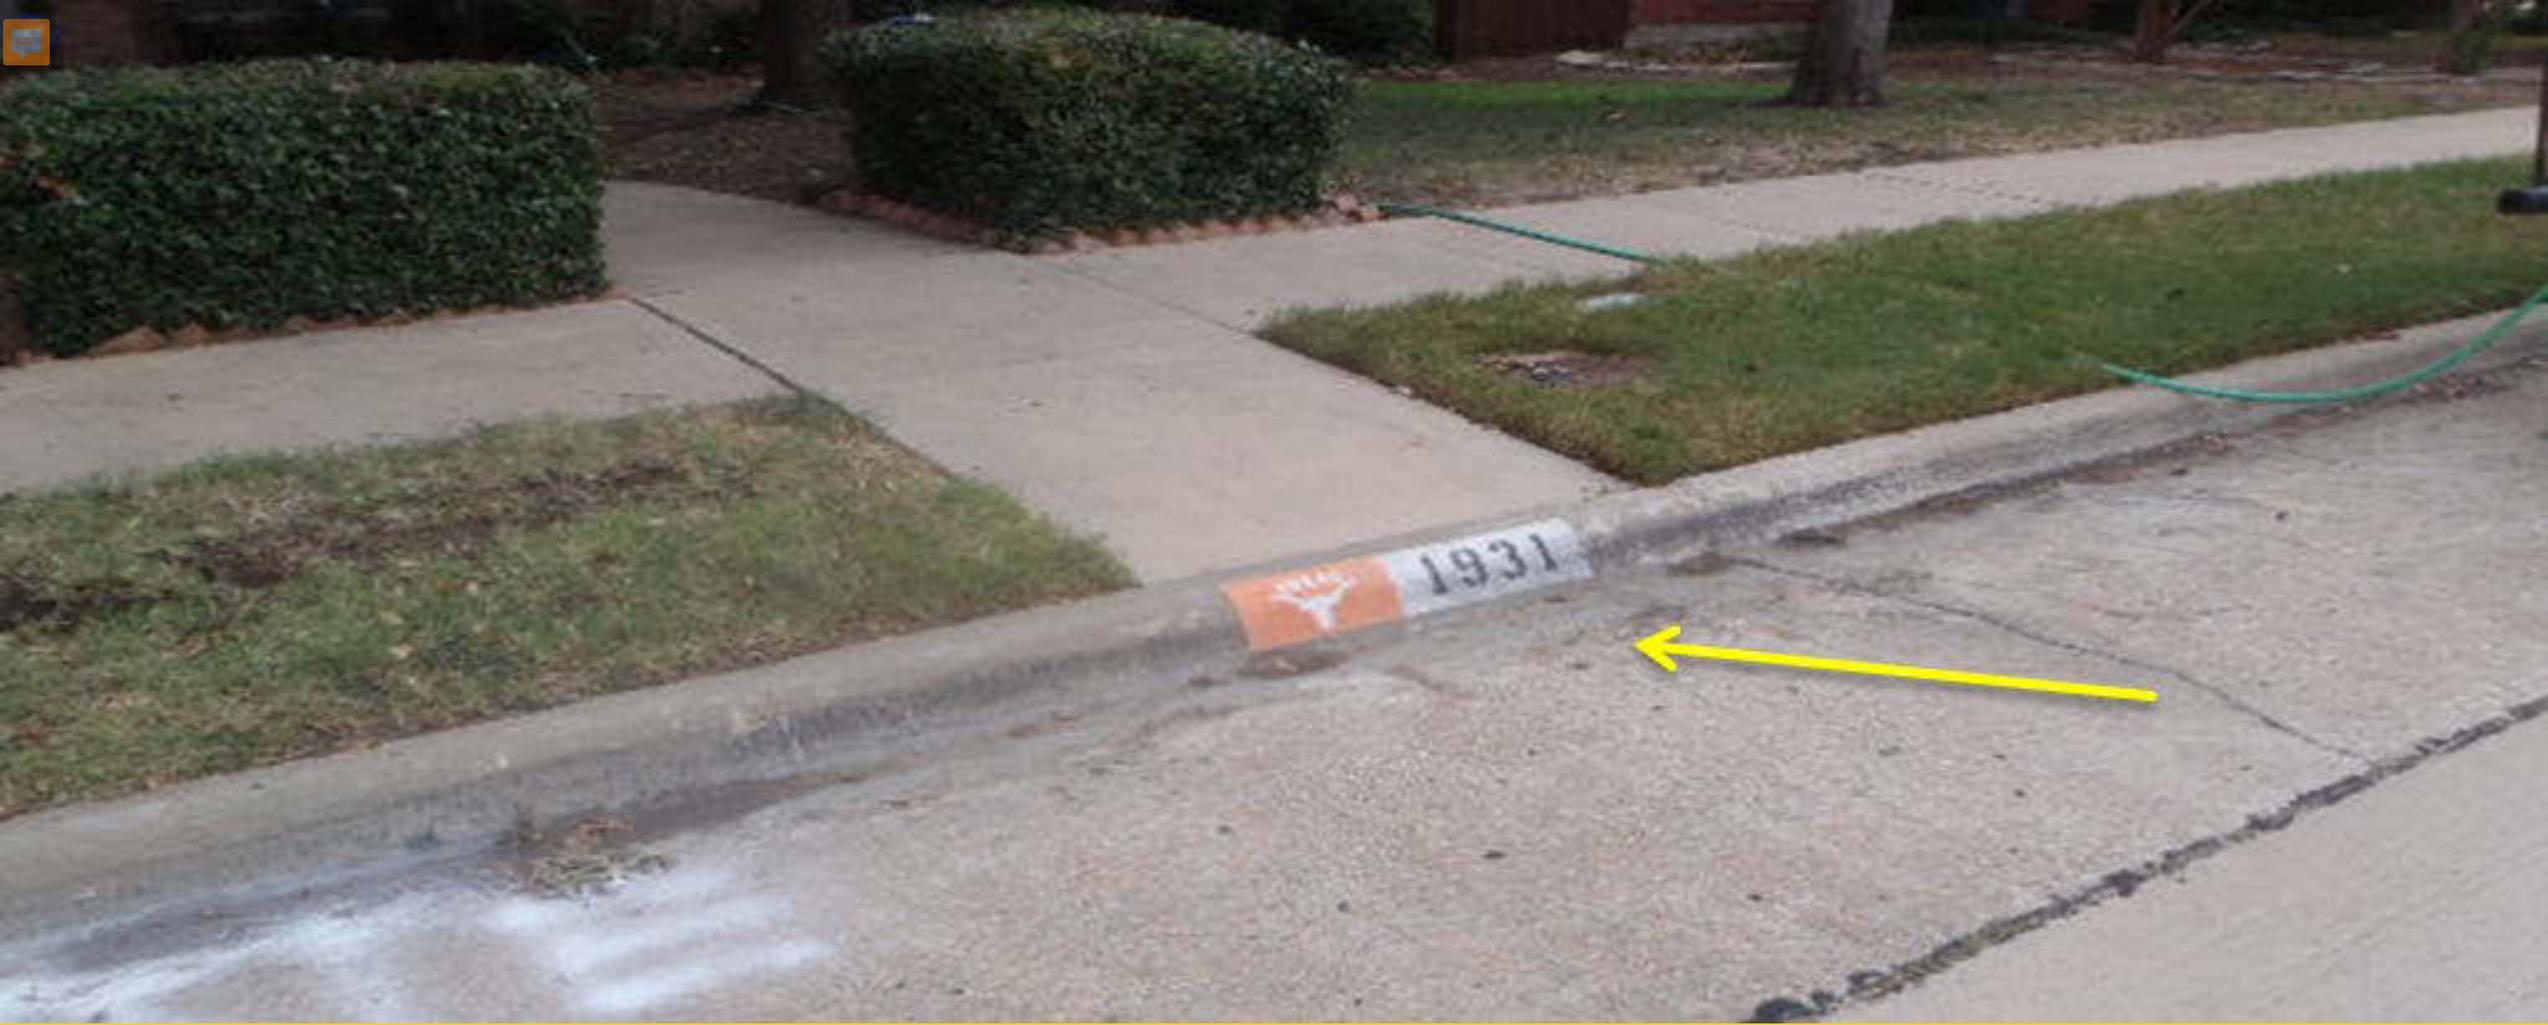
Photo of damage address using reference point

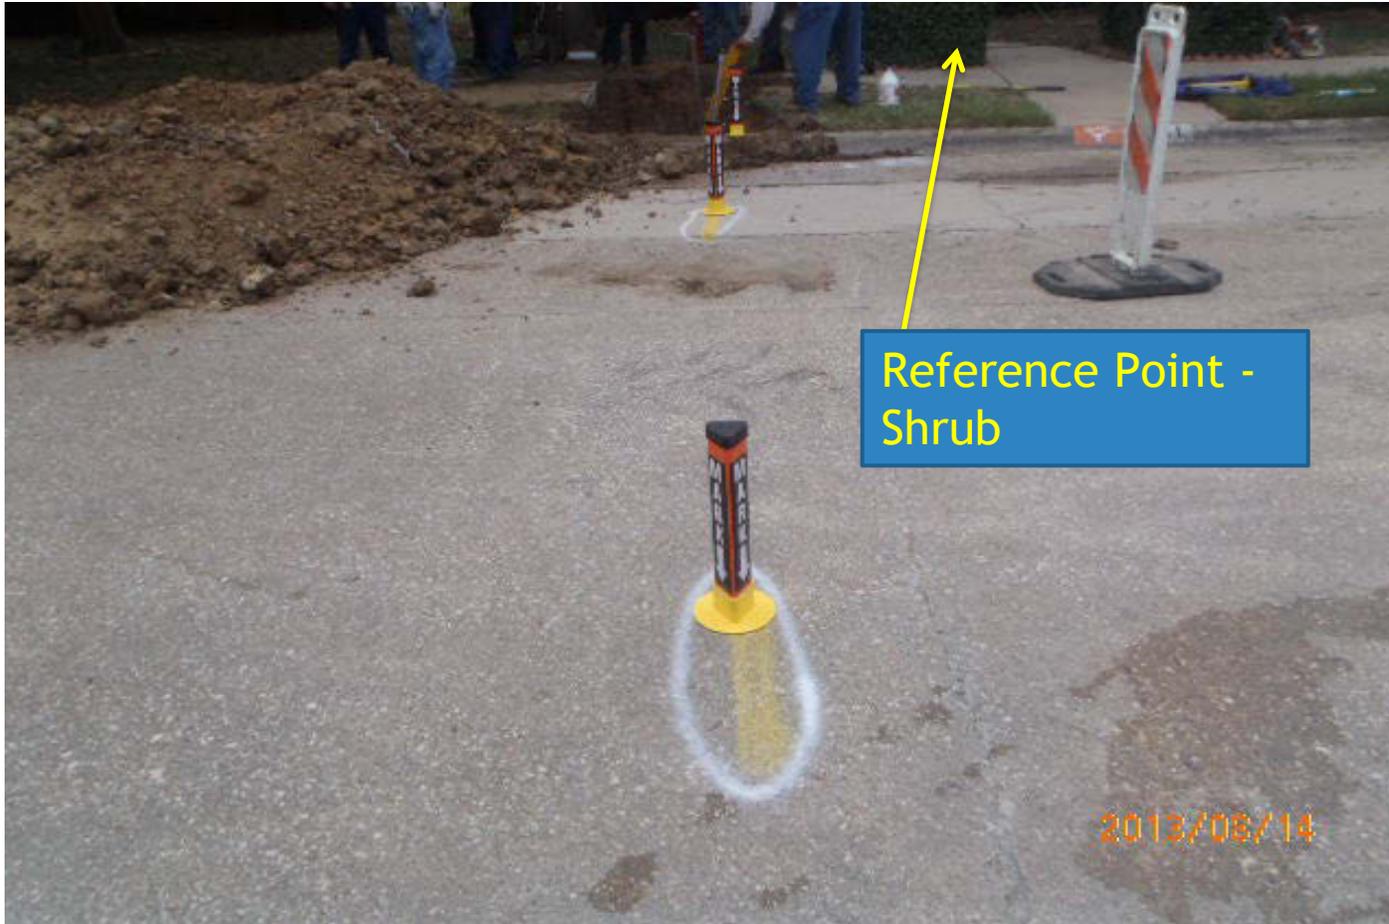
▪ Job aid #1-3

- Hit kit set up
- Marks circled in white paint
- Reference point from first photo
- Starting outside damage area

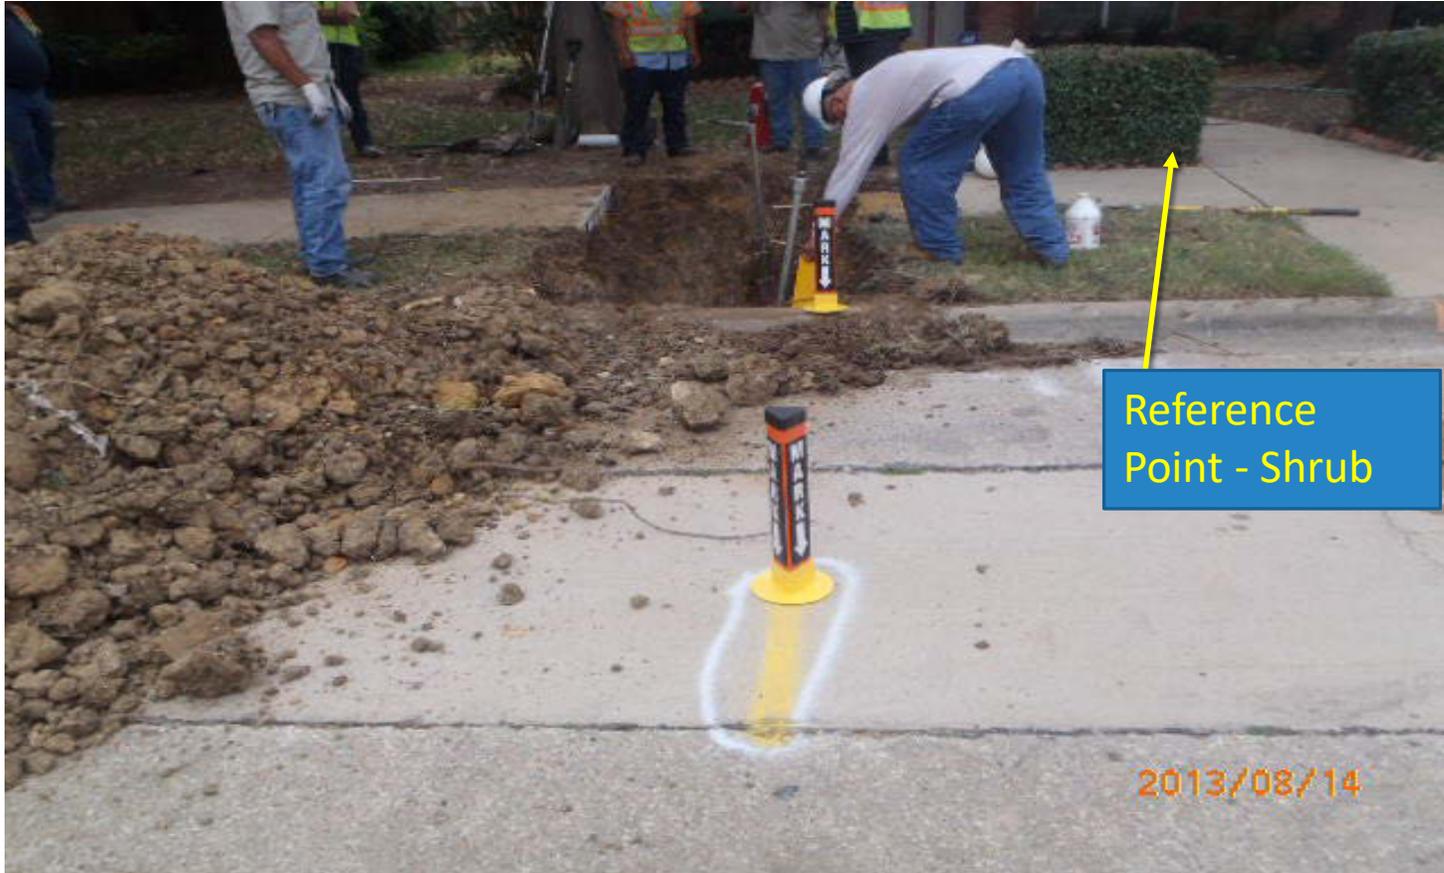
- Reference point maintained
- Moving closer
- Capturing hit kit and surroundings

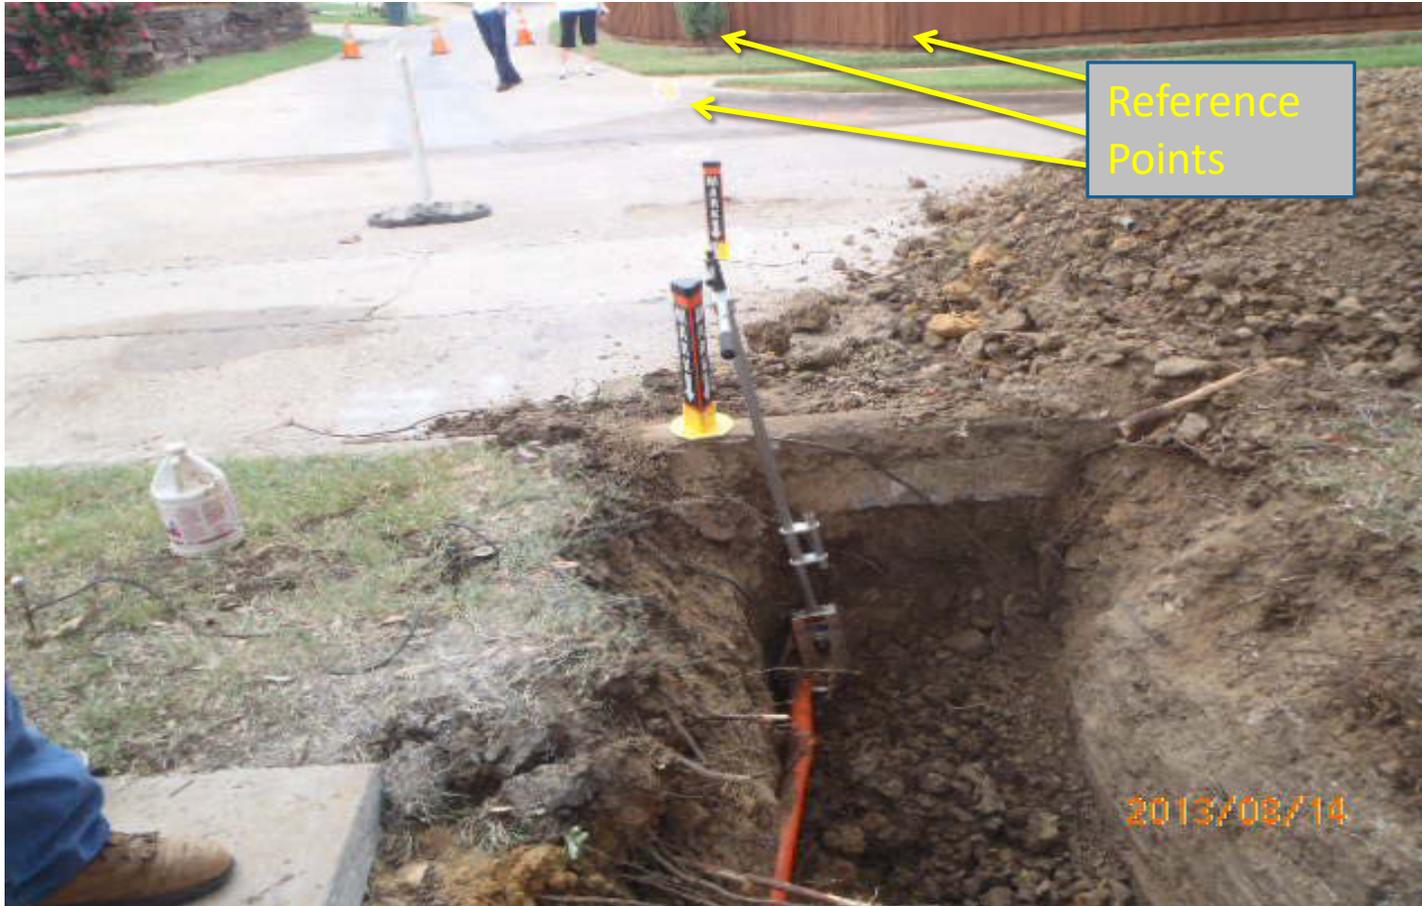
▪ Job aid #4-6

- New reference point(s) established
- Capturing hit kit and surroundings
- Damage is visible
- Also satisfies job aid photo #15

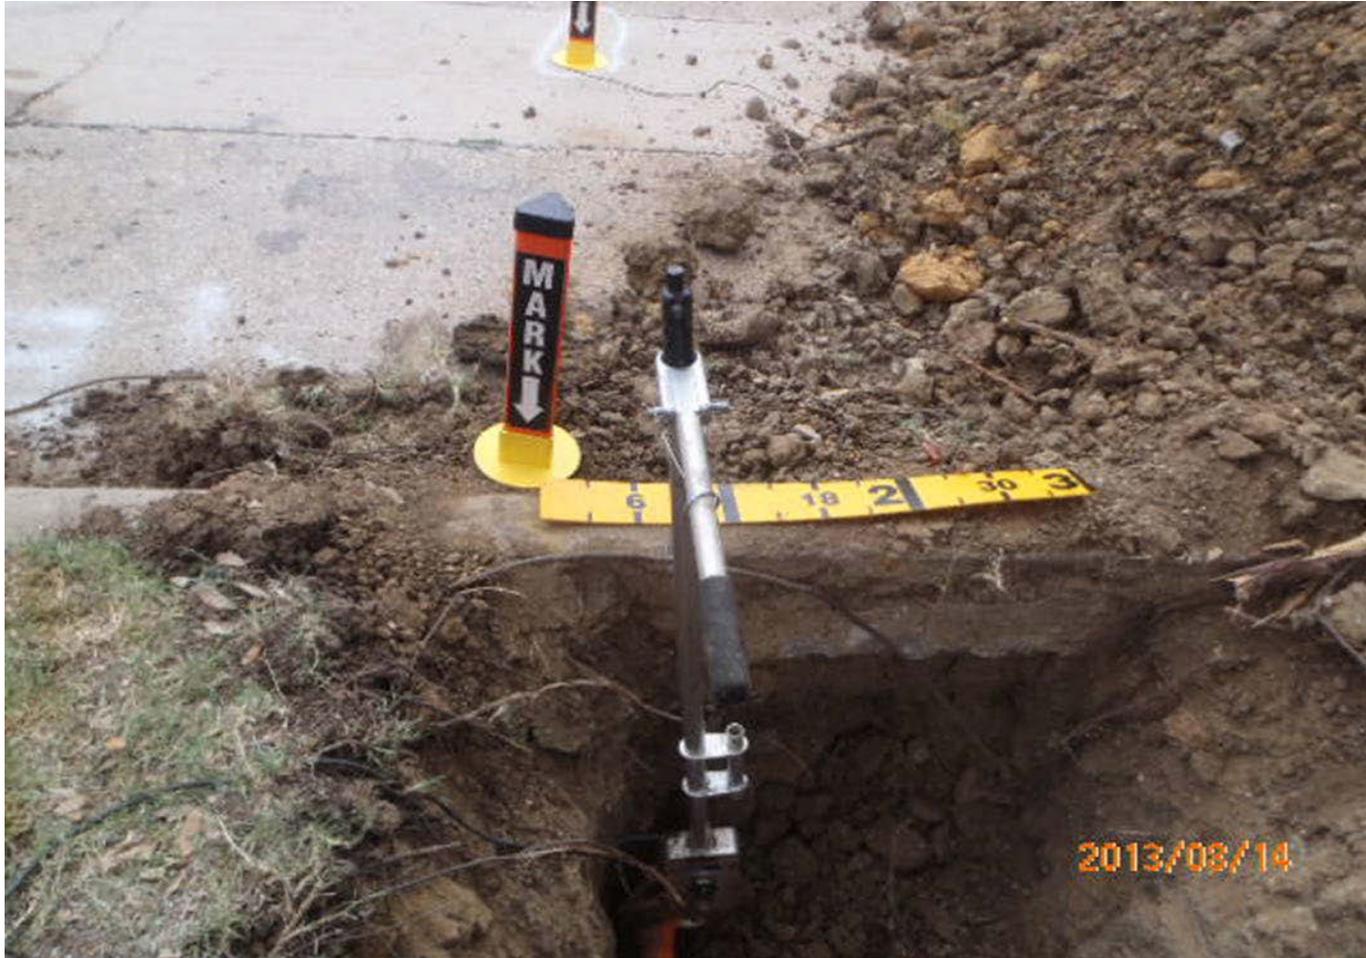
- Reference point maintained
- Moving closer
- Capturing hit kit and damage

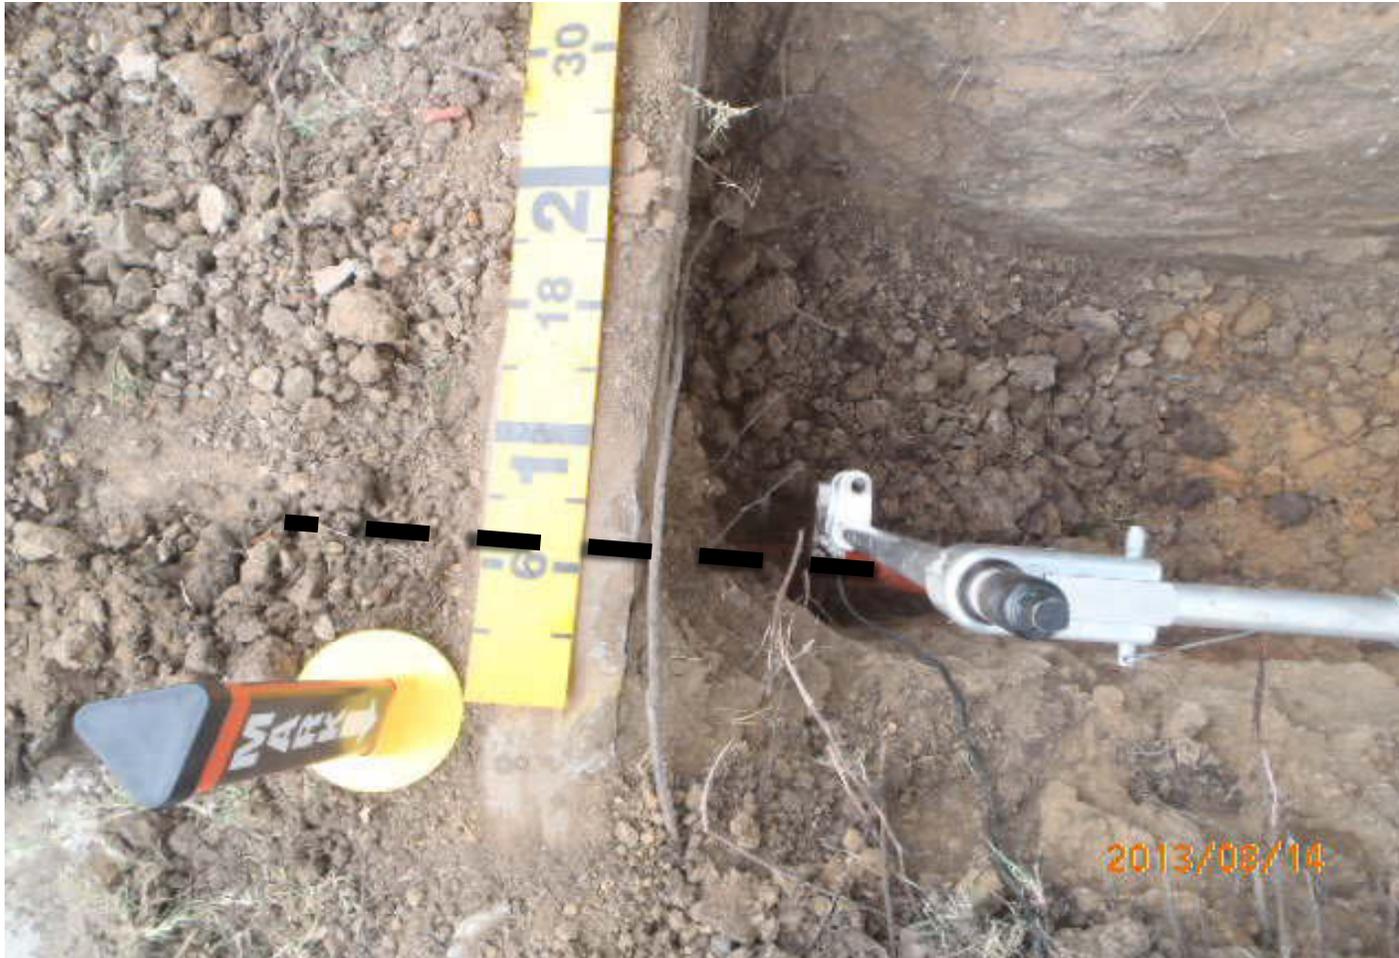
- Job aid #17
 - Zero end of ruler aligned
 - Ruler facing upward
 - Centerline to centerline
 - Damaged line is visible

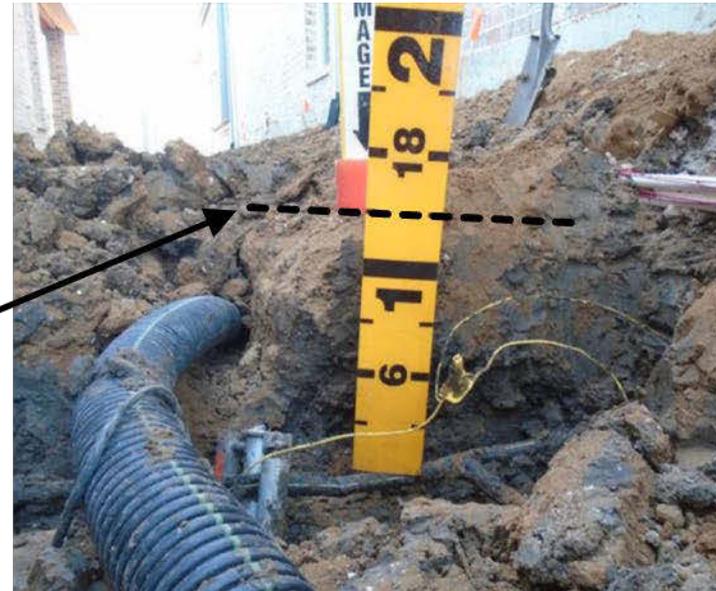
Job aid #16

Keep it straight
Get low
Get background

Watch for
Spoil piles!

Find and show
grade
if possible

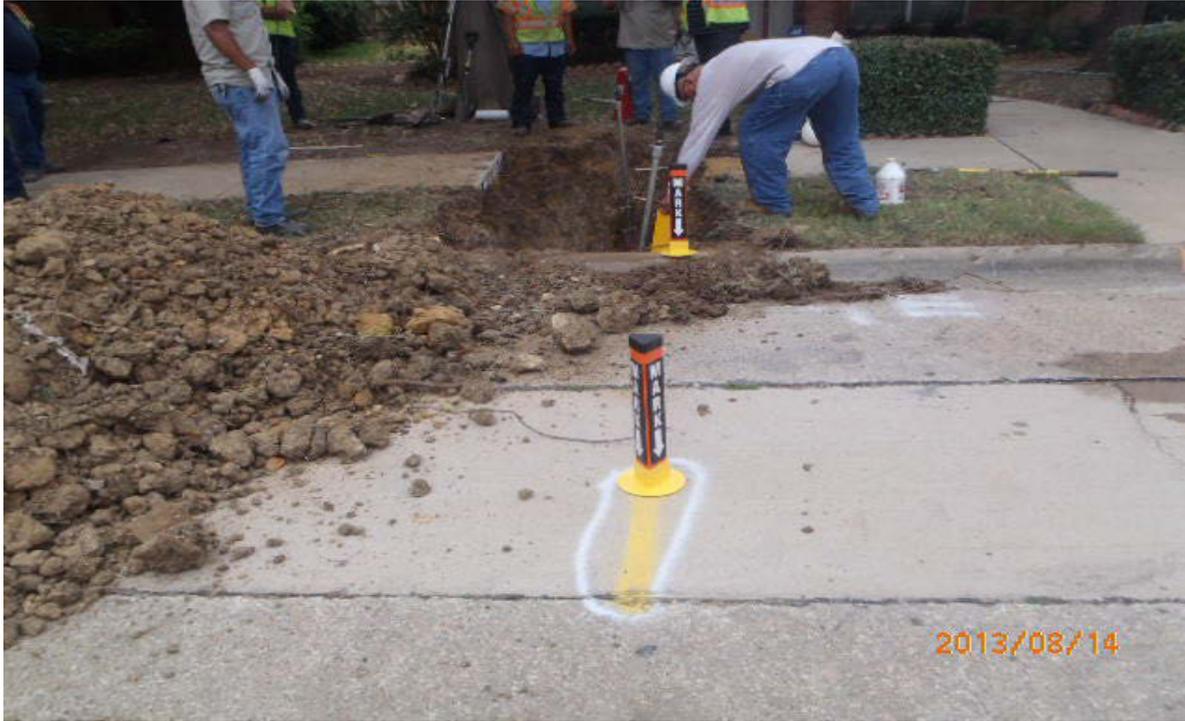
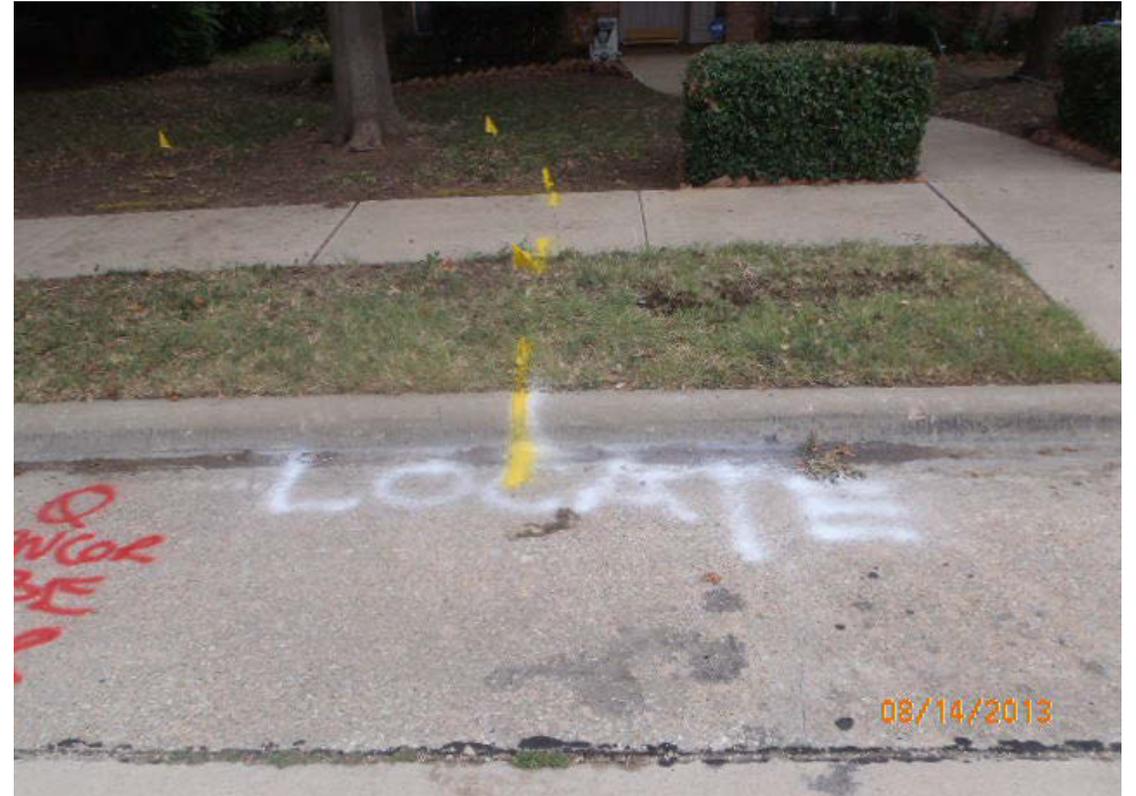
Damage

Pre-dig

How we prove we marked the line

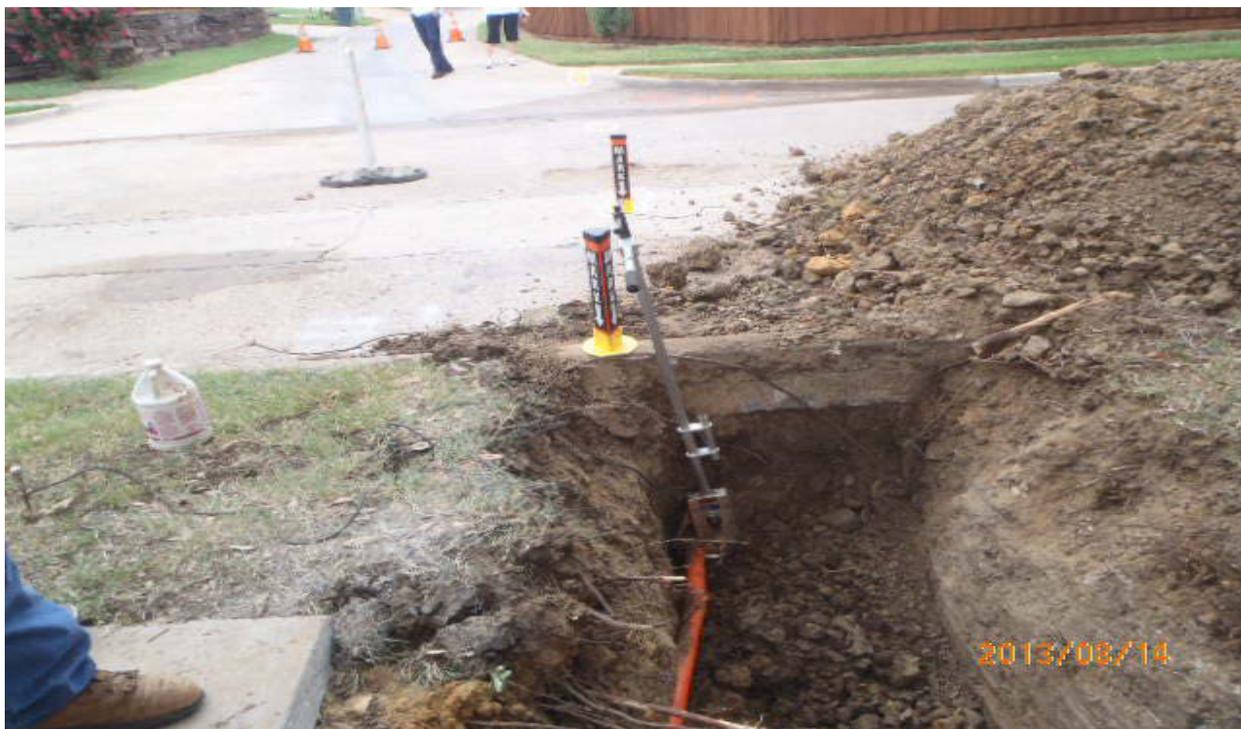
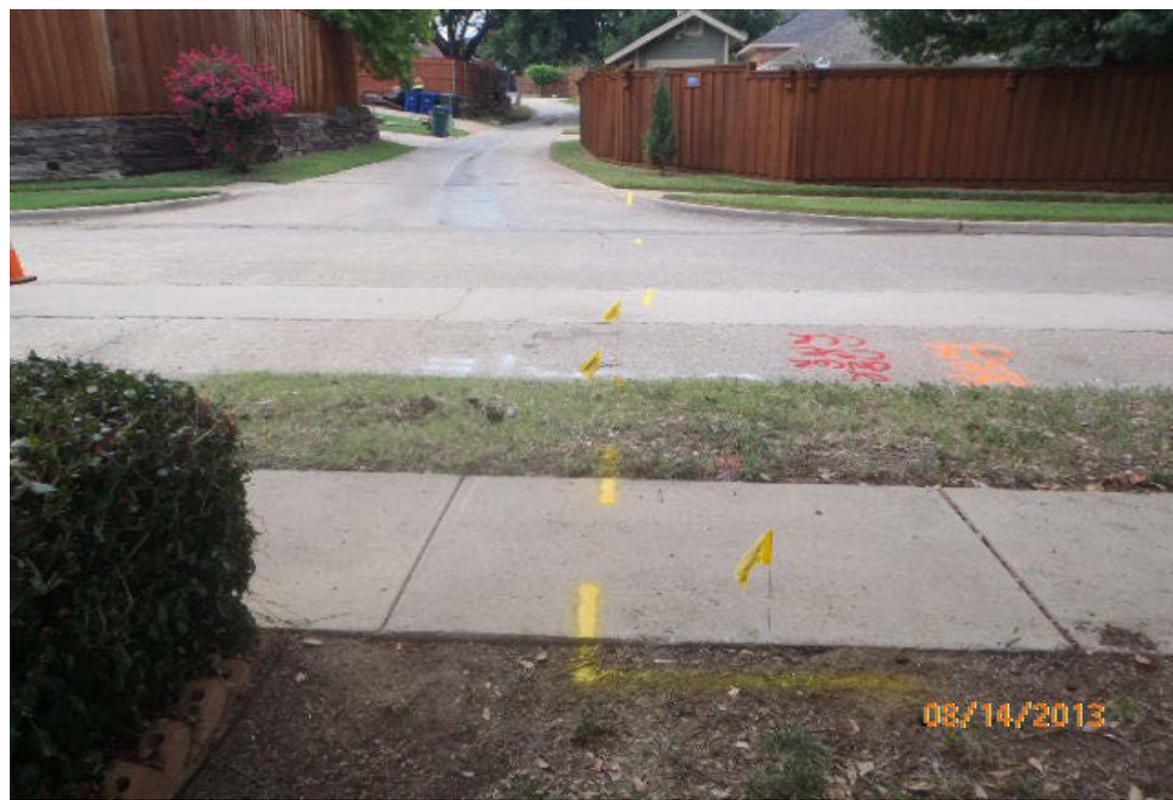
Damage

Pre-dig

Pre-dig and Damage Photos
