# Historic Bridge Adoption Information Packet

Lavaca County

CR 130

Rickaway Branch

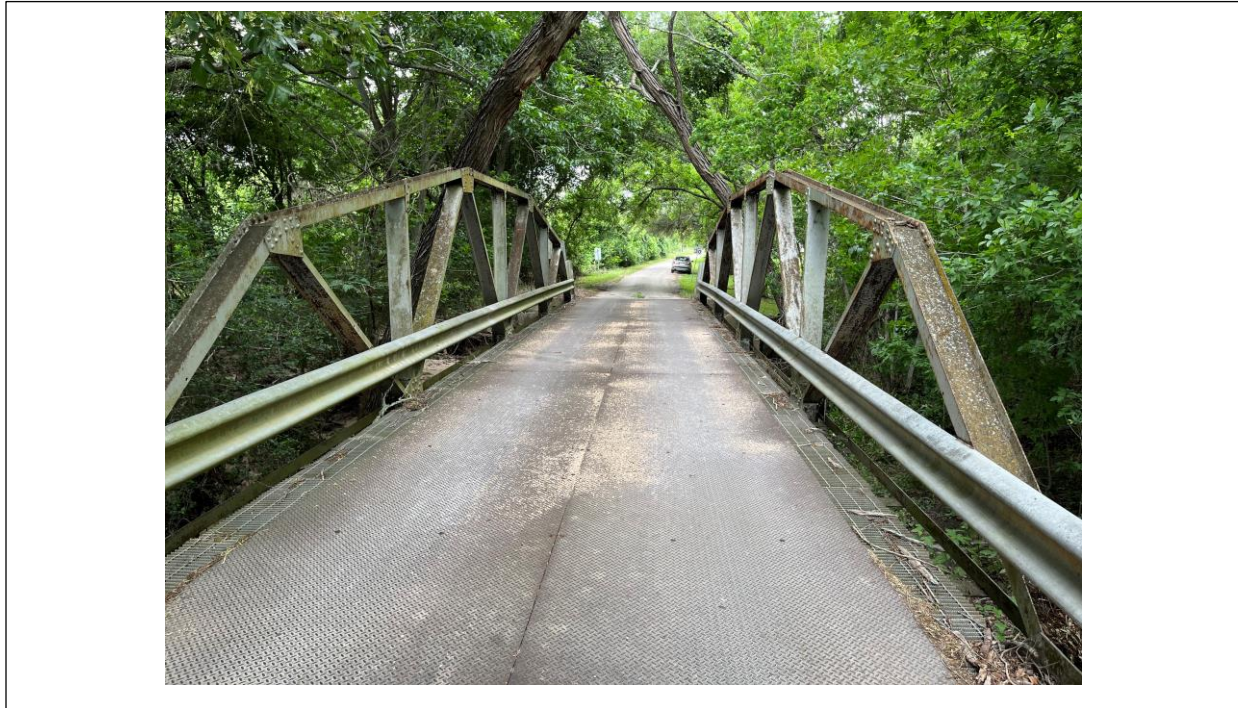
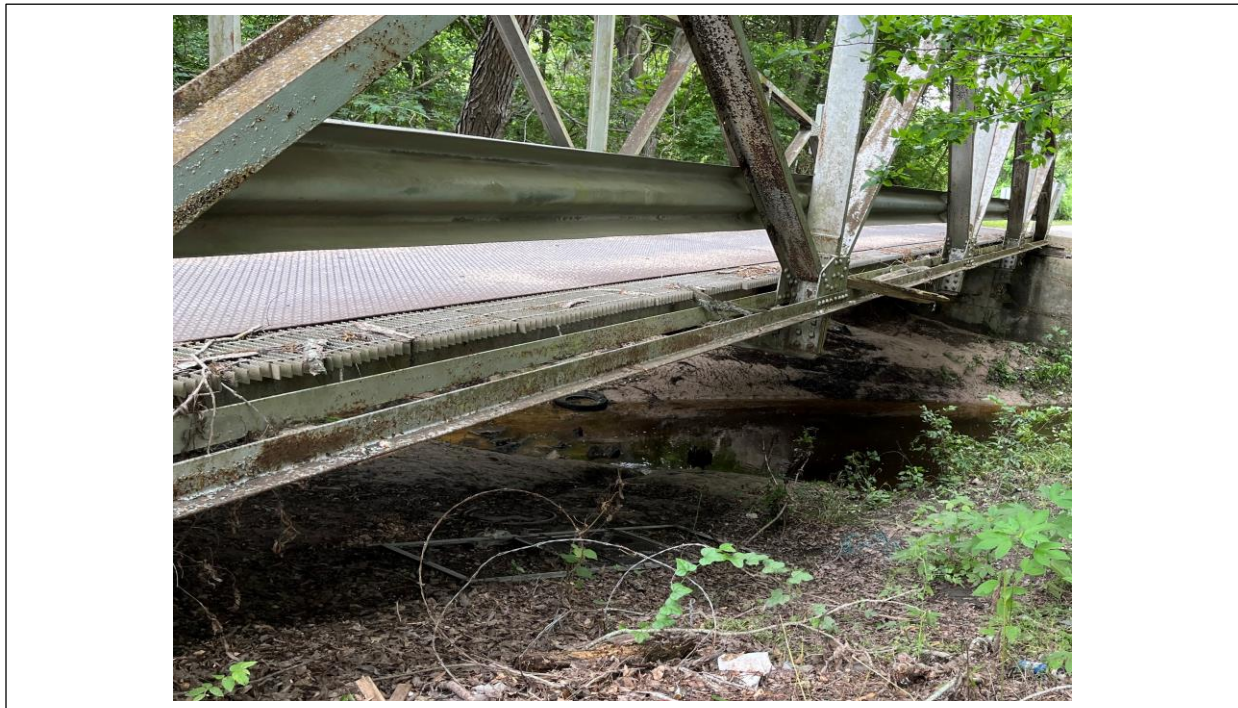
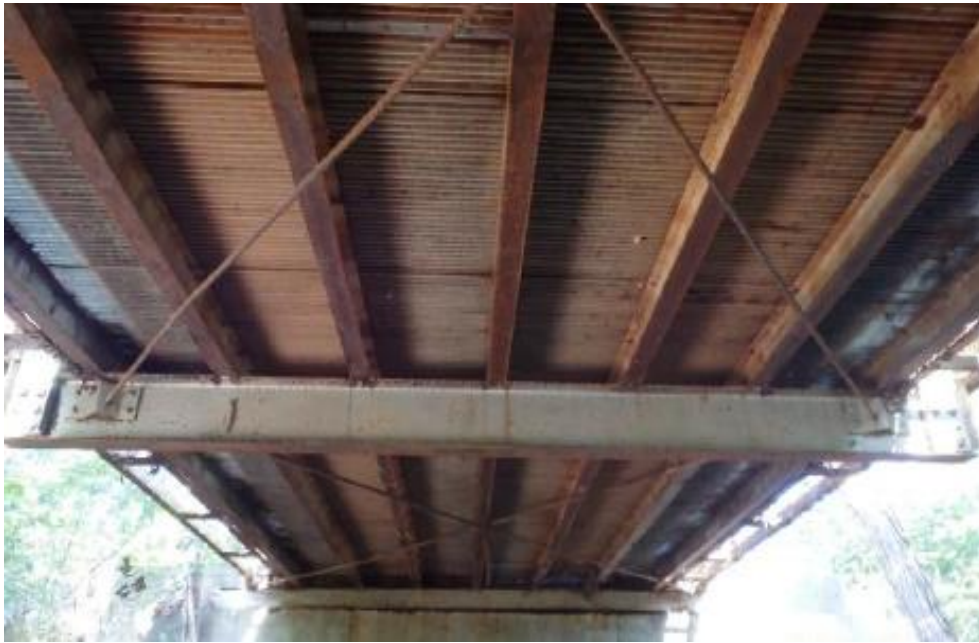
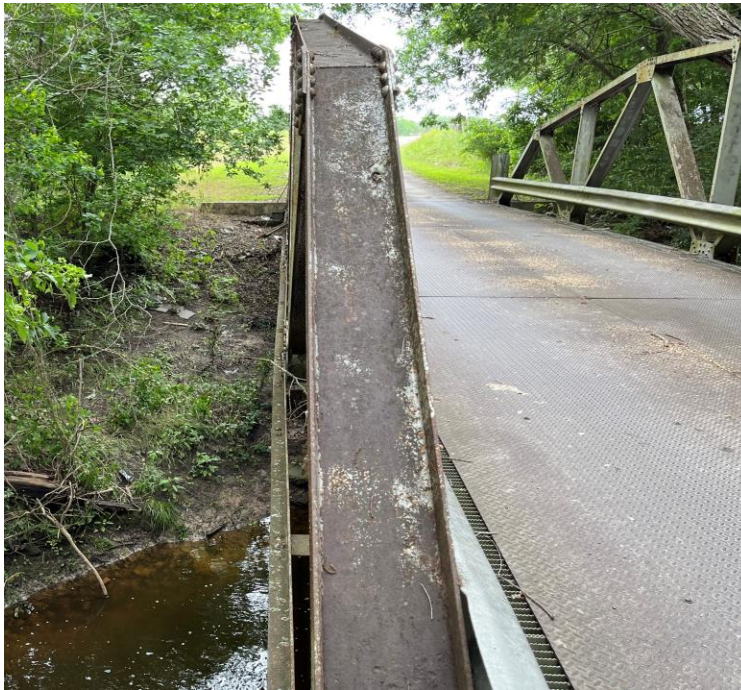
## Bridge Photographs

The bridge has an estimated date of construction of 1991, but the riveted construction of the truss implies that this bridge is much older. The bridge has widespread severe corrosion and section loss throughout the truss. The bridge is posted for a Weight Limit of 13,000 LBS Gross and 7,500 LBS Axle or Tandem. Multiple structural members have operating load rating capacities below that required to carry emergency vehicles and school buses at this location.

▪ Clean and paint existing structure:	\$91,000.00
<small>&lt;TxDOT testing indicated that this bridge has lead-based paint as a primer under the existing painted surface. This estimated cost is for the full abatement of the lead paint from the trusses and repainting the structure to prevent further rusting and corrosion&gt;</small>	
▪ Remove STR (Deck):	\$3,500.00
▪ Remove STR (Truss Stringer):	\$8,400.00
<hr/>	
<b>Total Costs</b>	<b>\$102,900</b>
