Geologic Assessment

U.S. Highway 290 (US 290) / State Highway (SH)
71 West from State Loop 1 (MoPac) to
Ranch-to-Market (RM) 1826 and SH 71 to
Silvermine Drive
Travis County, Texas
CSJ: 0113-08-060 and 0700-03-077

December 2016; Revised November 2017, August 2018

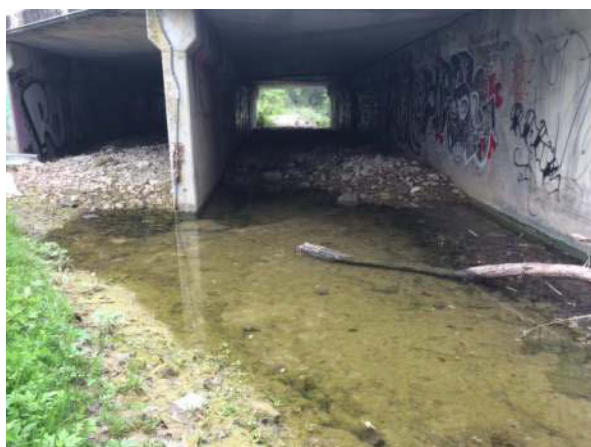
Feature F-1 is a group of widely spaced fractures within the Williamson Creek streambed located just upstream of US290. The orientation of the fractures, N34°E, suggests they may be related to displacement along the Mount Bonnell Fault, which is located a few hundred feet to the northwest. However, these fractures do not appear to be able to convey a significant amount of recharge into the subsurface because fracture apertures are less than one-tenth of one inch and the opposing sides are similar in shape. This suggests that enlargement through dissolution has occurred. As such, there is limited likelihood that recharge occurs through this feature.

Feature F-1. Widely spaced fractures within the Williamson Creek streambed located just upstream of US290

Because of the correspondence of the orientation of these fractures with the orientation of Mount Bonnell Fault, the feature could have a connection to a deeper karst feature in the subsurface. Appropriate precautions should be considered in planning for construction and during construction.

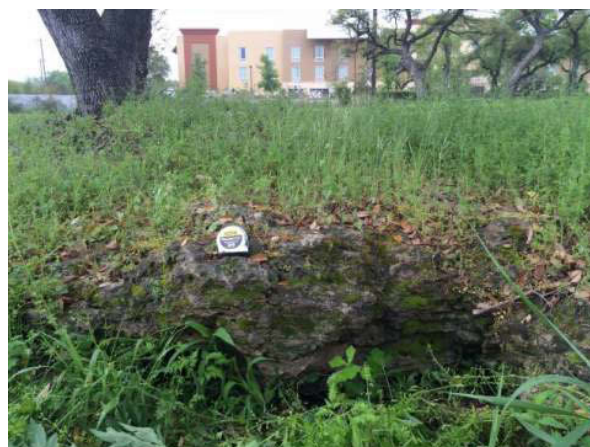
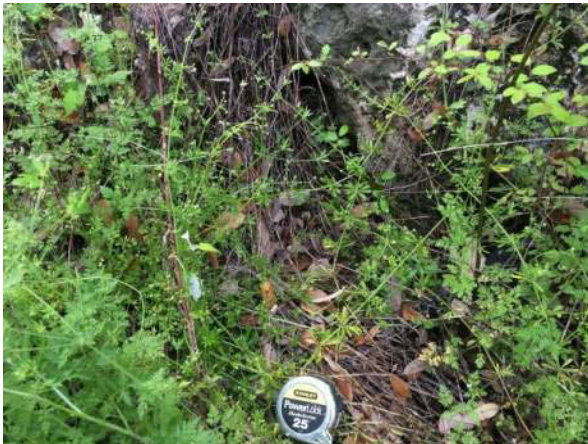
Feature F-2 is a solution cavity situated along the base of a bedding outcrop. The extent of the feature is limited due to infilling by soil and organic debris and animal burrowing is evident. The potential for rapid infiltration is low and the feature was evaluated as non-sensitive.

Feature F-2 solution cavity situated along the base of a bedding outcrop

Feature F-2 zoom-in of solution cavity situated along the base of a bedding outcrop

This feature likely does not have a strong connection to a deeper karst feature in the subsurface. Appropriate precautions should be considered in planning for construction and during construction.

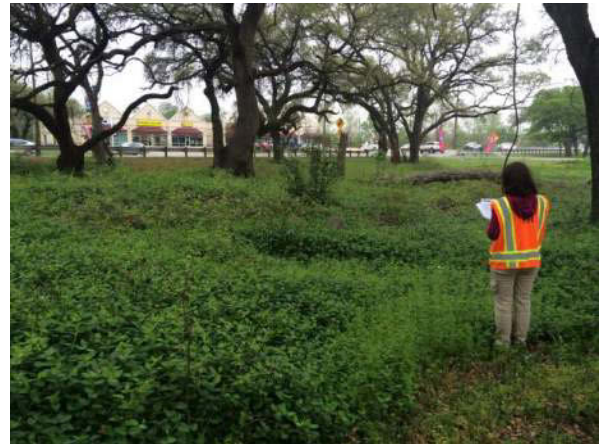
Feature F-3 is a small outcrop of limestone on the south side of US290 exhibiting small interconnected solution enlarged cavities. This type of feature, commonly referred to as a "honeycomb" texture, suggests the outcrop may at one time have been exposed to significant groundwater flow. It is positioned along a small drainage paralleling US290, however no water was present in the drainage, and it appears that surface flow is only present during significant precipitation events. Natural vegetation, plant debris, and high runoff potential soils

appear to cover most of the area. These factors limit infiltration while supporting rapid runoff. The feature was evaluated as non-sensitive with a low relative potential for infiltration.

Feature F-3 small outcrop of limestone on the south side of US290 exhibiting small interconnected solution enlarged cavities (Depression, veg cover)

This feature likely does not exhibit high infiltration and recharge to the subsurface. Appropriate precautions should be considered in planning for construction and during construction.

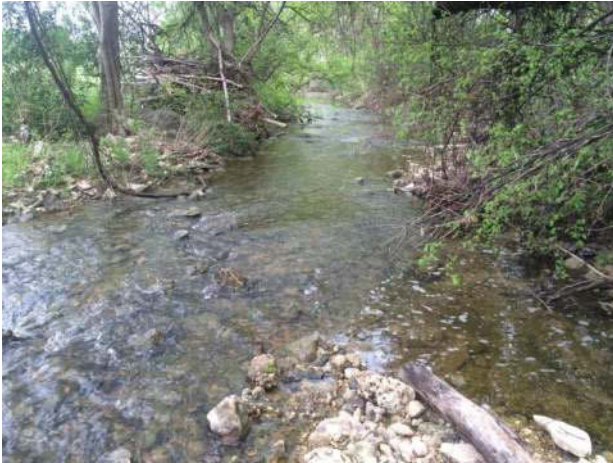
Where exposed within Williamson Creek, the Mount Bonnell Fault shows little evidence of solution enlargement. The location of the feature is based upon nearby fractures and changes in lithology on opposing sides of the fault. The fault juxtaposes the Glen Rose Limestone to the northwest against Edwards Limestone. Most fractures within the streambed appear to be sealed with fine grained sediment and vegetative debris. This feature is not exposed in any other location within the project area. It was evaluated as sensitive with a moderate potential for infiltration.

Feature F-5. Surface expression of the Mount Bonnell Fault within Williamson Creek.

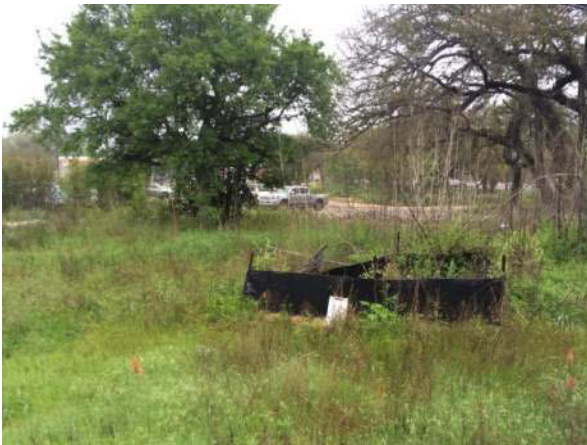
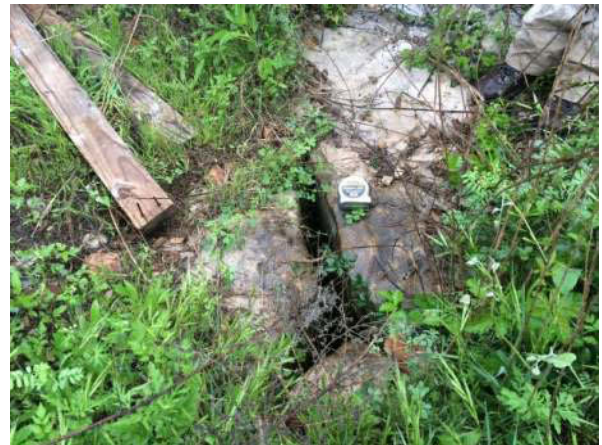
Feature F-6 – solution cavity located along the southern limits of the TxDOT right-of-way south of US290

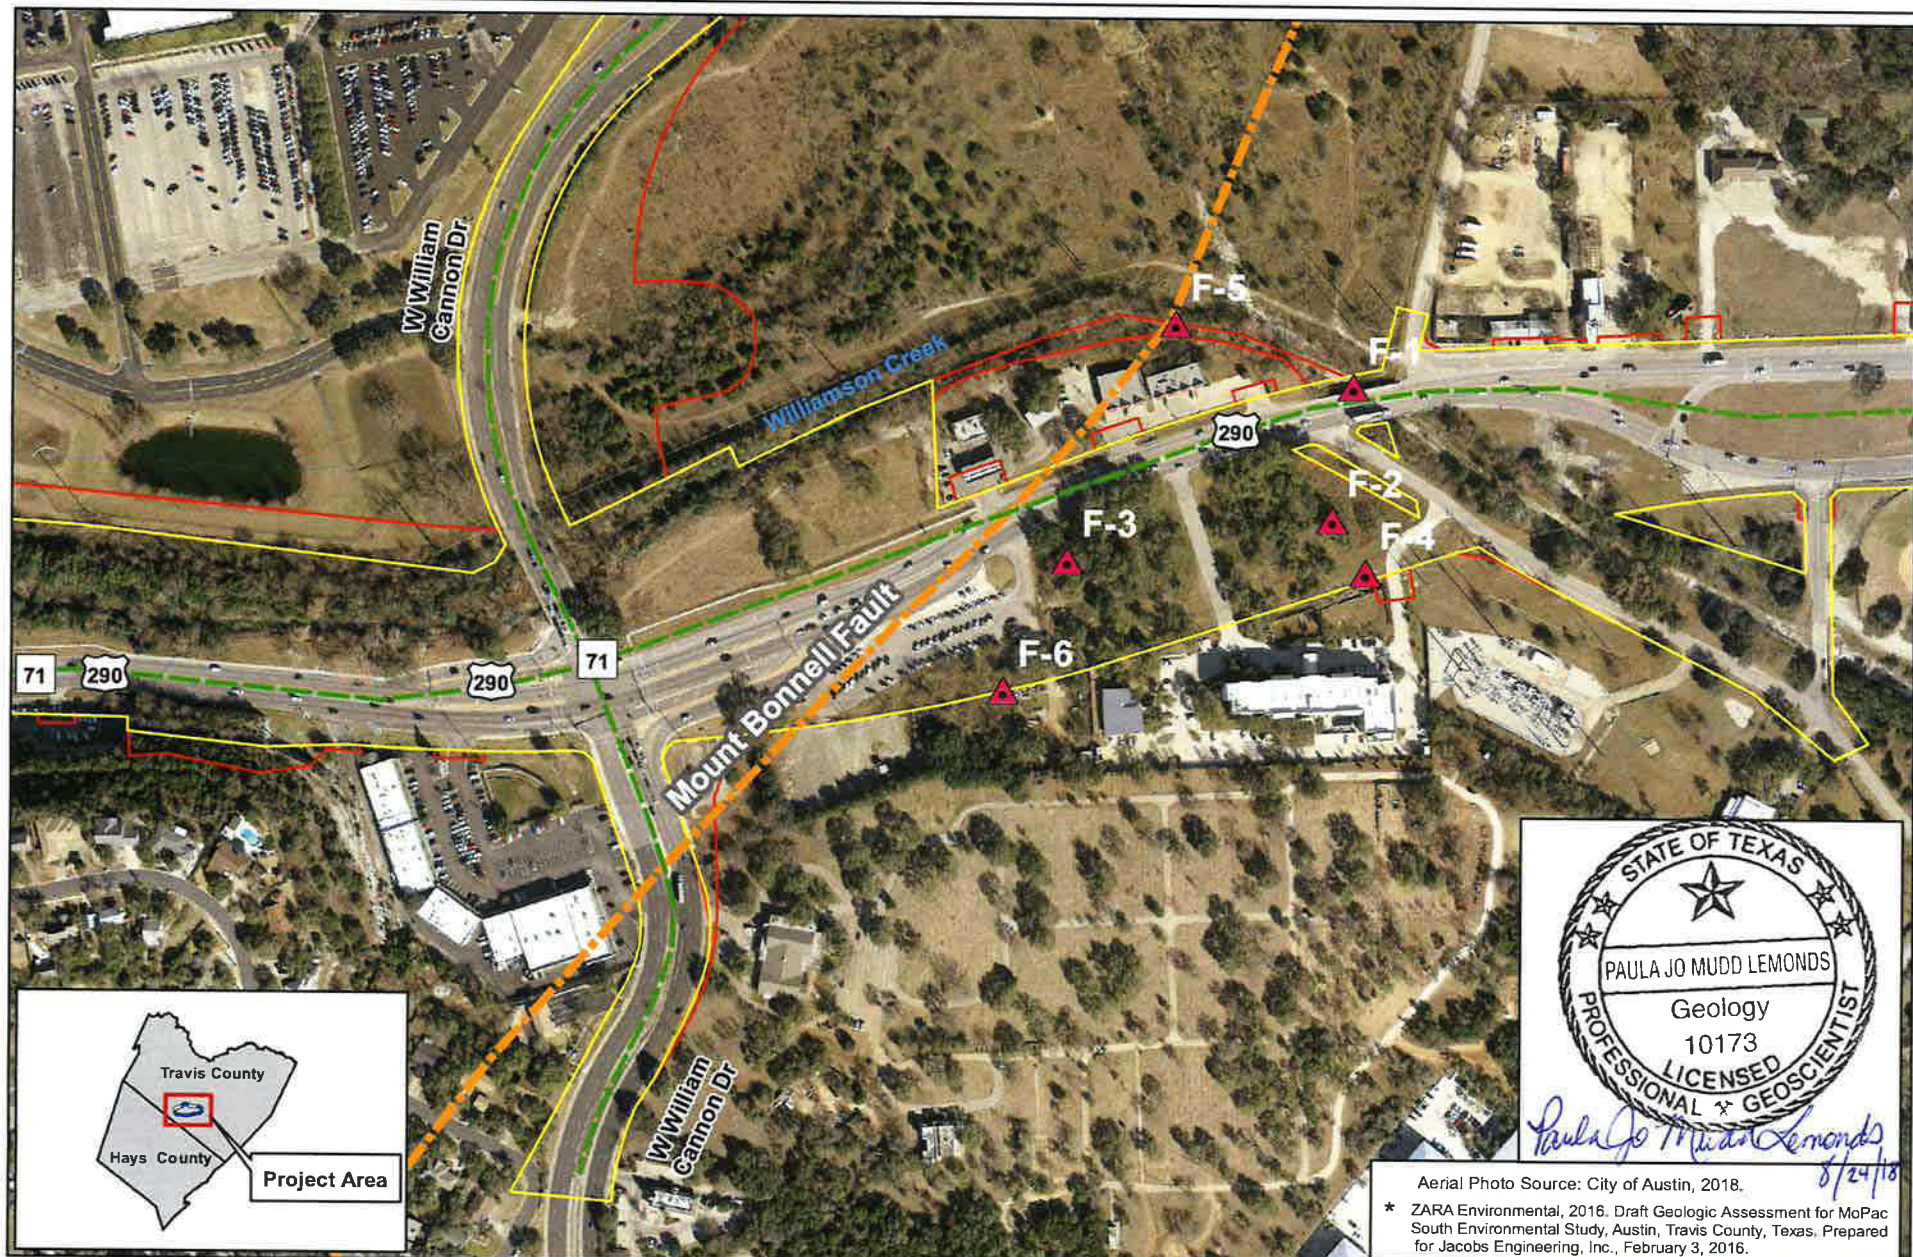
Figure 2a. Geologic Features Map
 Oak Hill Parkway: US 290W from Mopac/Loop1 to west of Circle Drive and SH 71 from US 290W to Silvermine Drive

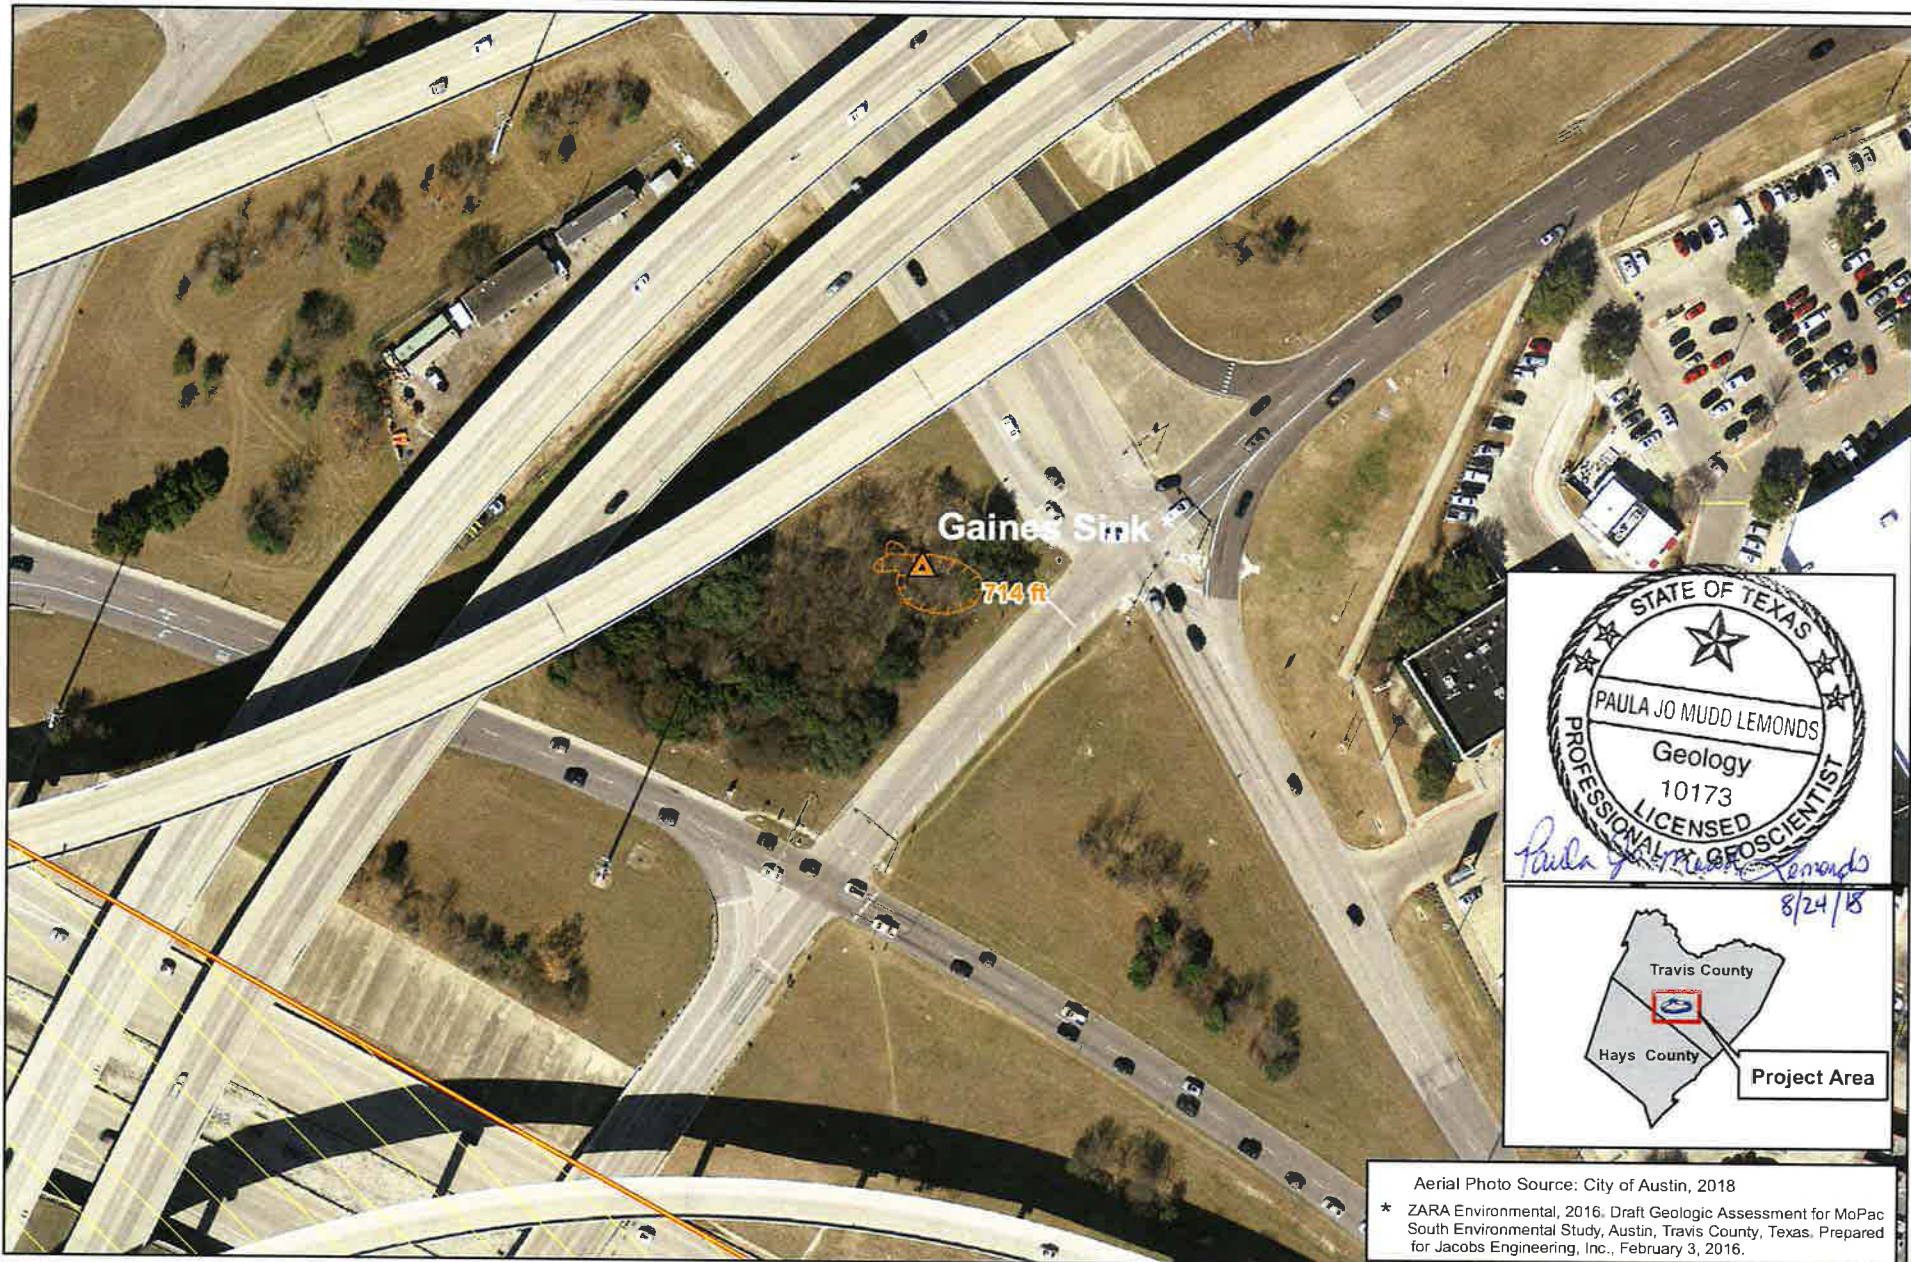
Figure 2b. Gaines Sink

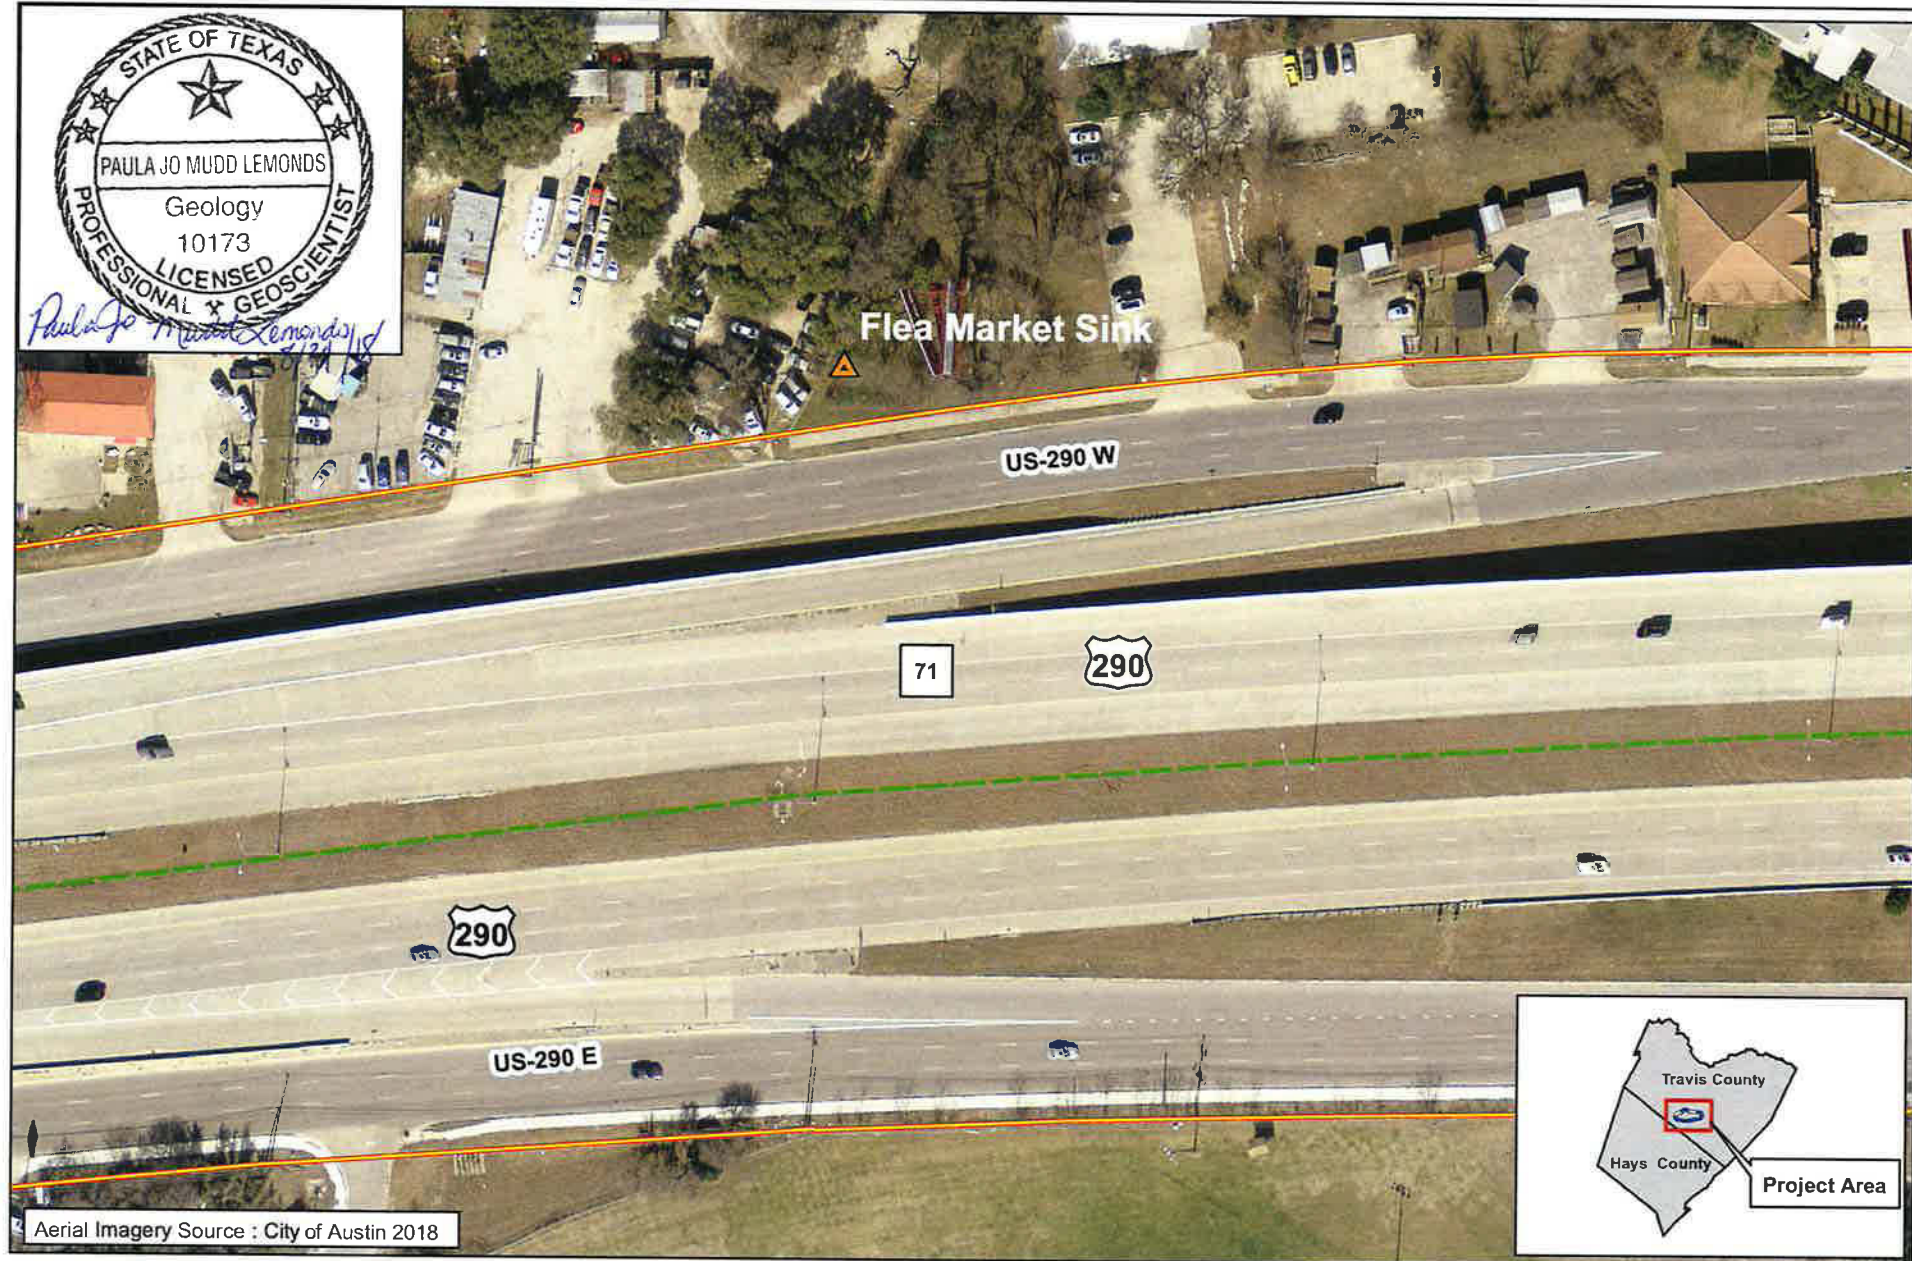
Figure 2d. Flea Market Sink
