# **Streams and Structures Roadway Design and Bridge Conference**

# Overview of Fluvial Geomorphology and a Tale of Two Bridges

# FM 68 at North Sulphur River

# FM 787 at Trinity River

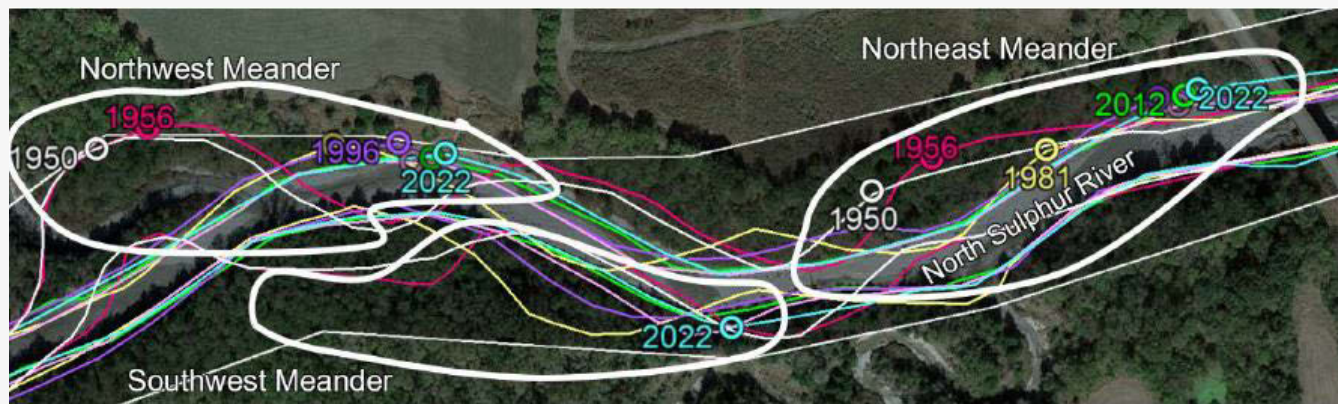
**Figure 6. Analyzed meander migration rate locations**

- Meander rates over the years were determined at three locations upstream of the project location, and plotted on a chart.

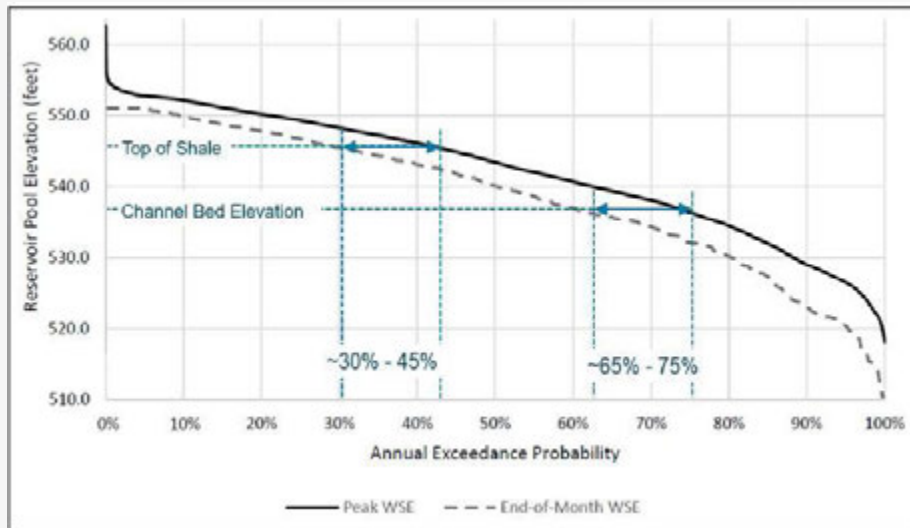
**Figure 8. FNI (2020) Basis of Design Report for Leon Hurse Dam Figure 2.12**

- Once the lake is filled, the riverbed at the bridge site is expected to be submerged for longer periods of time with reduced number of wet/dry cycles.
- To determine the degree to which the estimated scour will be reduced, the annual exceedance probability plot prepared by FNI (2020) for the Leon Hurse Dam was utilized.

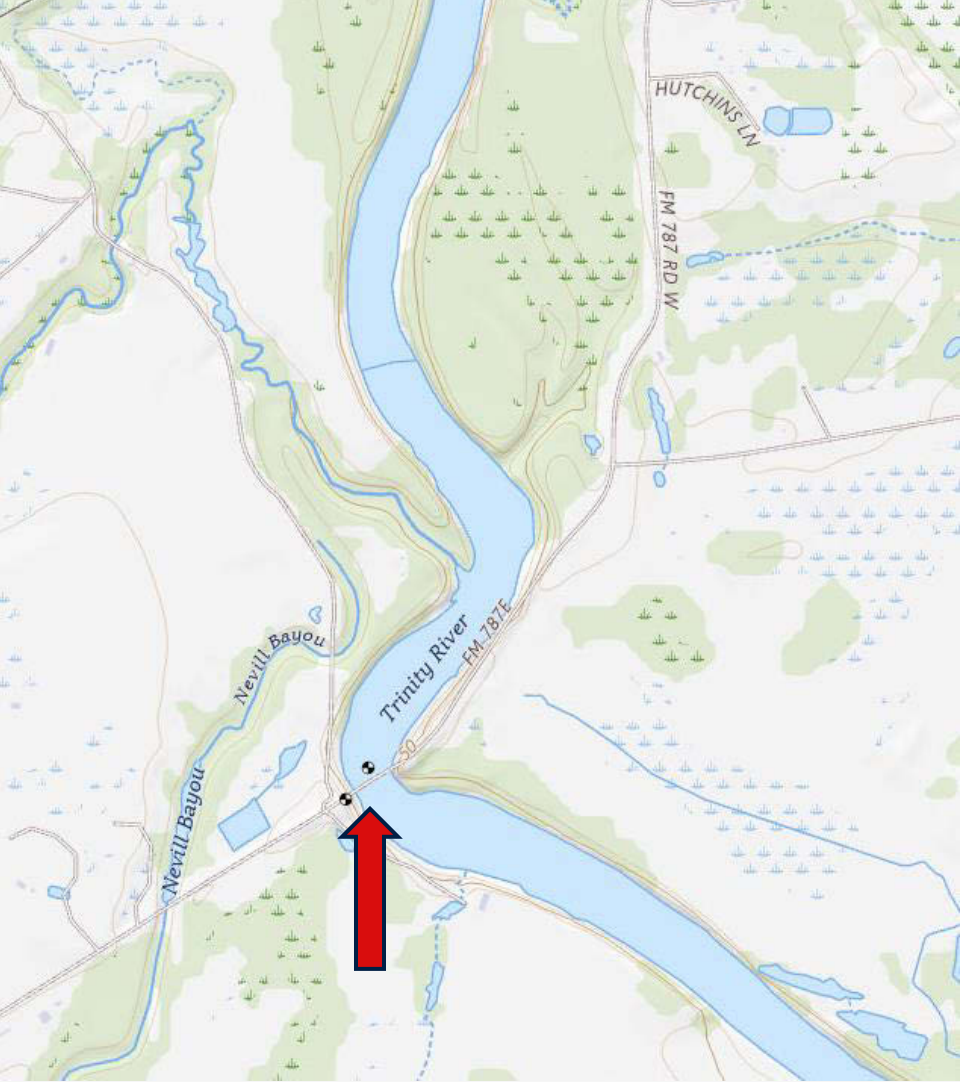
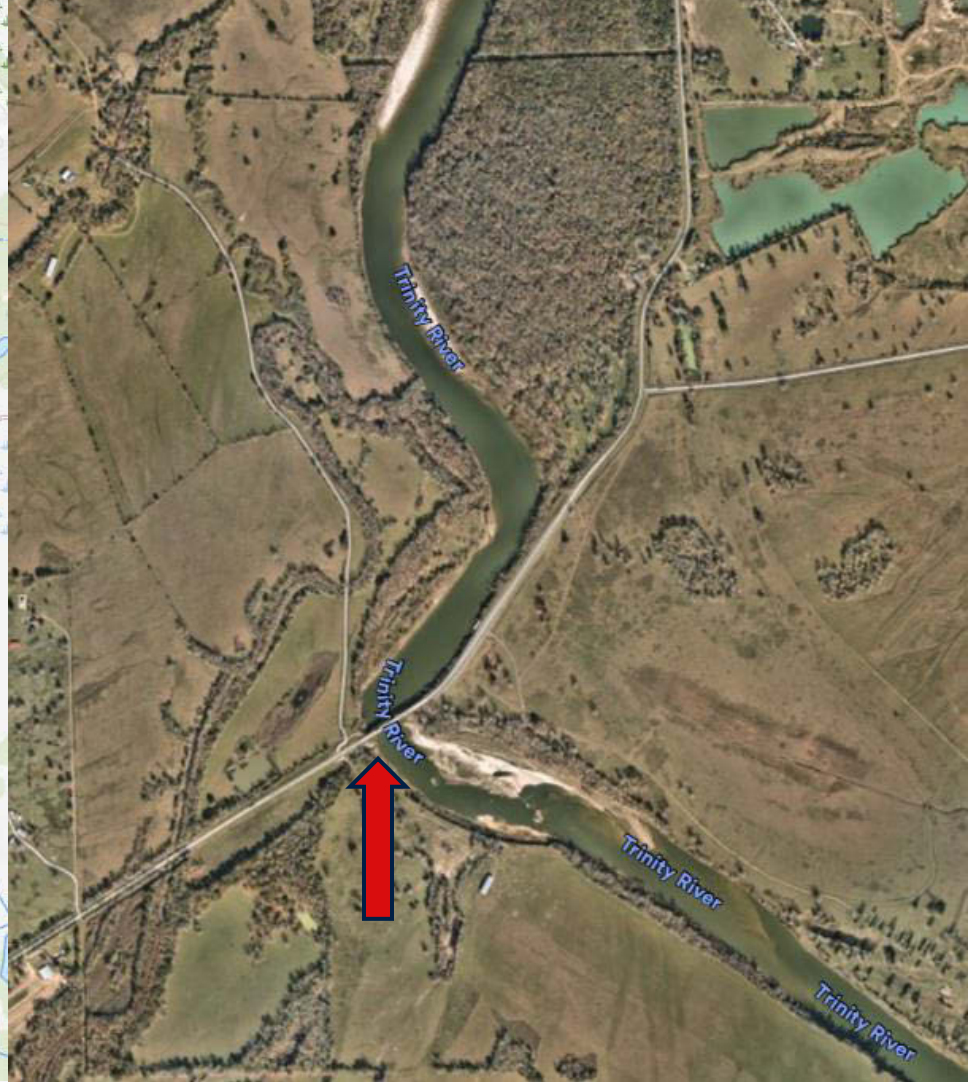
**May 7, 2024 - collapse of west approach slab**

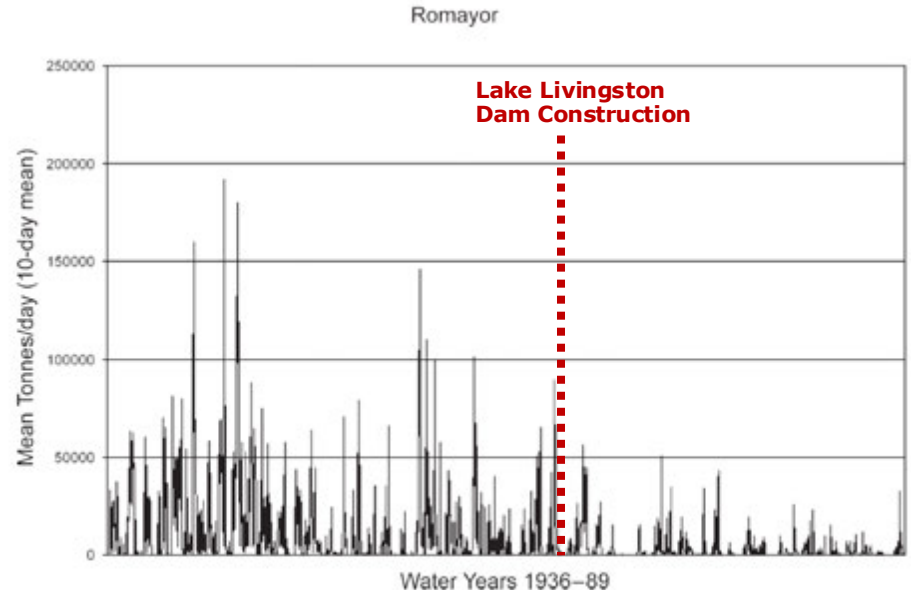
**Figure 2.** Sediment loads as 10-day means at the Romayor gaging station. Data from the Texas Water Development Board. Samples were taken with a point sampler (the Texas Sampler); results are multiplied by 2.37 to calibrate with depth-integrated samples as described by Phillips et al. (2004).

- Sediment loads in the Trinity River after construction of the Lake Livingston Dam were significantly less than before
- At the FM 787 crossing, chronic scour and significant bank erosion were noted
- Channel had exposed sandstone bedrock (no bed material left)
