RE: US 181 Harbor Bridge Replacement Project
CSJ# 0101-06-095
Notice of Nonconforming Work

TxDOT retained International Bridge Technologies (“IBT”) to provide an independent review of ARUP-CFC’s design of the New Harbor Bridge. Attached to this letter as Exhibit A is a report prepared by IBT dated April 23, 2022 (the “IBT Report”) detailing its findings regarding FDLLC’s design. The IBT Report identifies a number of instances of Nonconforming Work¹ that raise significant and alarming concerns with the design and construction of the New Harbor Bridge. The findings in the IBT Report establish that FDLLC has failed to provide a design for the New Harbor Bridge that ensures the safety and integrity of the New Harbor Bridge. In short, FDLLC has failed in many significant and material ways to perform the Work on the New Harbor Bridge in accordance with the Contract Documents. Attached to this letter as Exhibit B is a table summarizing certain findings by IBT and corresponding provisions of the Contract Documents that FDLLC has breached. The table is intended as a high-level summary and FDLLC should refer to the complete IBT Report for a full description of IBT’s findings and the numerou

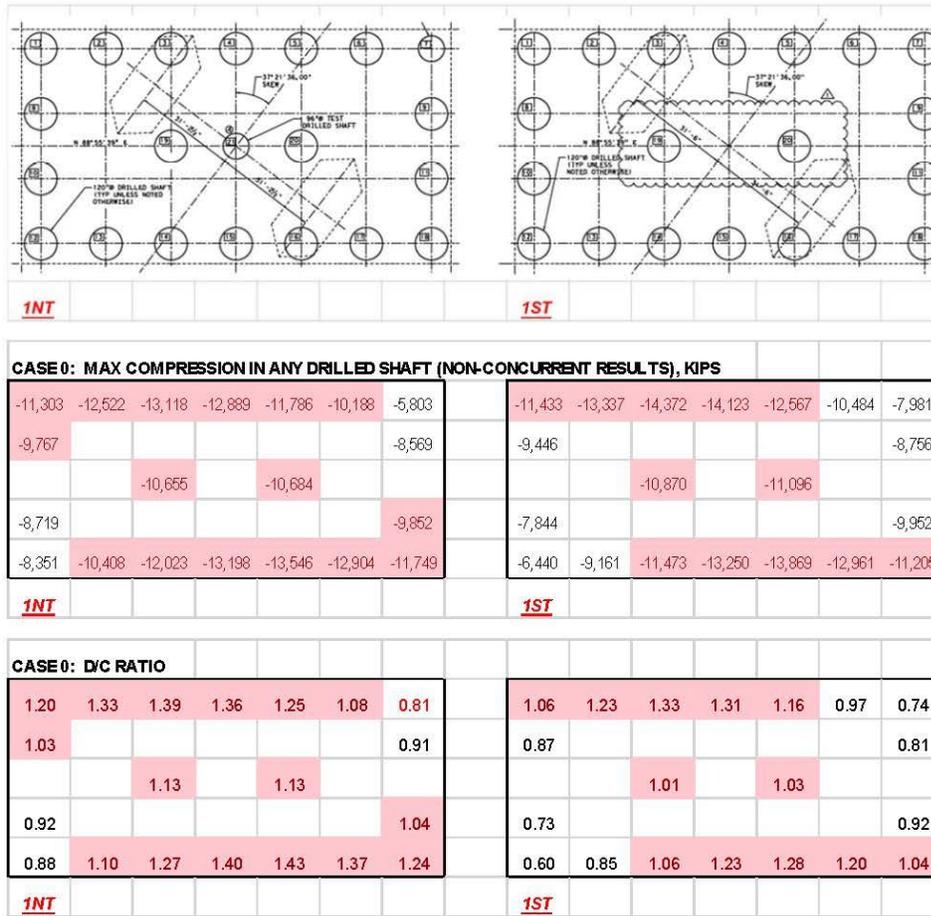
At foundation 1NT, 16 of the 20 drilled shafts are deficient for Service and for Strength and Extreme load combinations. At foundation 1ST, 12 of 20 drilled shafts are deficient under Service loads and 10 of 20 are deficient under Strength and Extreme load combinations. Figures 2 and 3 below show the maximum compression observed in each drilled shaft along with D/C ratios for each shaft for Service, Strength, and Extreme load combinations.

Figure 2: Summary of Service Axial Compression and D/C Ratios for 1NT/1ST Drilled Shafts – Drilled Shaft Layout Schematic Provided by Others

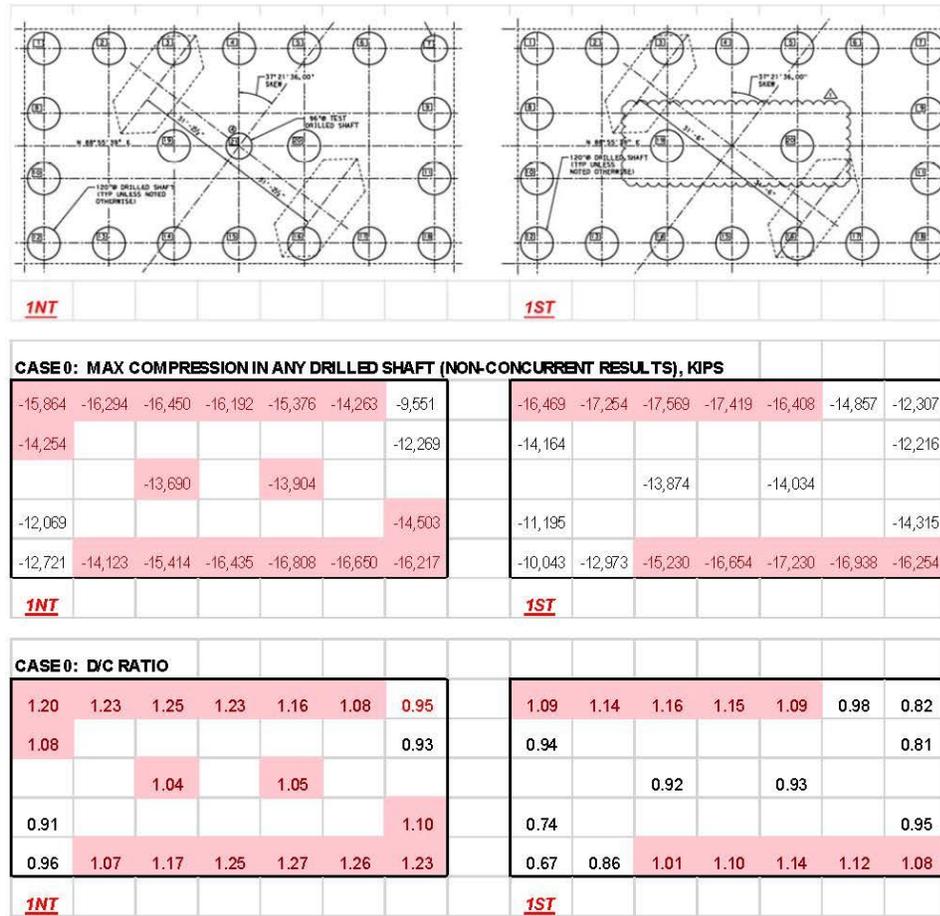
Figure 3: Summary of Strength and Extreme Axial Compression and D/C Ratios for 1NT/1ST Drilled Shafts – Drilled Shaft Layout Schematic Provided by Others

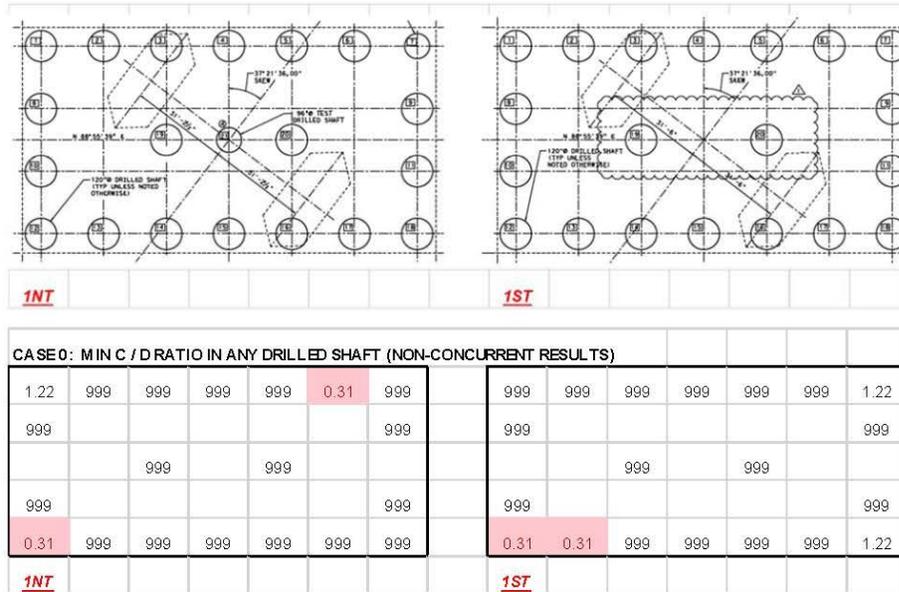
Figure 6: Summary of Minimum Transverse Reinforcement C/D Ratios for Drilled Shafts – Drilled Shaft Layout Schematic Provided by Others

Note that a C / D ratio of 999 presented in Figure 6 above indicates that the shear demand is less than one-half the factored concrete shear capacity, and therefore transverse reinforcement is not required as per AASHTO §5.8.2.4 at this location.

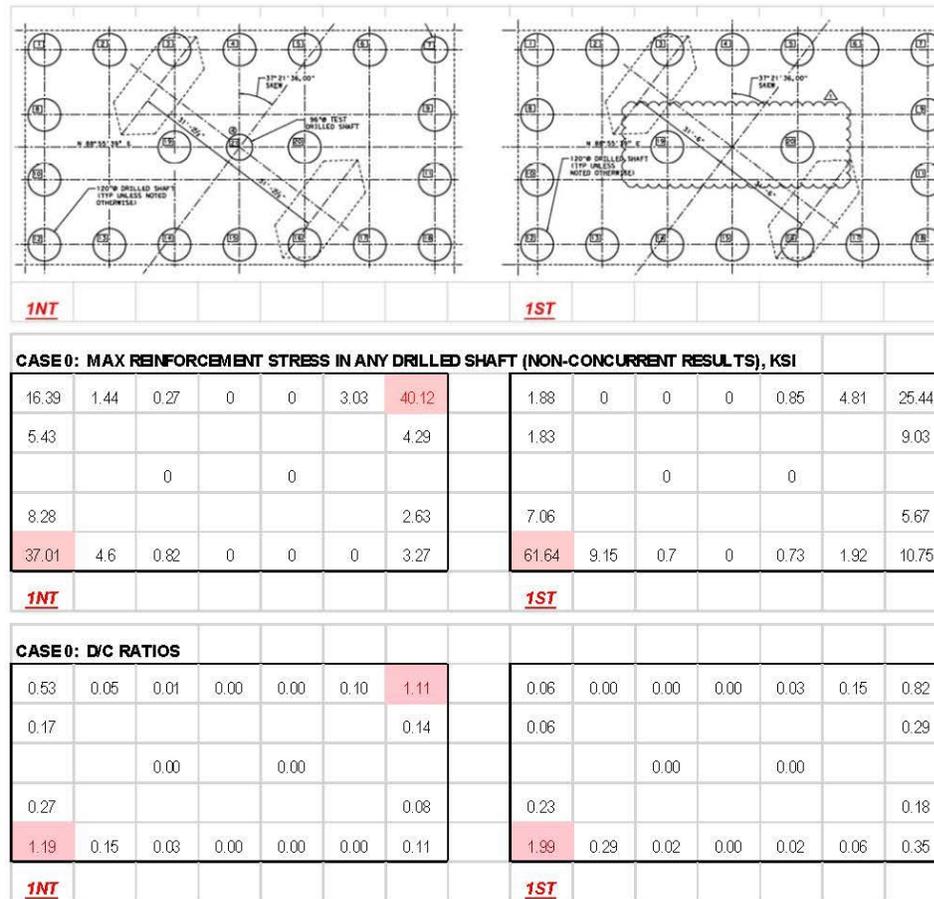
Figure 7: Maximum Longitudinal Reinforcement Stress and Equivalent D/C Ratios for Control of Cracking by Distribution of Reinforcement – Drilled Shaft Layout Schematic Provided by Others

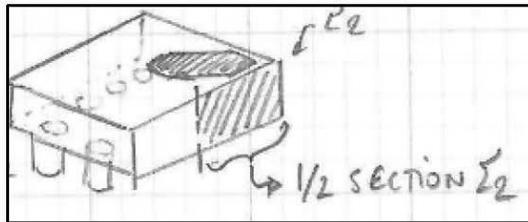
As observed with the flexural demands in the foundation cap, the shear loads are highly concentrated adjacent to the tower legs. For conventional designs, AASHTO may allow for the full-section width to be considered as part of the capacity, but that generally applies to a concentrically loaded cap without pronounced edge loadings, which is not the case for the foundation caps at Towers 1NT and 1ST. Therefore, both full- and half-sections are checked for one-way shear.

Figure 23: Sketch Showing Concentrated Reaction from Tower Leg at the Edge of the Foundation Cap

A summary of results for one-way action is provided below. If the entire width of the cap could be mobilized to resist the demand, it would have sufficient capacity. However, considering the half-width, which is more appropriate considering actual behavior, the cap does not have sufficient capacity.

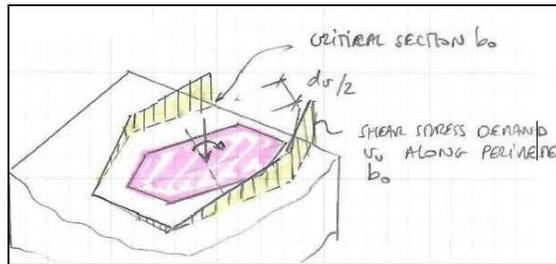
For two-way action, multiple locations were evaluated to verify the structural capacity. Cases considered at locations in the foundation cap around the drilled shafts were found to be adequately reinforced. However, for locations around the tower leg, there is insufficient capacity to resist two-way action. In this case, axial load and bending moment from the tower leg apply localized stresses normal to the cap concentrated at the "pointy toe" of the tower leg near the edge of the cap, as shown in Figure 24 below.

Figure 24: Graphical Representation for Two-Way Action at Tower Leg

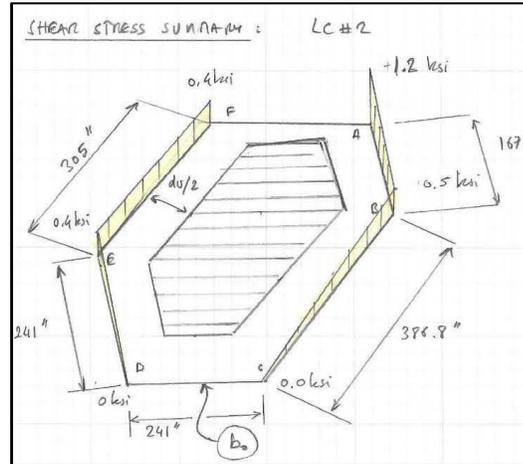
Figure 26: Shear Stresses at Critical Foundation Cap Sections Around the Tower Leg Perimeter under Maximum Loading – Side A-F Represents the Edge of the Cap

The loading pattern shows very high shear stress concentrations next to the edge of the foundation cap. The load resistance capability of the foundation cap is limited by having the leg so close to the edge. This prevents the distribution of the shear resistance to a “full” perimeter around the base of the leg.

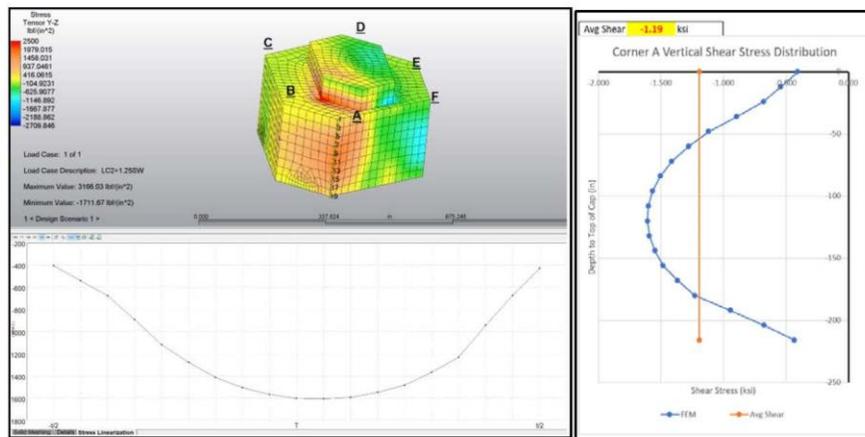
The brick element model was able to provide the shear stress variation through the depth of the foundations cap. For comparison, the average shear stress over the depth of the cap at Corner A (the location of the greatest shear stresses) was computed to be 1.19 ksi, which closely agrees with the 1.20 ksi shear stress observed in the thick plate model at this location. Based on this, it can be concluded the thick plate model results were sufficient in identifying the deficiencies stated above. However, the brick element model revealed that the maximum shear stress at mid-depth of the foundation cap at Corner A exceeds 1.5 ksi, which is more than 25% greater than the average shear stress considered by the thick-plate element model used to identify the two-way action deficiency stated above.

Figure 30: Brick Model Results at Two-Way Action Plane at Foundation Cap 1ST

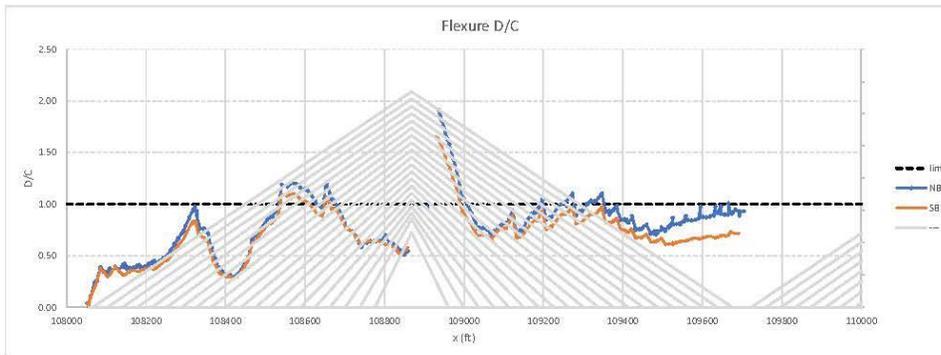
Figure 34: Flexural D/C ratio for NB and SB box girders

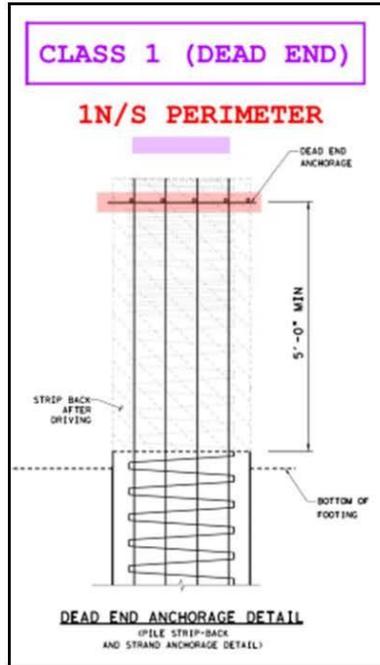
Ⓢ CONTRACTOR TO SUBMIT DEAD END ANCHORAGE DETAILS TO ENGINEER FOR REVIEW AND APPROVAL. THE DEAD END ANCHOR MUST DEVELOP THE FULL TENSILE CAPACITY OF EACH INDIVIDUAL STRAND.

Figure 38: Vague Dead End Strand Anchorage Detail in Pier Foundation 1N and 1S – Detail Provided by Others

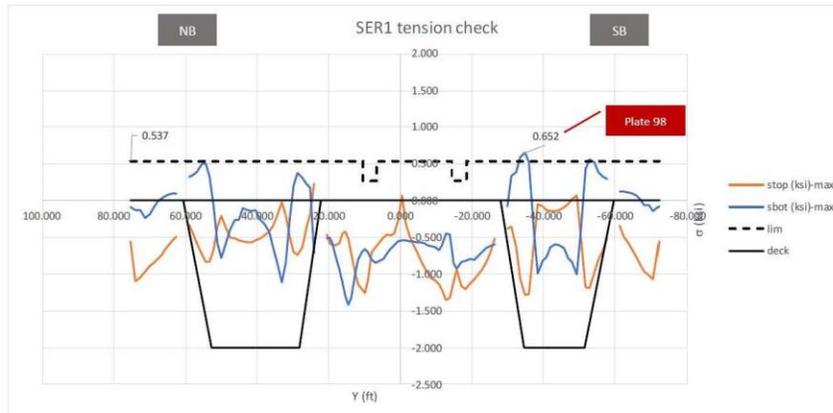
The bottom fiber stresses in the southbound box girder at the top slab haunch exceed the allowable stress limits of AASHTO LRFD Table 5.9.4.2.2-1 under Service load combinations, as show in Figure 43 below.

Figure 43: Top slab Service tension check

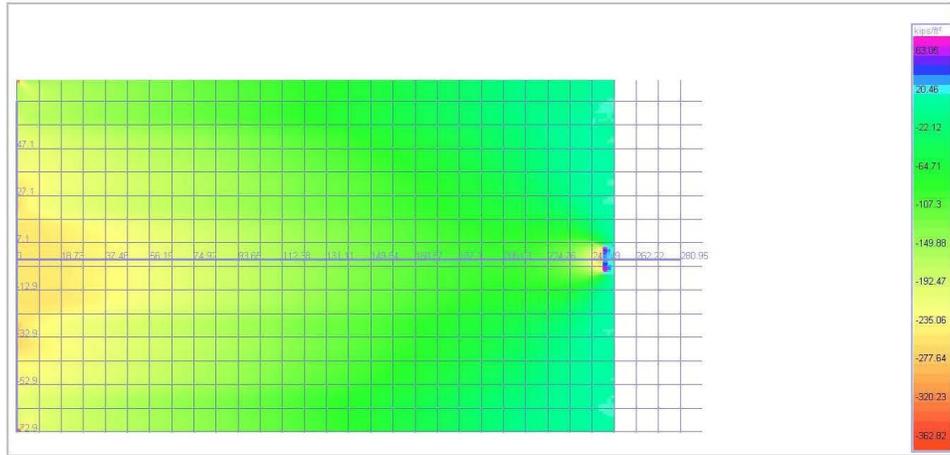
When looking at the compressive incremental stresses in top slab due to Stay S26 stressing, Figure 45 below shows that diffusion is only complete at approximately 70 ft in front of the stay forces.

Figure 45: Top slab incremental stresses for stay stressing S26 (the grid is 10 ft by 10 ft)
