Section 6: Bridge Inspector Requirements

Mark Wallace – TxDOT Bridge Division

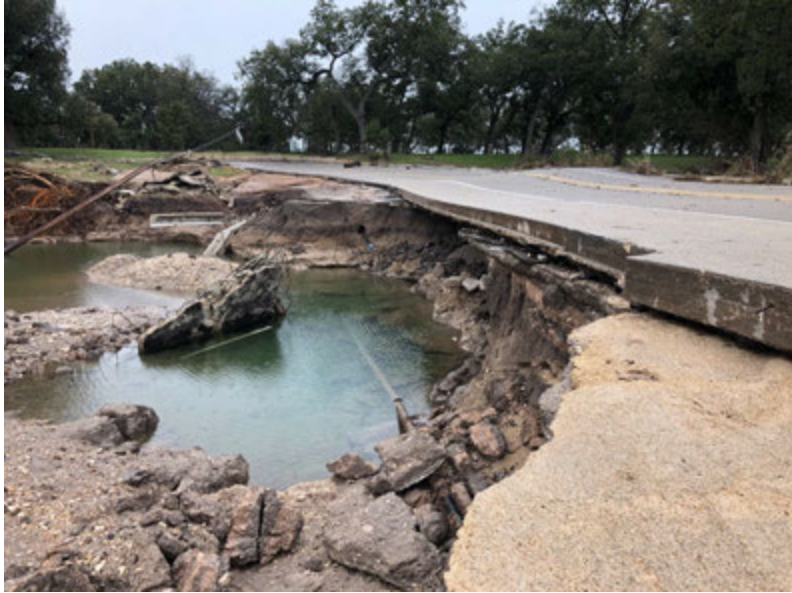
Scour on downstream side of approach due to an overtopping event.

High flow can cause VERY large drift accumulations. **What has to happen at this bridge?** (Hint – the amount of water passing this location will not change because of the drift!)

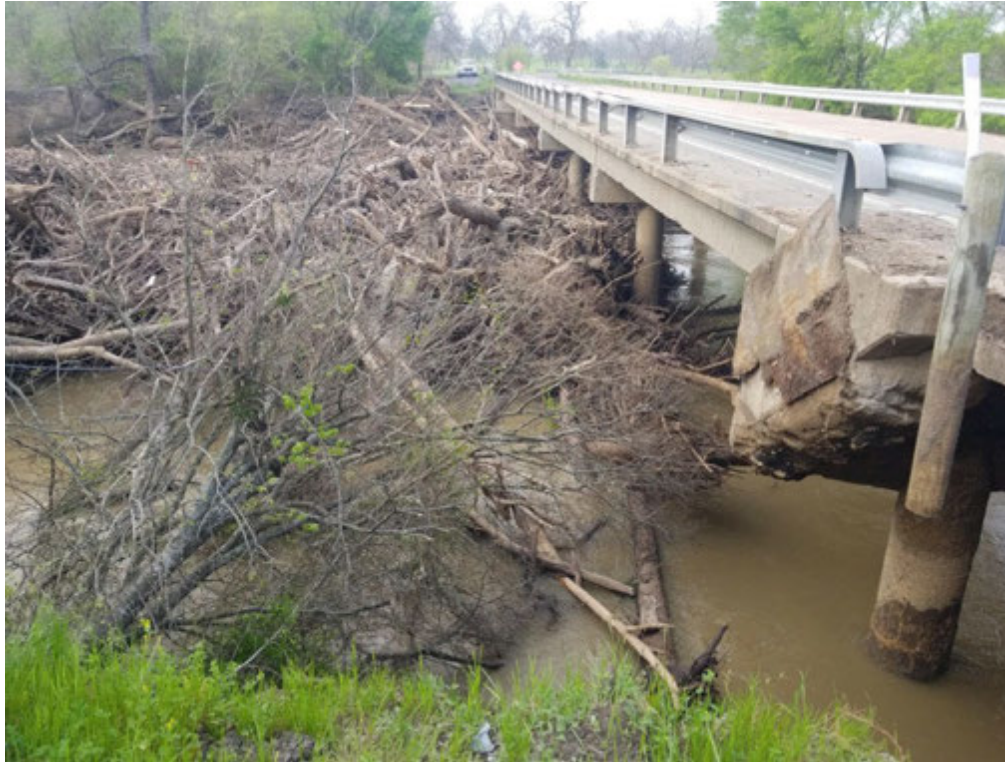
Not the same bridge but the problem is the same. Smaller hydraulic opening due to drift accumulation, so water has to accelerate, increasing the likelihood of damaging scour.

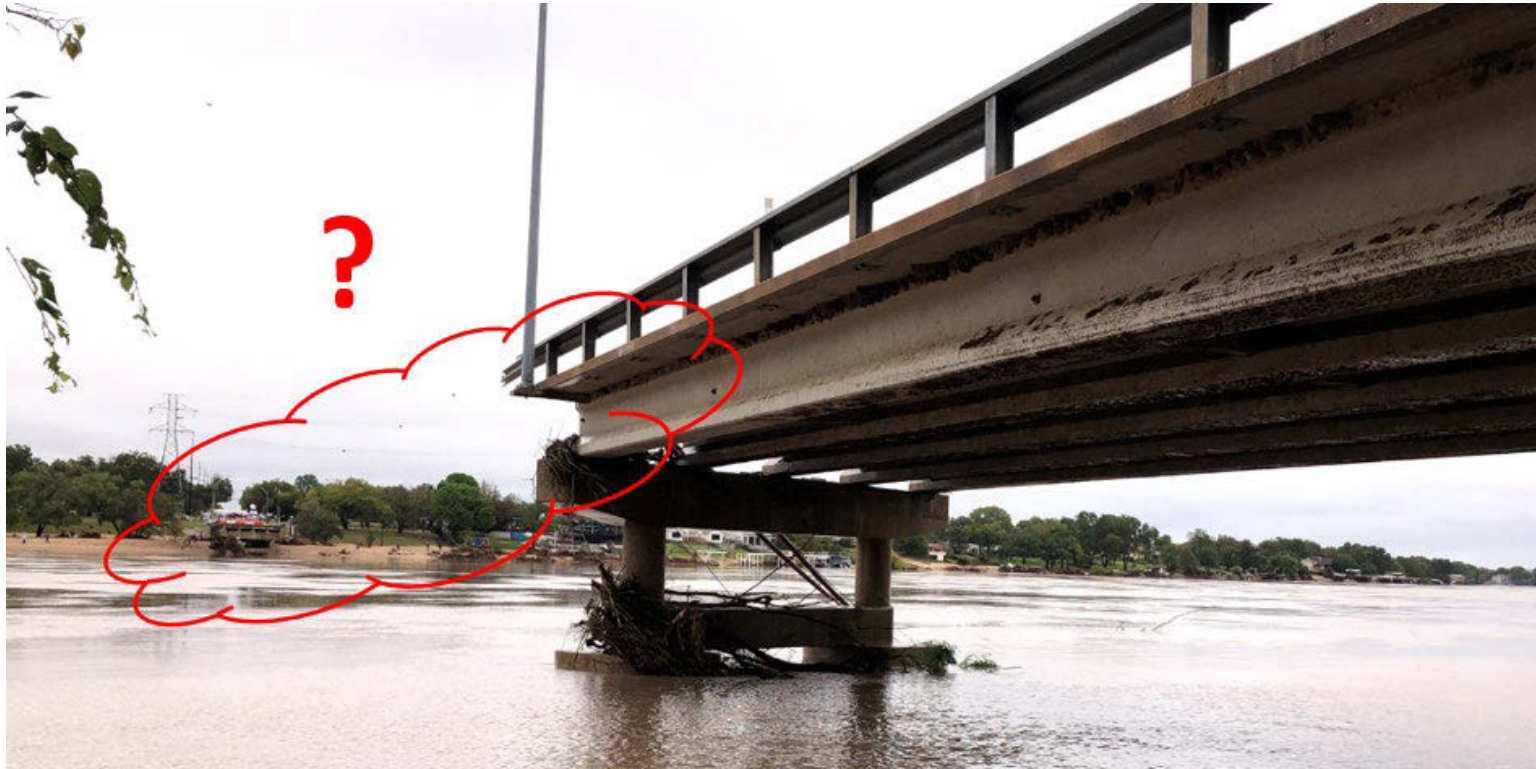
RM 2900
in
Kingsland

What is
missing
from this
picture?!

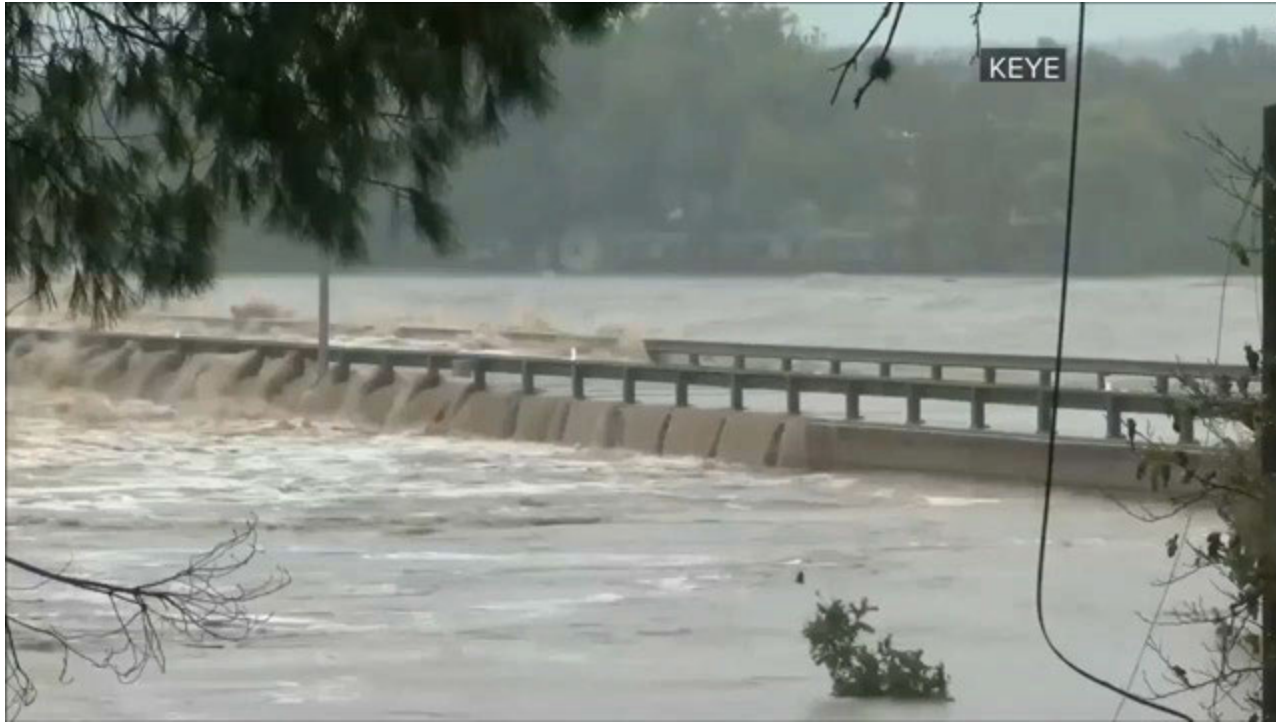
The collapse was caught on camera by a new crew.

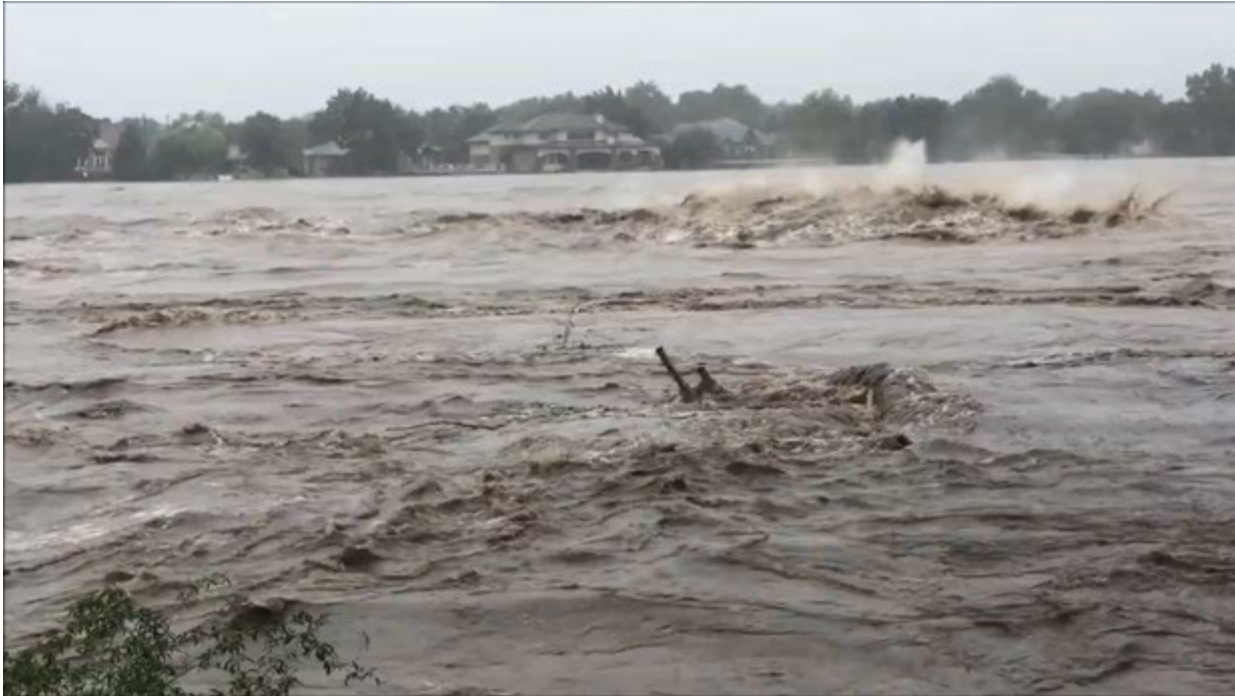
A local uploaded caught this span washing downstream. (A few hundred feet from FM 2900.)
