Develop Performance of Baseplate Connections in COSS and Traffic Signal Structures

0-7192

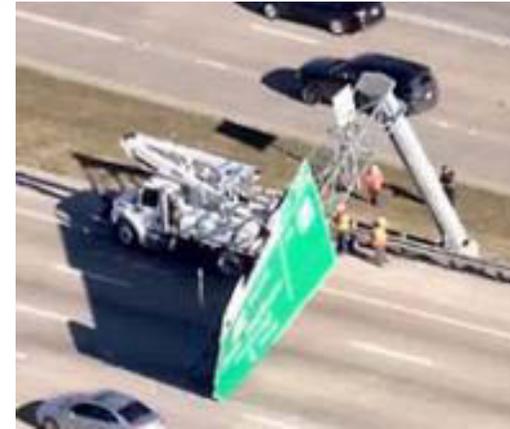
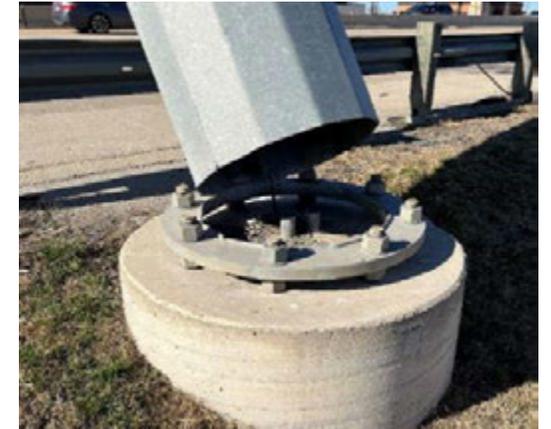
Cantilever Structures Failed in Texas:

- COSS (11 years in service)
- Two TSS (2 years in service)

Collapse of Cantilever Structure—Hwy 75, Allen, TX

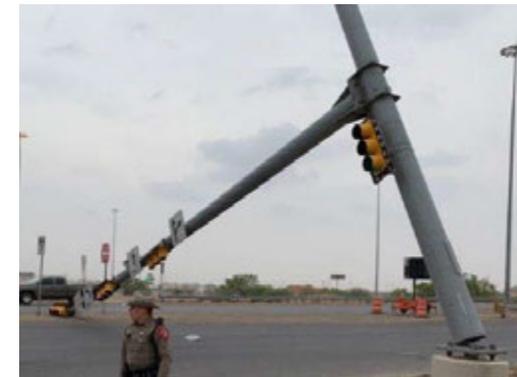
Collapse of Cantilever Structure—Odessa, TX

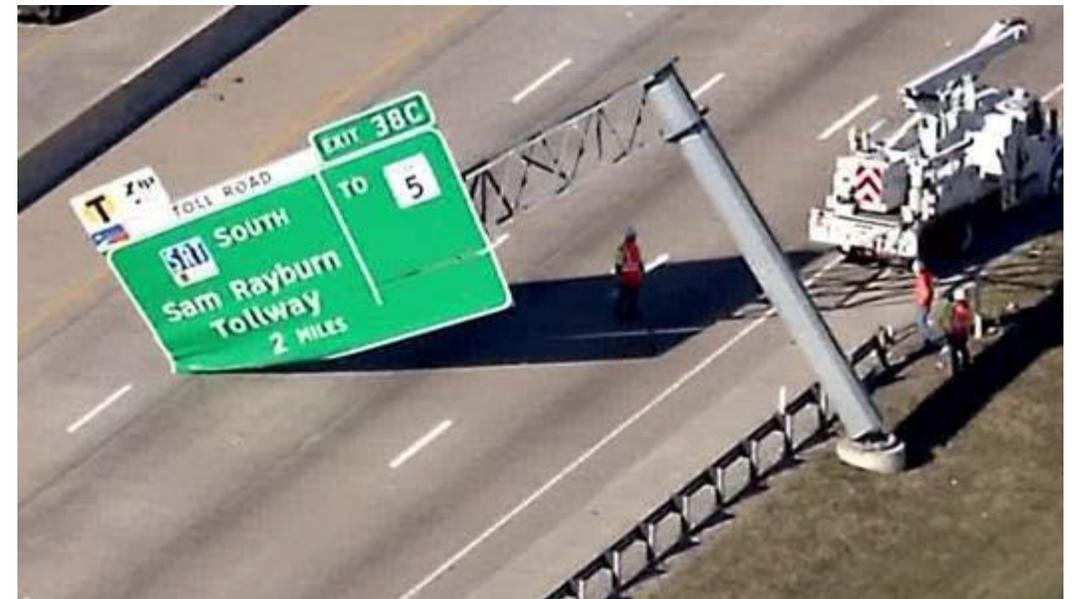
COSS Located at ZONE 4 with Wind Velocity: 70 mph

Pole:

Pole Height: 29 ft

Outer Pole Diameter: 30 in.

Pole Thickness: 0.281 in.

Baseplate Thickness: 1.75 in.

Service Life ~ 11 years

*Collapse of COSS in Dallas-Collin County on Feb 18, 2022
wfaa.com (2022)*

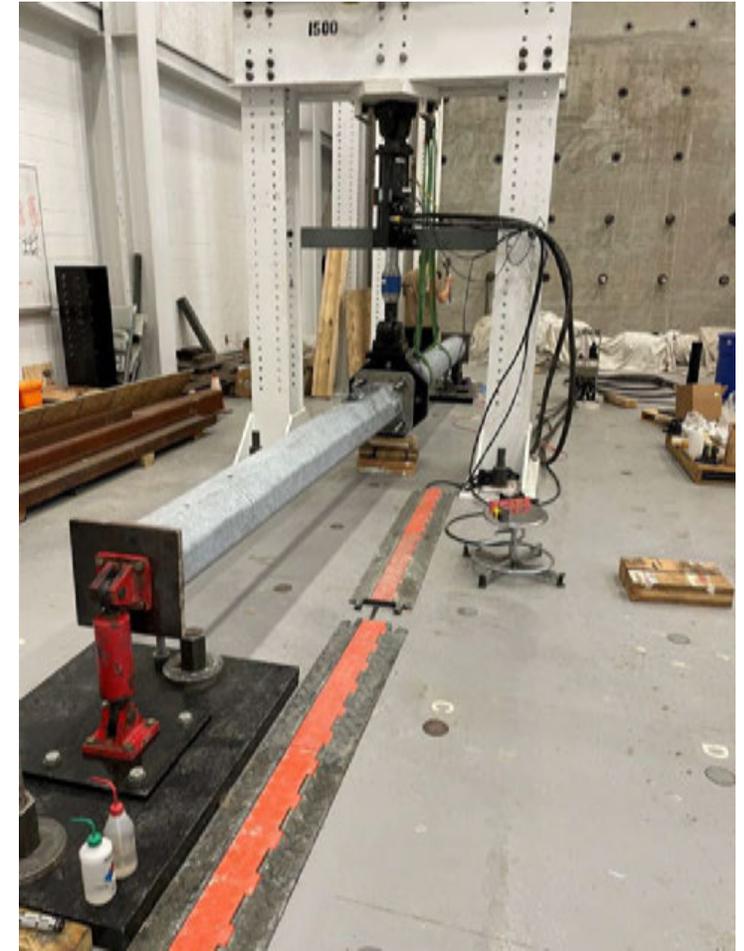
*Testing Program of
Two Poles*

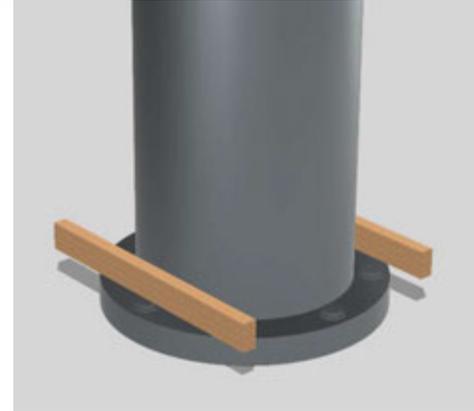
Measurement of the Outer Diameter Pole

- Outer diameter of the poles was measured using a measuring tape
- Truss Span was measured using Leica DISTO X3 Laser Distance Meter
- Baseplate thickness and wall thickness of the poles was measured using Olympus 27 MG Ultrasonic Thickness Gauge
- Zinc coating thickness was measured using Elcometer 456 Nonferrous Metal Coating Thickness Gauge

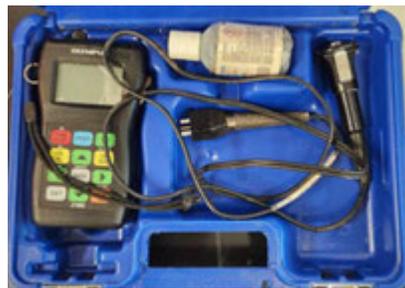
Ultrasonic Thickness Gauge
