# Field Assessments and Repair Details

Chris Gomez, PE

TxDOT Bridge Division – Construction and Maintenance Branch

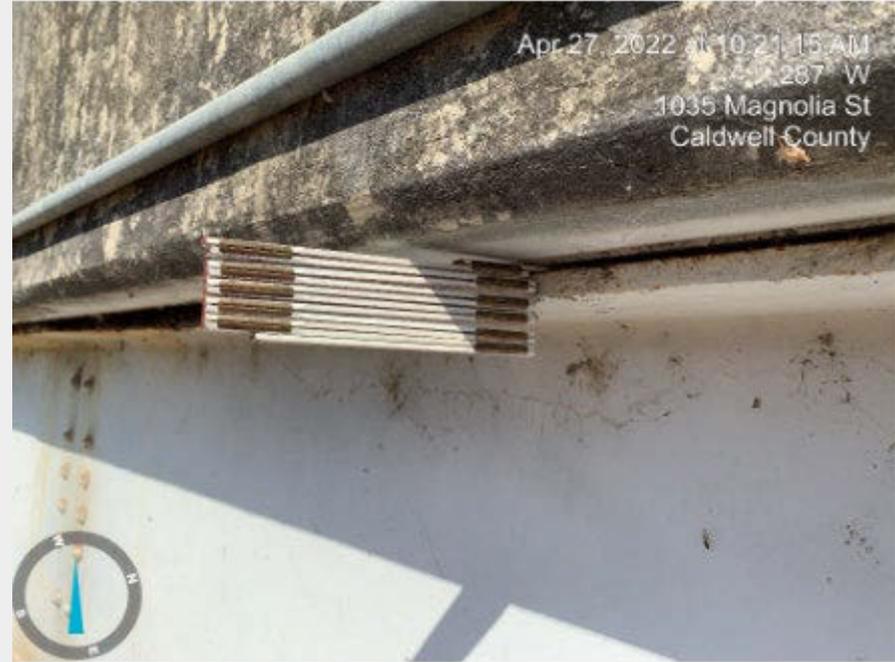
- Overall/Big Picture
  - Alignment
  - Settlement
  - Widenings or other structure modifications

★ Look down length of rail at eye level

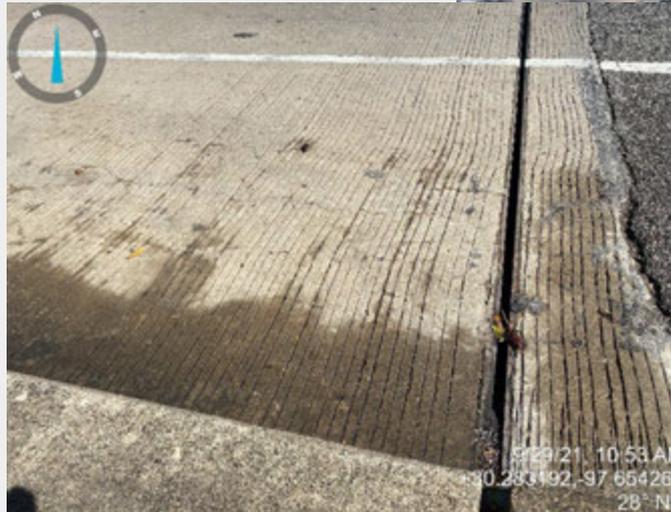
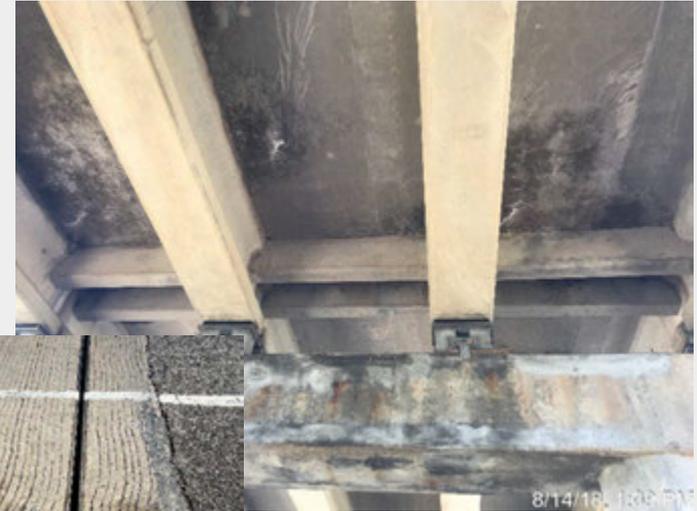
- Rails

- Rail Type?
  - "non-standard" on the inspection report doesn't mean "unacceptable"
- Retrofit?
- Measure height

- Joints

- Joint type?
- Seal intact?
- Spalling or other damage?

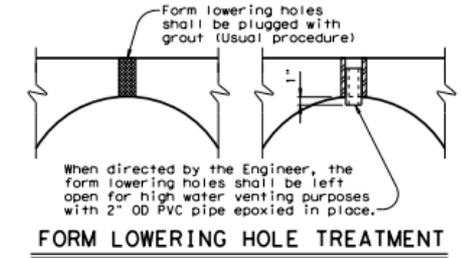
- Longitudinal cracking at tops of arches
  - Usually not a concern, but will lower condition ratings
- Spalling/cracking at midspan
  - Due to water from form-lowering holes
  - Plug or use PVC pipe to extend holes below arch soffit

(From CG-MD Standard)

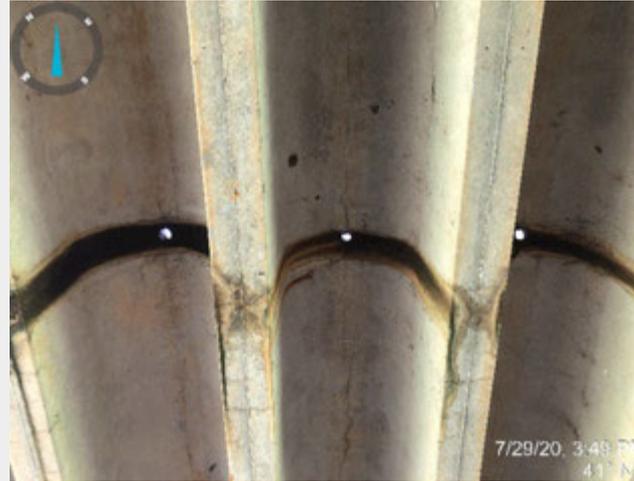
- Substructure spalling
  - As joints fill with debris pan girder expansion/contraction becomes limited
  - Concrete-on-concrete bearing at cap corners produce spalling
  - Prevention is key!
    - Clean joints FULL DEPTH
    - May extend repairs to provide additional bearing area

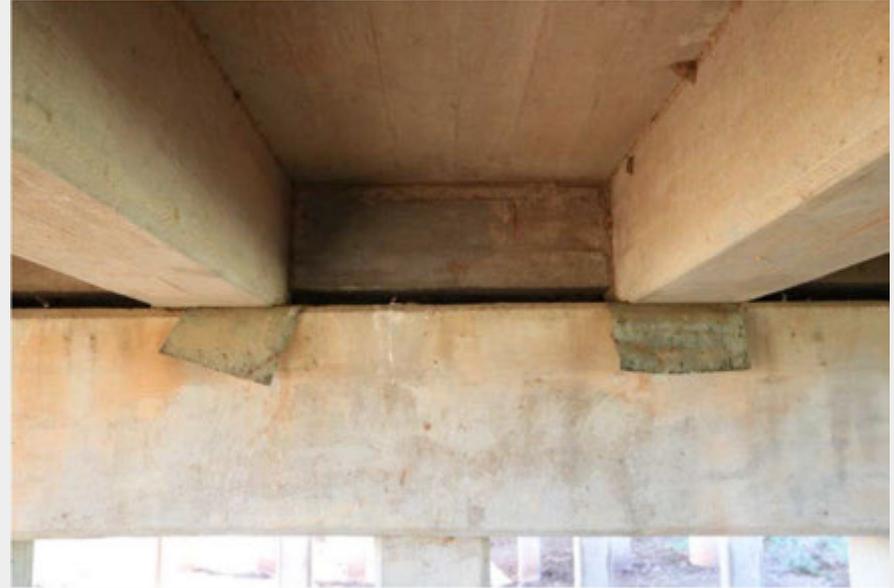
- Substructure issues similar to Pan Girders
- Lead sheets
  - Common FUA item
  - Consider other alternatives to replacement of sheets
  - Lifting may cause more damage than taking no action

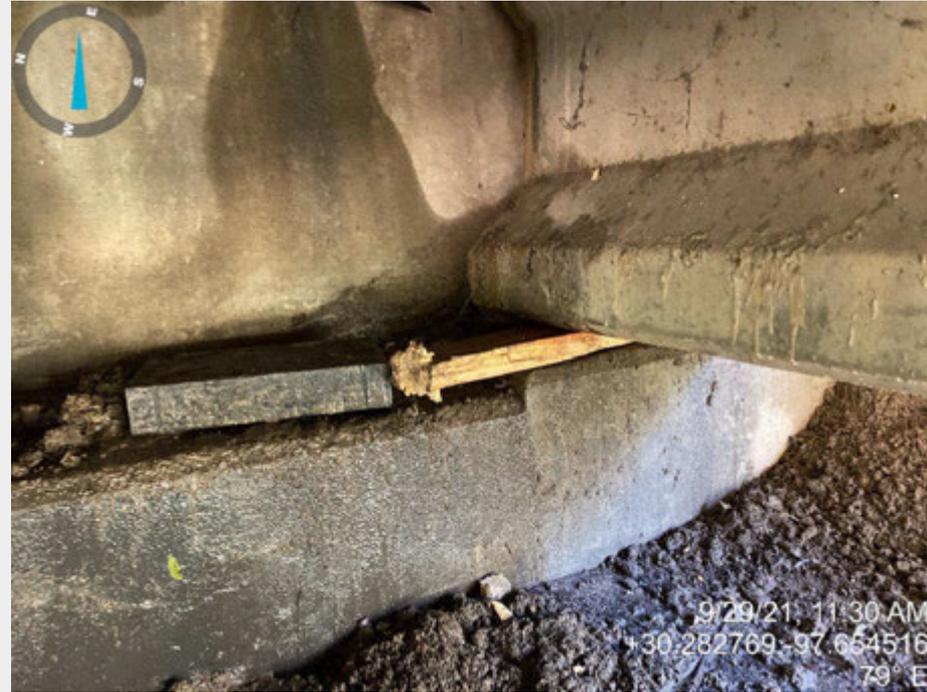
- Usually very limited issues
  - Overheight impacts
  - Spalled/delaminated beam ends
- Elastomeric bearings
  - Old bearings prone to slip
  - Test: Natural rubber will hold a flame
  - SS 4002
  - Replace all pads at bents or abutments where slip is occurring

Temporary fix – Timber Bearings!

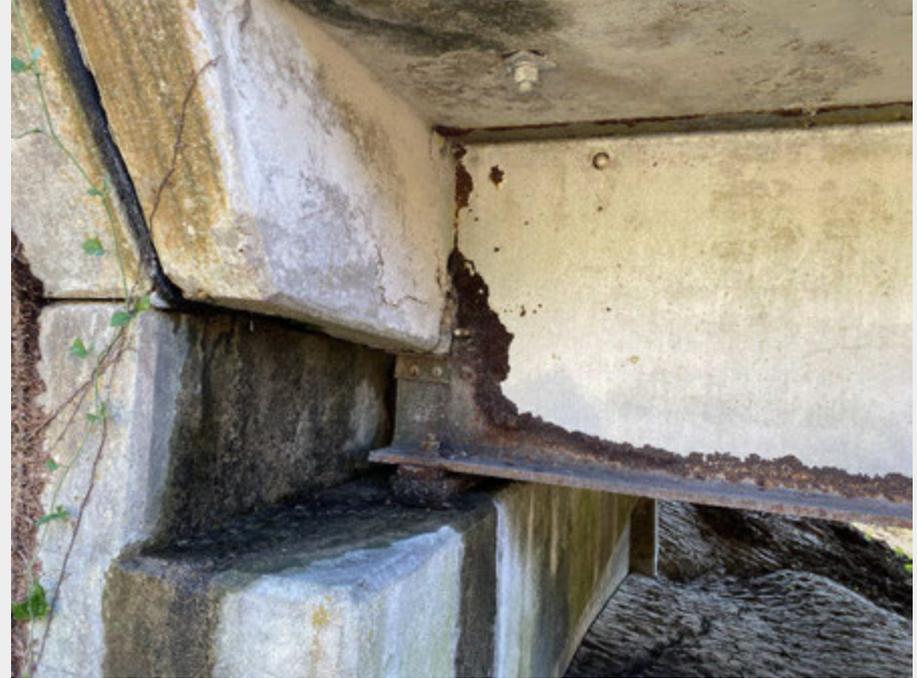
- Paint Condition
  - Consider zone painting
  - Not intended to address paint failure
  - Intended to address *areas of concern* related to paint failure
  - Typically beam ends at expansion joints, exterior bottom flanges

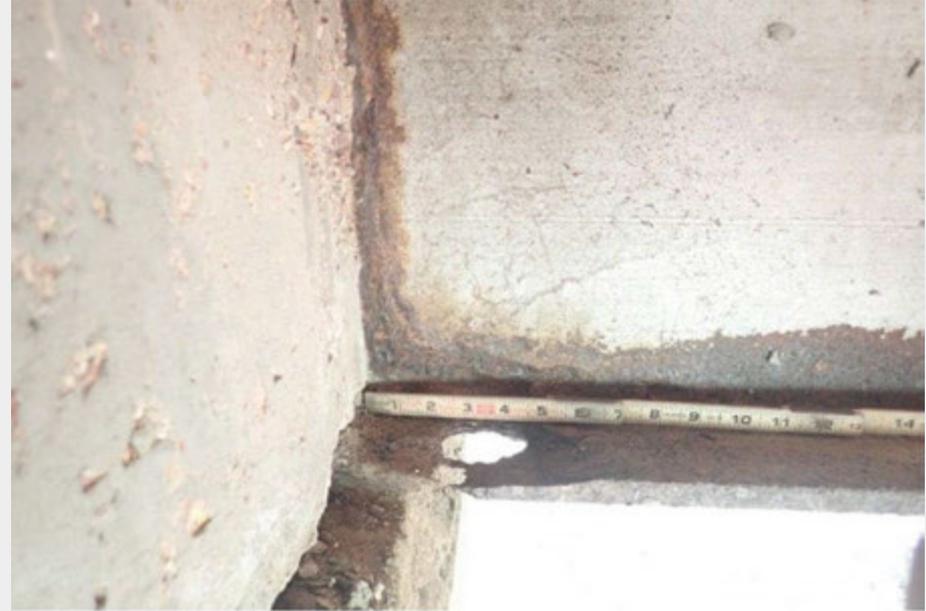
- Section Loss
  - Consider location
    - Webs at beam ends
    - Flanges at mid-span
  - Repairs
    - Maintain load path
    - Minimize “stress risers”
    - Smooth transitions
    - Grind edges of holes
    - Paint repair area

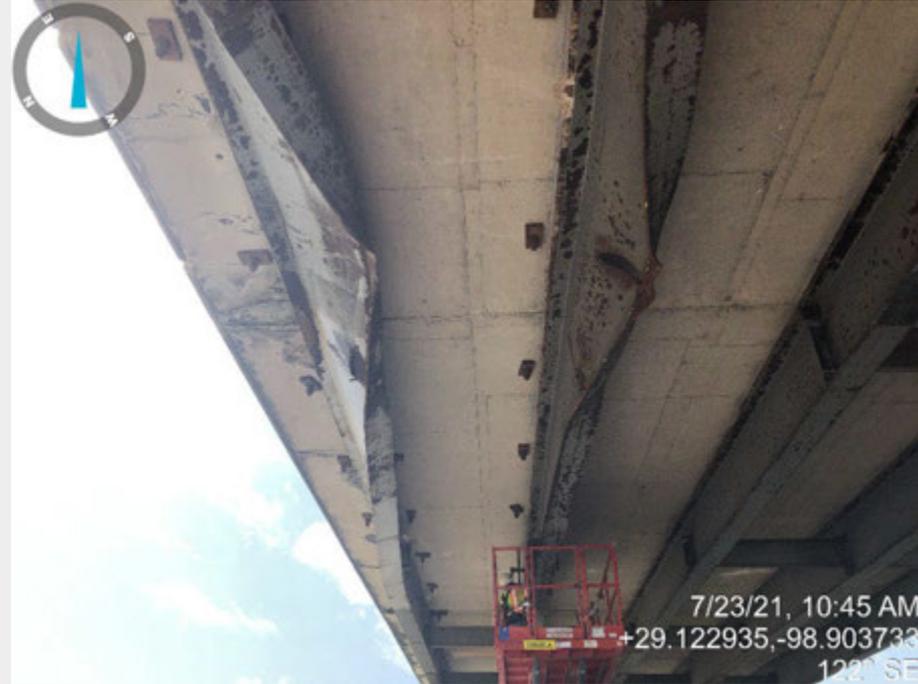
- Overheight Impacts
  - Very common
  - Steel → Older → Lower clearance
  - Repairs
    - Heat straightening (Item 784)
    - Grind out defects
    - Crack arrest hole drilling
    - Half section replacement
    - Full section replacement

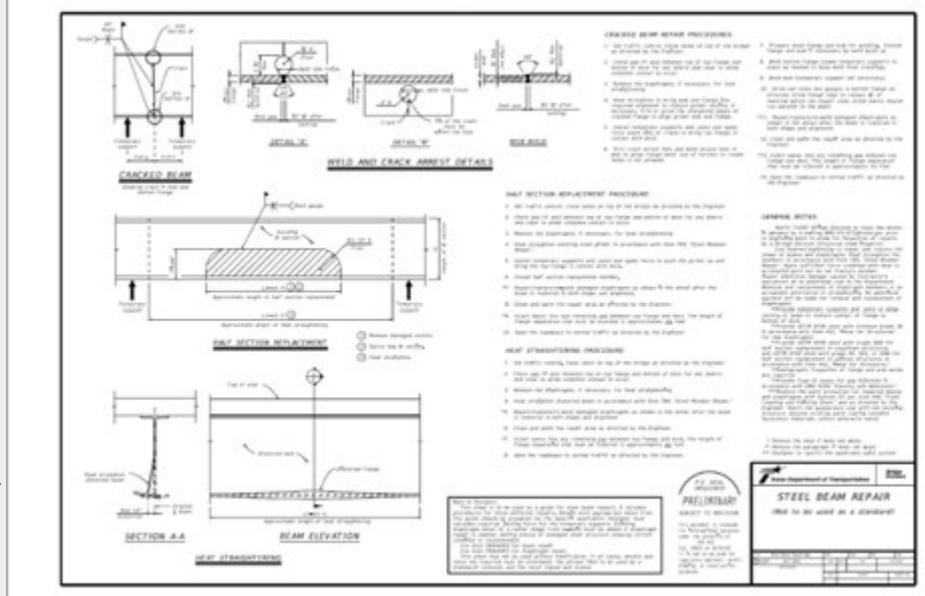
WD-SBR-22

- Overheight Impacts
  - Very common
  - Steel → Older → Lower clearance
  - Repairs
    - Heat straightening (Item 784)
    - Grind out defects
    - Crack arrest hole drilling
    - Half section replacement
    - Full section replacement

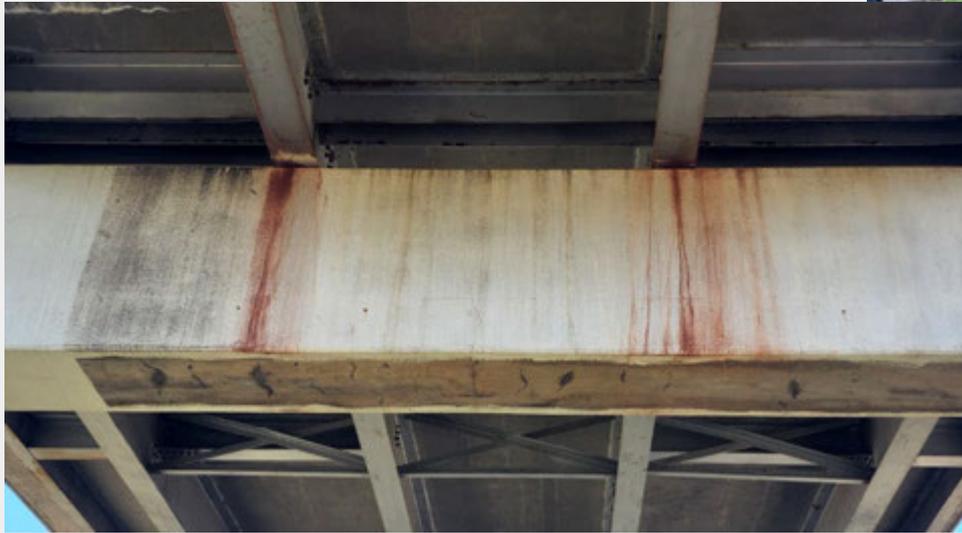
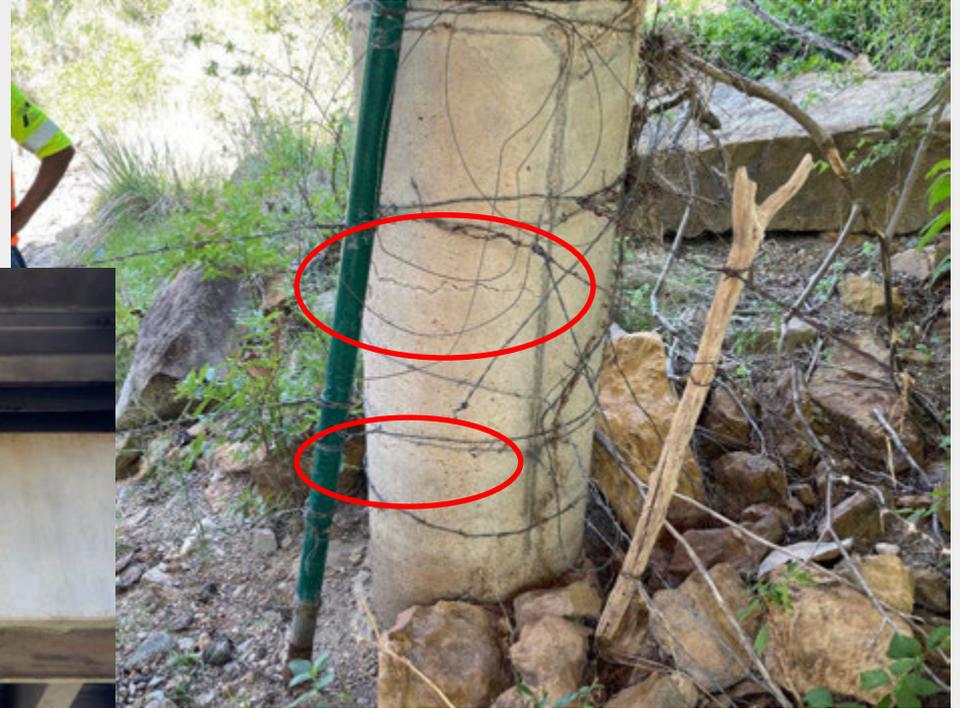
- Column cracking/spalling
- Stress cracks in cap

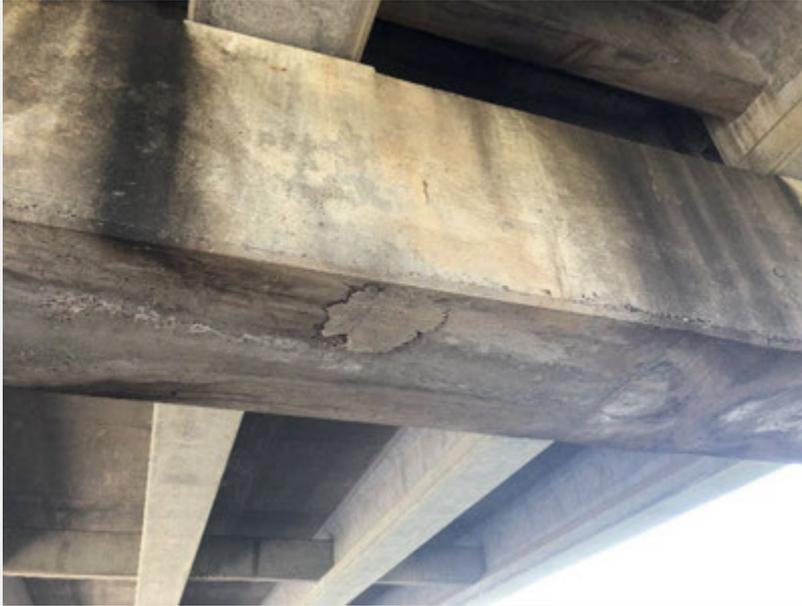
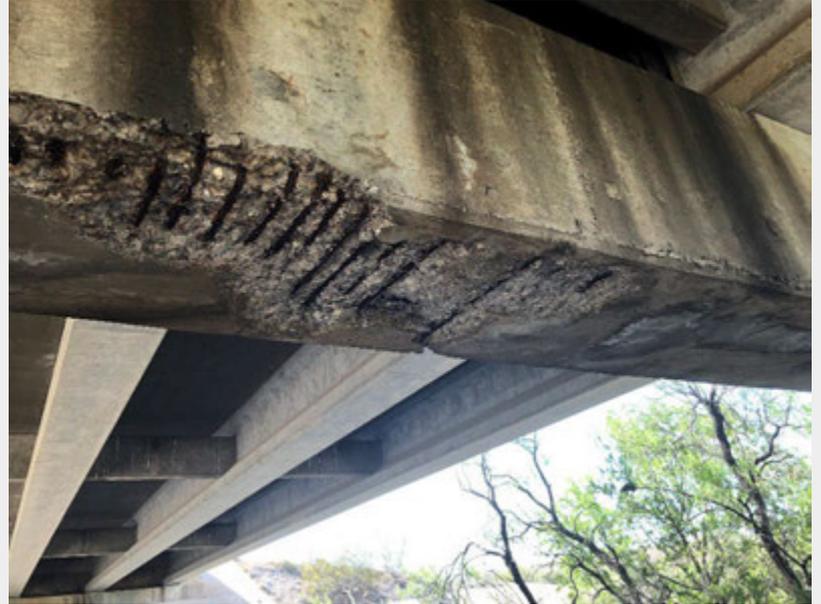
- Substructure spalling
  - Overestimate quantity!

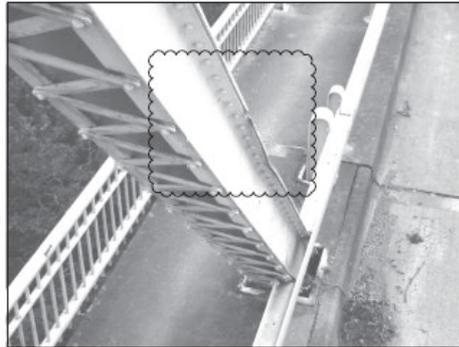
DIAGONAL MEMBER AT  
SPAN 8 NEAR TRUSS #2 (L2U2)

(Approximate length of heat straightening = 5 ft.)

DAMAGED DIAGONAL MEMBER

(Step 1)

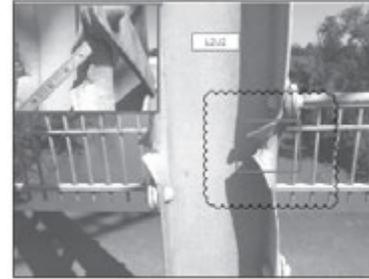
VERTICAL MEMBER AT  
SPAN 8 NEAR TRUSS #2 (L2U2)

(Approximate length = 2 ft. of repair)

VERTICAL MEMBER

(Step 2)
