Selection of BMIP Projects

Mike Roetheli, P.E.
Abilene Bridge Engineer

April 25, 2025

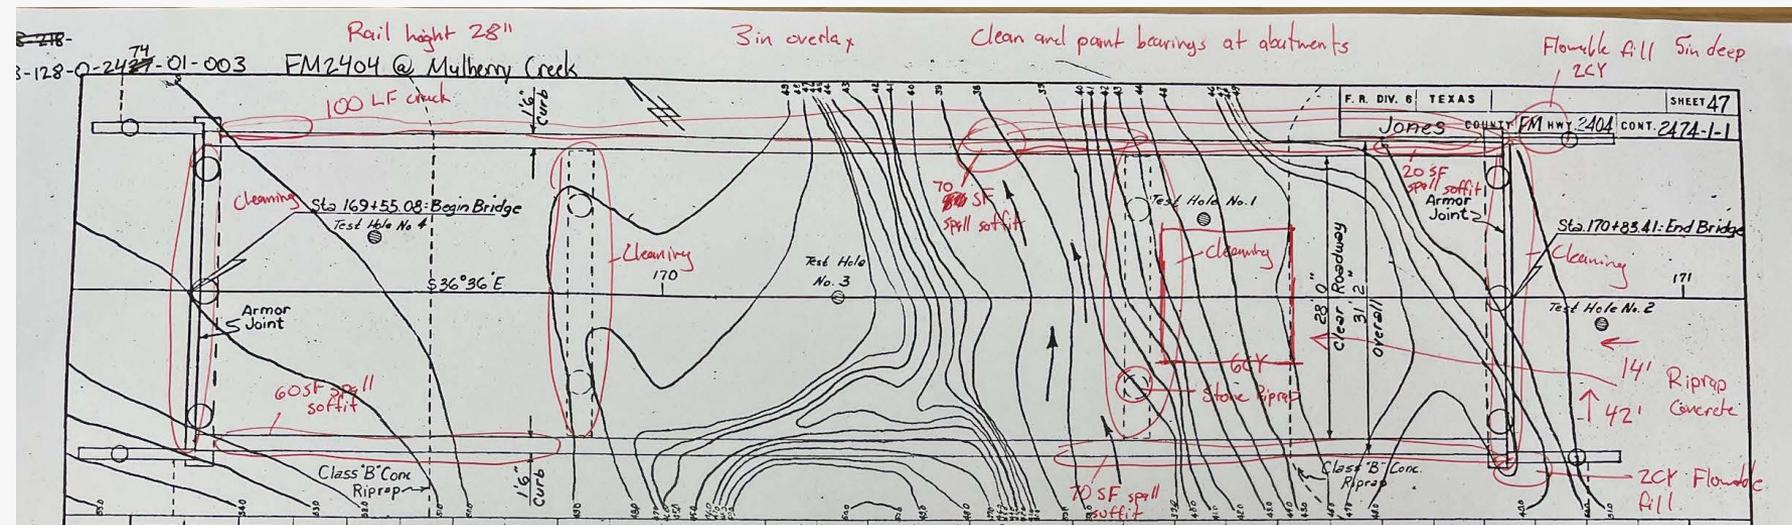
Candidate List- Field Assessment

- Begin to gather field data
 - Make notes on As-built printouts of needed repairs, est. quantity, etc
 - Photos of defects
 - Use drones to take pics/inspect hard to see areas (bearings, top of caps)

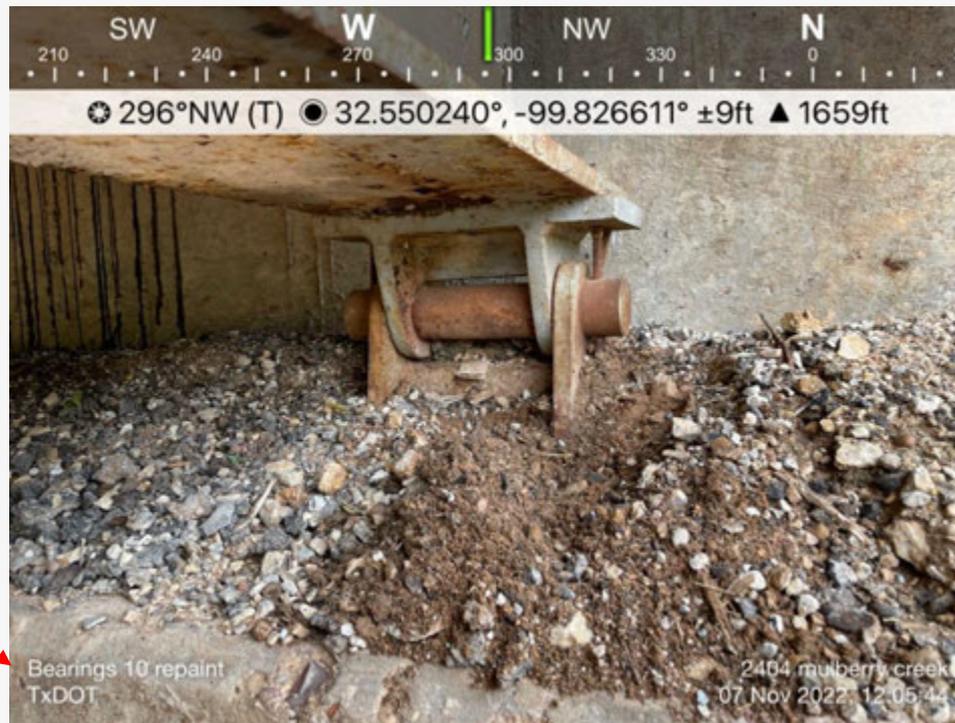
- Pictures

- Too many pictures? Nope.
- Use Solocator or similar app to make notes on pictures
 - Label Bridge
 - Put estimated quantity on photo

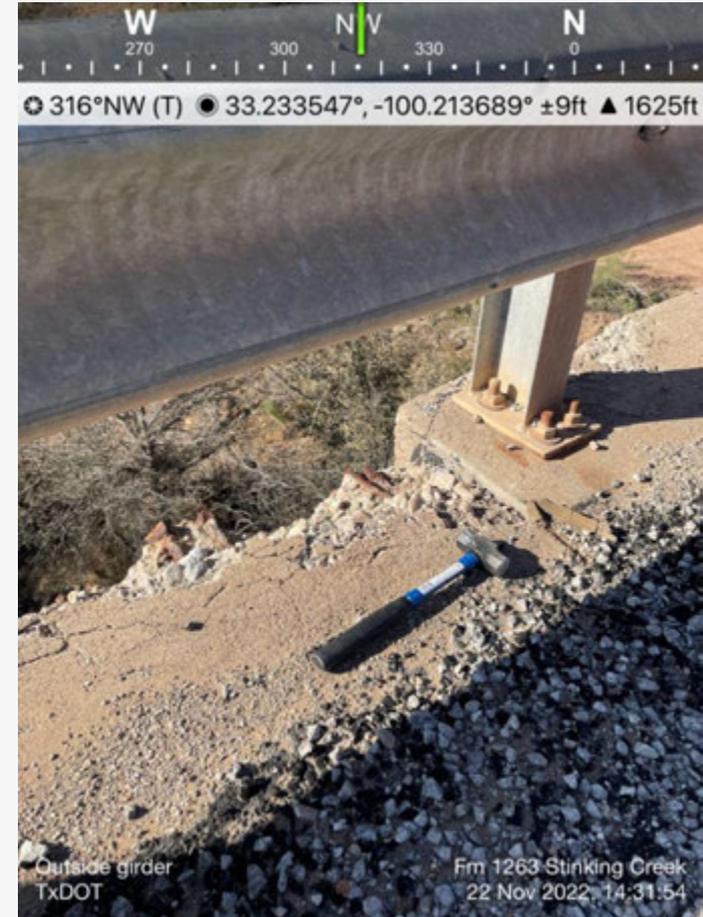
BMIP CANDIDATE EVALUATION FORM

4) Provide a brief description of the proposed scope of work on this structure:
 Put a PPC overlay on this deck to protect the deck, seal the small cracks already present and keep de-icing chemicals from further degrading the bridge. Clean & re-seal the joints.
